An audit of trained river entrances, armoured harbours and groynes and their multi-use and eco-features in NSW

Shellharbour to the Victorian border (Illustrated Volume III)

Title: An audit of trained river entrances, armoured harbours and groynes and their multi-use and eco-features in NSW: Shellharbour to the Victorian border (illustrated volume III)

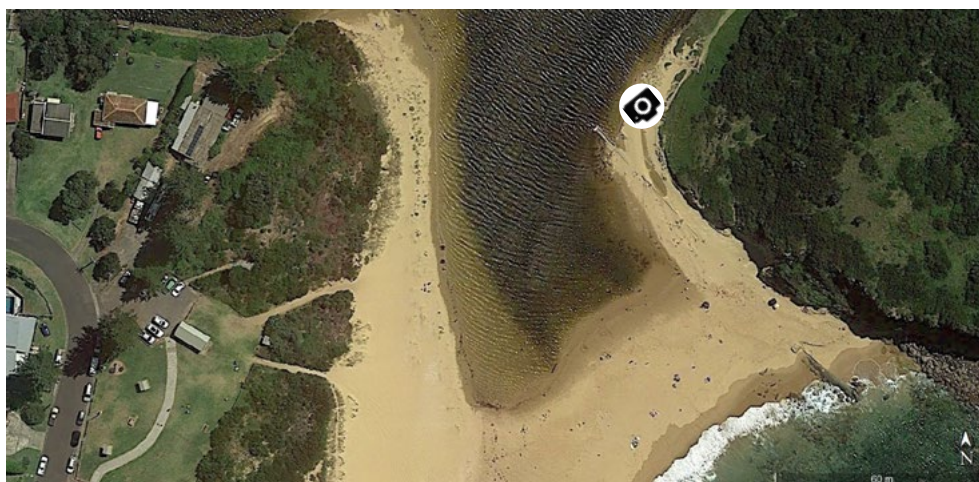
Entrance of Werri Lagoon, Gerringong with the concrete training pipe on the northern bank *Credit: Google Earth*

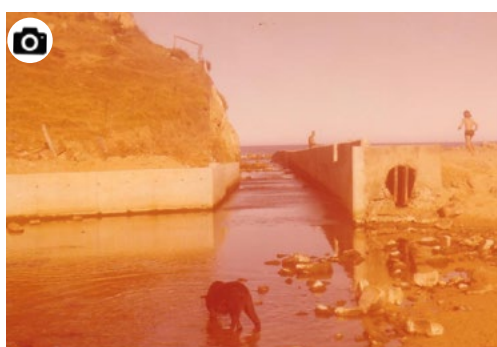
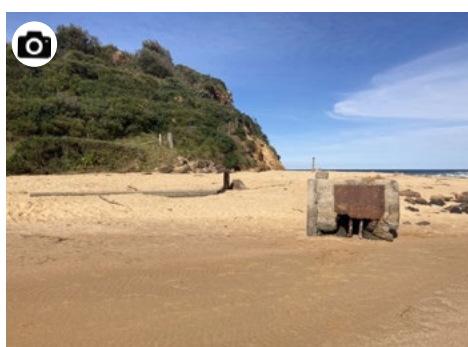
Werri Lagoon estuary is partially trained with a disused, deteriorating and often buried concrete race and pipeline structure on the northern side of the entrance. The estuary entrance is now managed in accordance with the Werri Lagoon Interim Entrance Management Policy. This involves occasionally using an excavator to create a breakout channel when water in the Lagoon has reached a trigger height of 1.65 m AHD (Kiama Council 2005).

Part of the deteriorated and buried concrete race and pipeline at the entrance to Werri Lagoon in 1970s (LHS) and today. *Credit: Kiama Council and Byron Robinson*

Recommendations: make the area safer by removing hazardous components (protruding metal pieces)

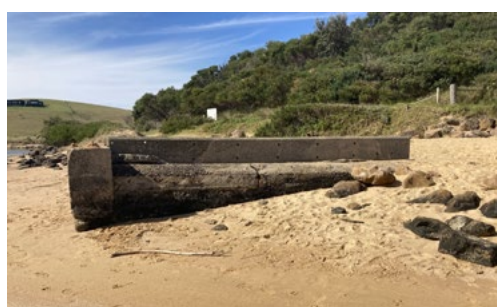
Lagoon inlet showing part of the deteriorated and buried concrete race and pipeline at the entrance to Werri Lagoon.

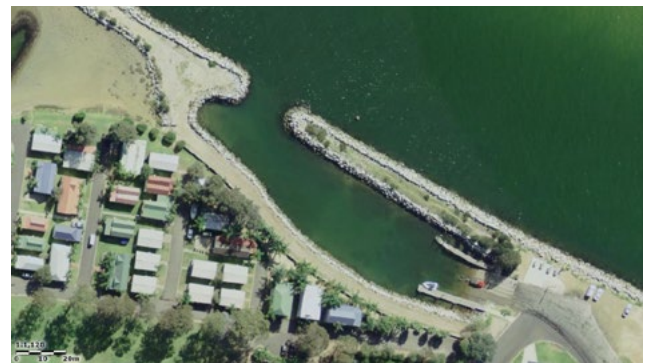
Inlet with key fish habitats that could be improved

- Enhance key fish habitat by improving flushing along parts of the training wall, especially where a stormwater outlet discharges into a backwater

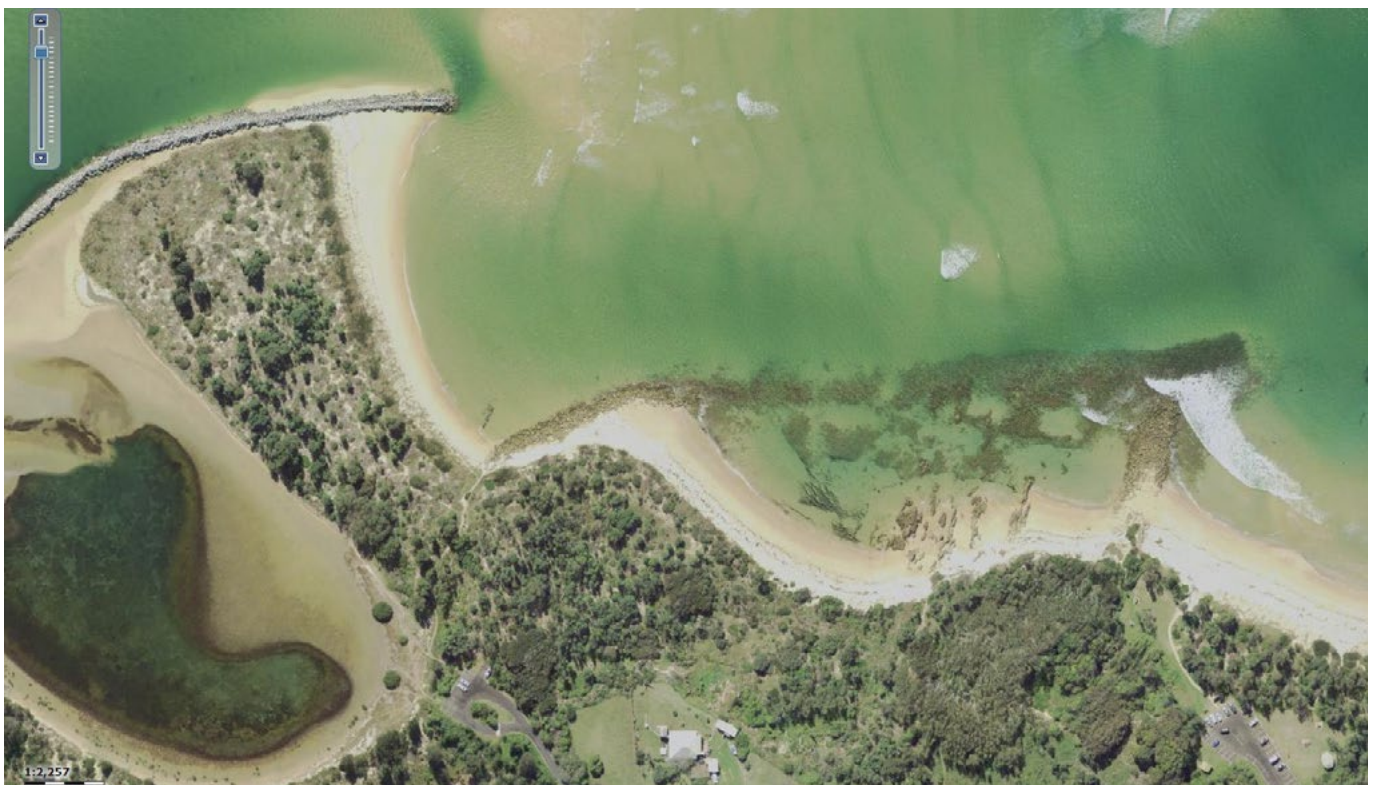
The Moruya River southern breakwater and submerged remnants of the original, heritage listed, southern breakwater. Credit: Six Maps

Recommendations for possible inclusion in future maintenance or upgrade works	
Future multi-use features	Future eco-features
– Document and recognise heritage values	Nil
