# An audit of trained river entrances, armoured harbours and groynes and their multi-use and eco-features in NSW

Stockton to Shellharbour (Illustrated Volume II)

First published December 2021

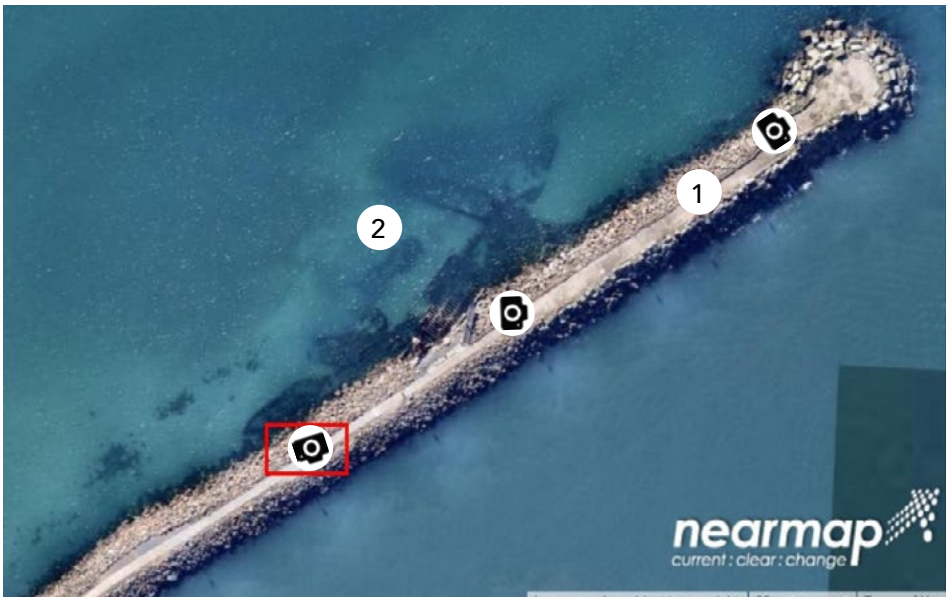
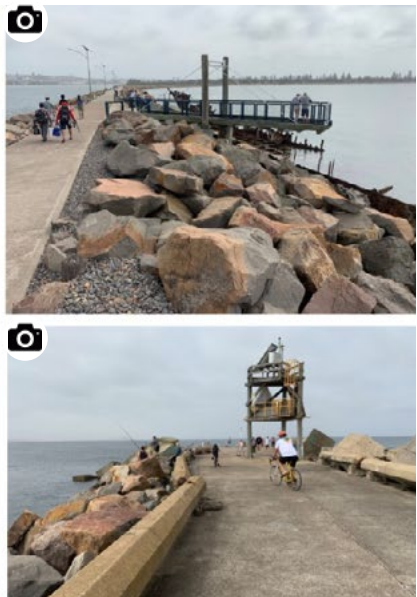
Aerial photo of the Hunter Northern breakwater showing (1) the breakwater and (2) heritage shipwrecks and water access  
Credit: nearmap

Safety stairs have been installed to assist divers accessing the shipwrecks adjacent to the Hunter River northern breakwater (detail from the top aerial image) Credit: nearmap

<p><b>Future multi-use features</b></p> <ul style="list-style-type: none"> <li>– Maintain pedestrian walkway surface</li> <li>– Rock placement for seating and fishing opportunities</li> <li>– Rock placement for emergency safety stairs</li> </ul>	<p><b>Future eco-features</b></p> <ul style="list-style-type: none"> <li>– Increase submerged habitat complexity</li> <li>– Key fish habitat enhancement along training walls</li> </ul>
---	--

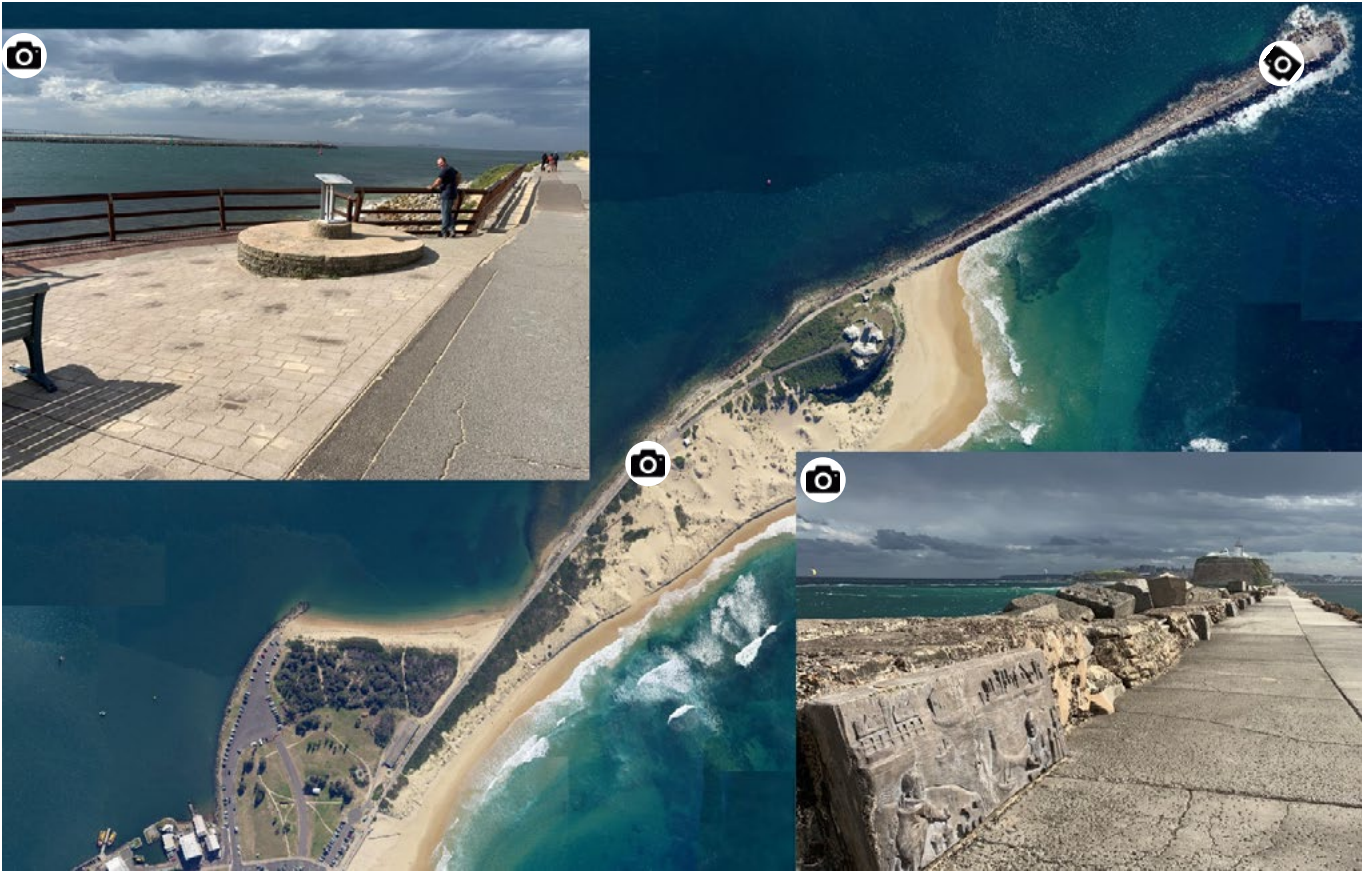
The Hunter estuary southern breakwater showing seating opportunities and relief artwork used to explain the historical importance of the breakwater *Credit: Google Earth*

<p><b>Future multi-use features</b></p> <ul style="list-style-type: none"> <li>– Maintain pedestrian walkway surface</li> <li>– Rock placement for emergency safety stairs</li> </ul>	<p><b>Future eco-features</b></p> <ul style="list-style-type: none"> <li>– Increase submerged habitat complexity</li> </ul>
---	---

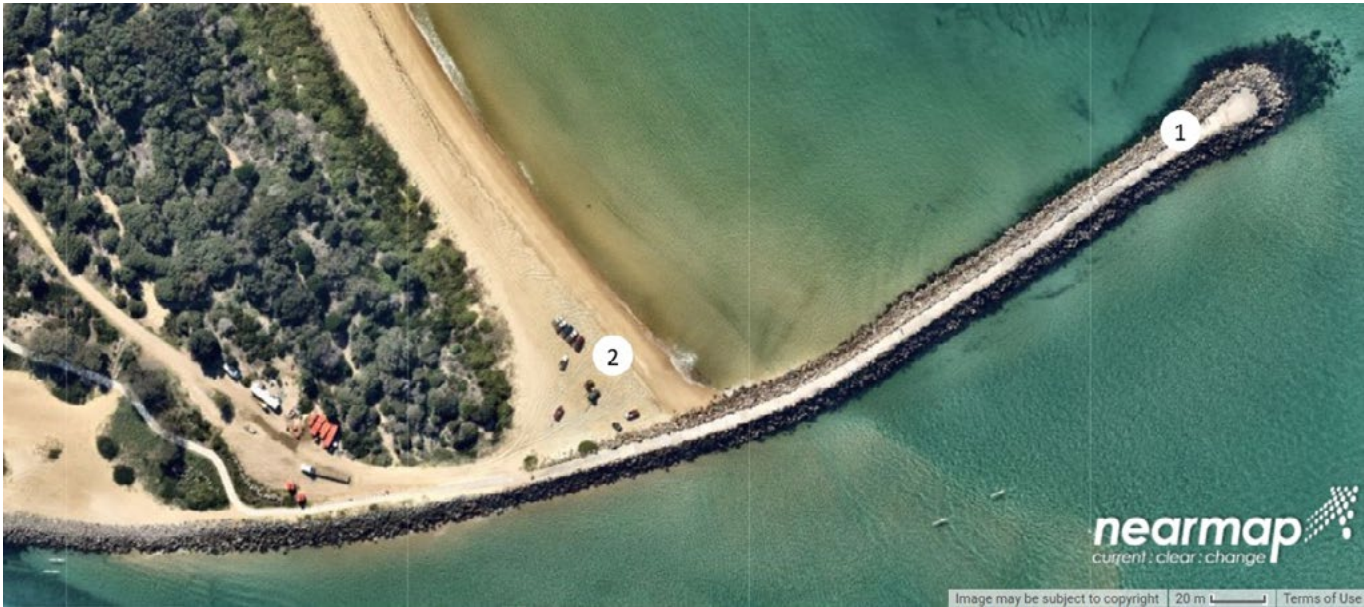
Aerial photo of the Lake Macquarie Northern breakwater showing (1) the northern breakwater; (2) commercial fishers haul mullet from the beach *Credit: NearMap*

<p><b>Future multi-use features</b></p> <ul style="list-style-type: none"> <li>– Maintain pedestrian walkway surface</li> <li>– Rock placement for seating and fishing opportunities</li> <li>– Rock placement for emergency safety stairs</li> </ul>	<p><b>Future eco-features</b></p> <ul style="list-style-type: none"> <li>– Increase submerged habitat complexity</li> <li>– Key fish habitat enhancement along training walls</li> </ul>
---	--

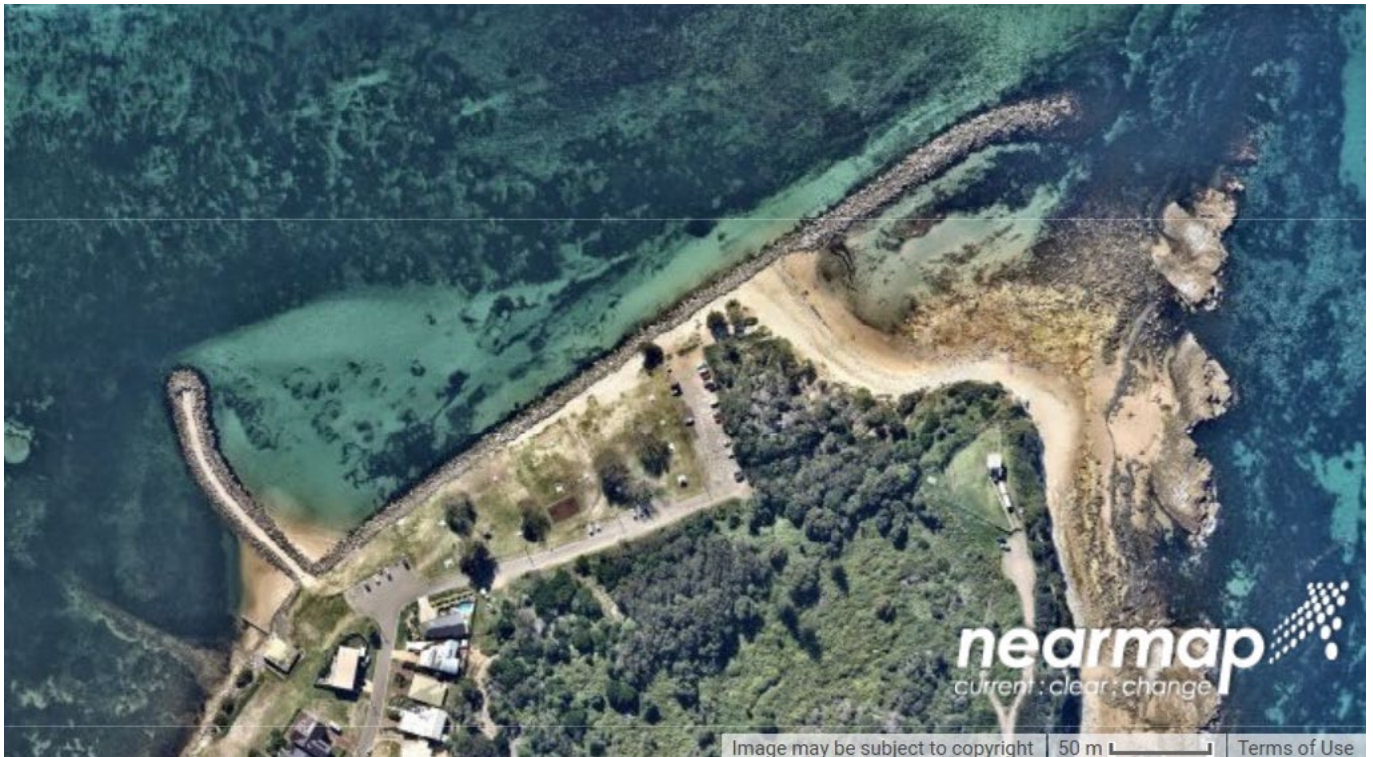
Aerial photo of (1) the Lake Macquarie southern breakwater (2) Lucys Groyne and (3) remnant erosion protection works  
 Credit: nearmap

<b>Future multi-use features</b>	<b>Future eco-features</b>
– Rock placement for emergency safety stairs	– Maintain breakwater fauna refuge area

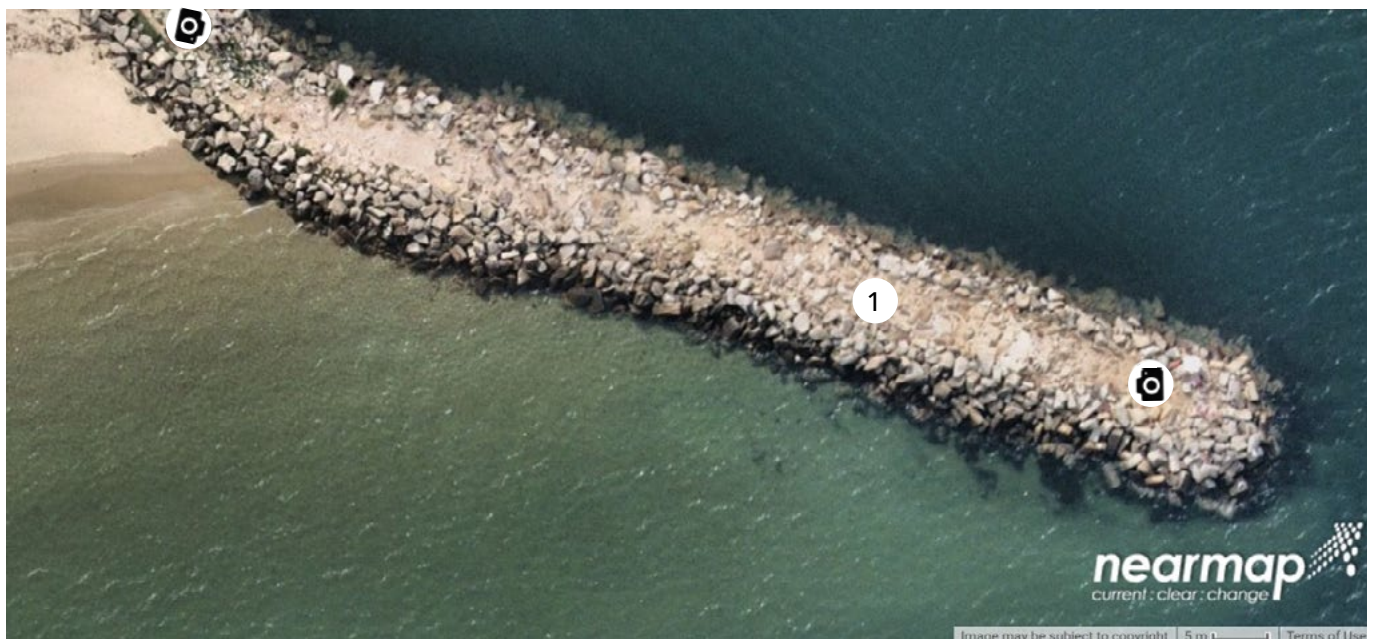
The southern training wall of the artificial entrance of the Cooks River into Botany Bay *Credit: nearmap*

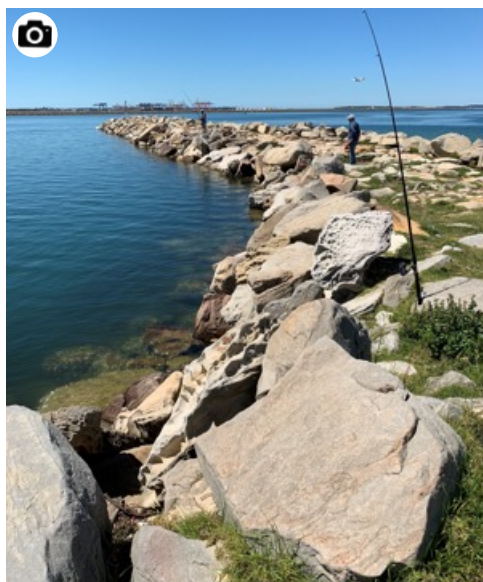
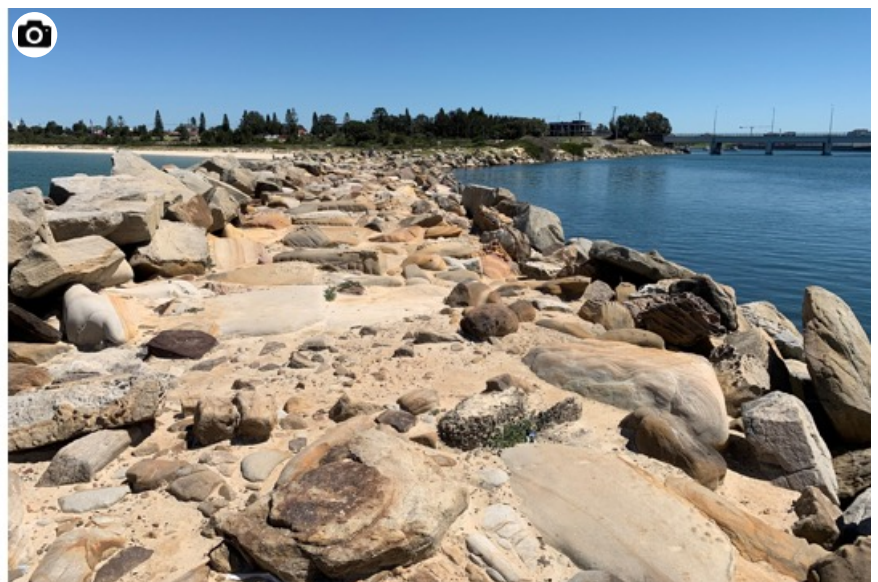
Fishing and plane spotting are popular activities on the southern wall, but the rubble surface is a hazard.

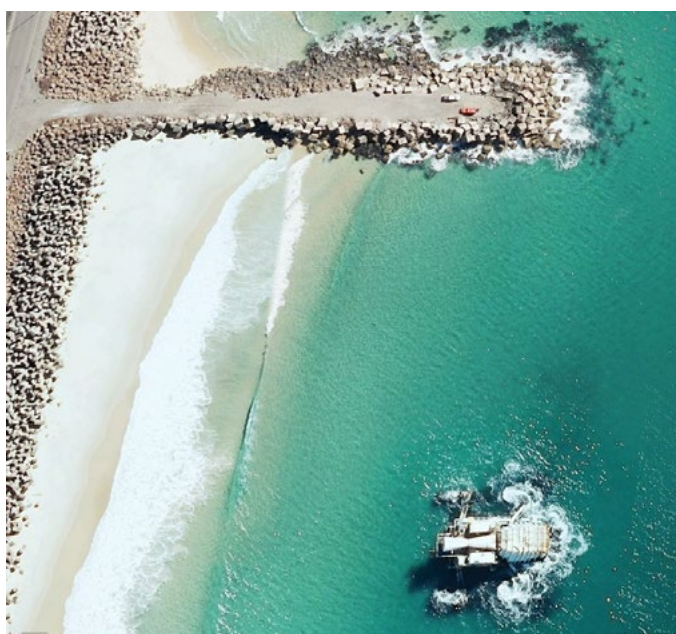
Approximately 1.2 million cubic metres of material dredged from Port Kembla was placed in the swash zone of South Wollongong Beach in the 1970s.

In 2006, an experimental wave energy generator known as the MK1 was installed. The generator worked for a short period only, and in 2017, the rusted and wave-impacted structure that had not operated for seven years was removed. The Google Earth image (left) shows the structure in 2008 when it was still functioning.

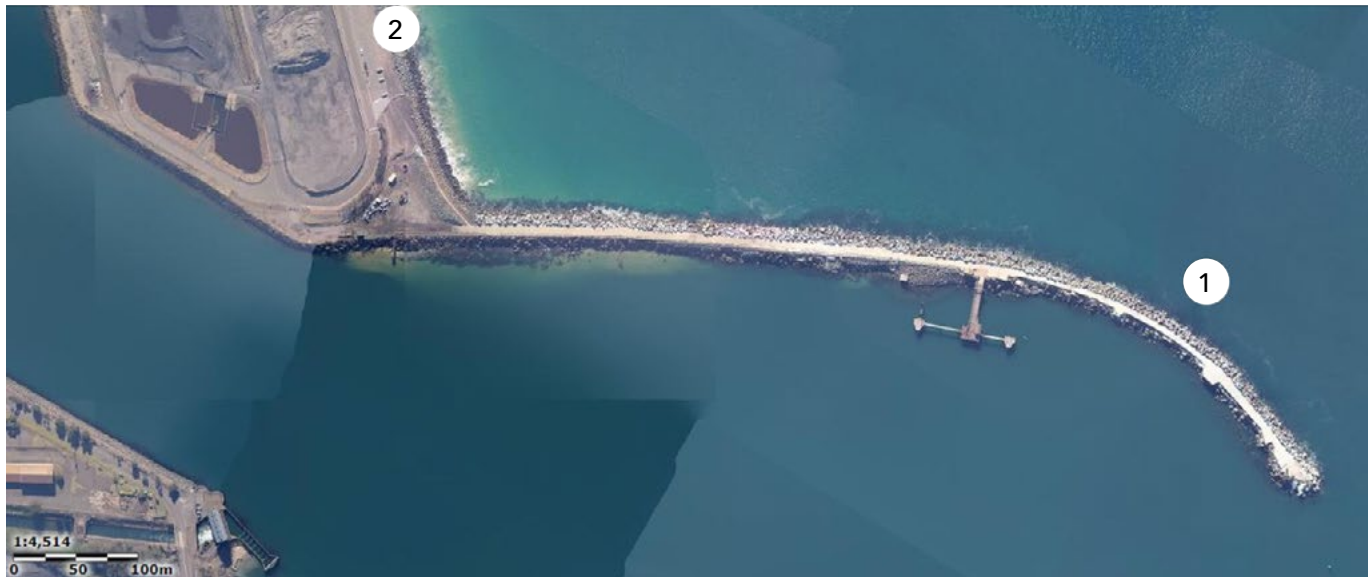
The northern Port Kembla breakwater: (1) the breakwater; (2) Rock armoured South Wollongong Beach south of the MM Groyne Credit: Six Maps

Recommendations for possible inclusion in future maintenance or upgrade works	
<b>Future multi-use features</b>	<b>Future eco-features</b>
<ul style="list-style-type: none"> <li>– Maintain and improve pedestrian walkway surface</li> <li>– Rock placement for seating and fishing opportunities</li> <li>– Rock placement for emergency safety stairs</li> </ul>	Nil

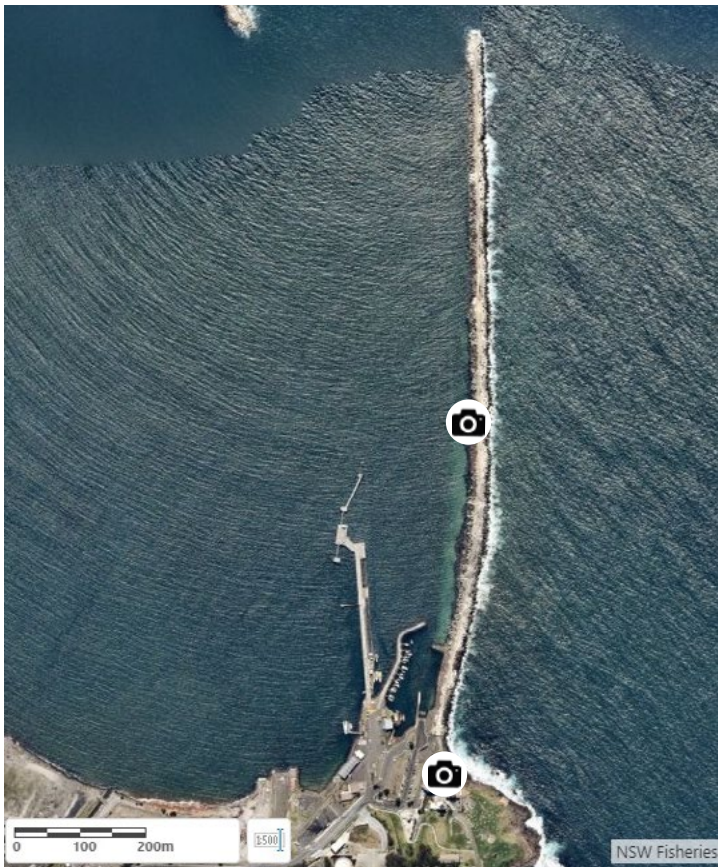
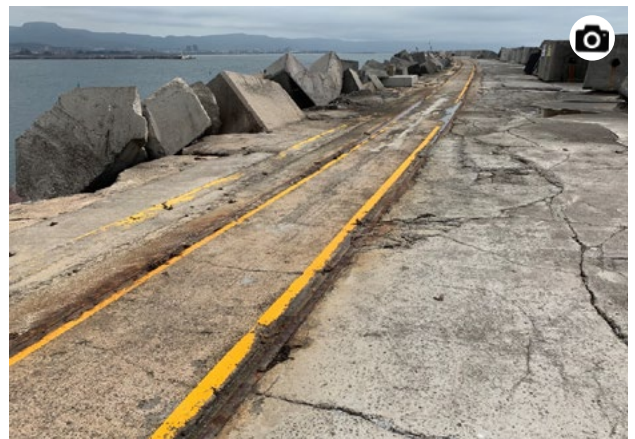
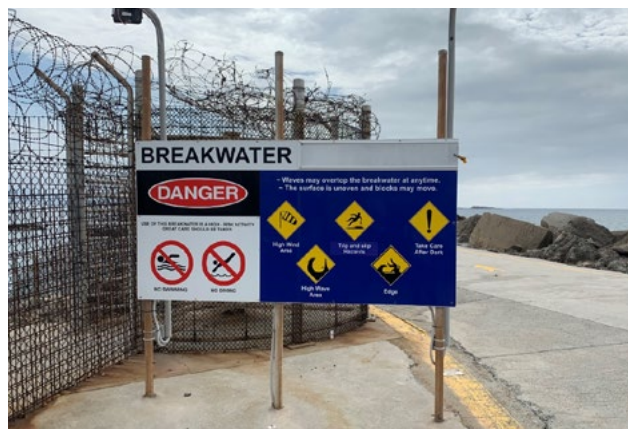
The Port Kembla eastern breakwater  
Credit: nearmap

Recommendations for possible inclusion in future maintenance or upgrade works	
<b>Future multi-use features</b>	<b>Future eco-features</b>
<ul style="list-style-type: none"> <li>– Maintain and improve pedestrian walkway surface</li> <li>– Improve opportunities to enjoy the view</li> <li>– Rock placement for seating and fishing opportunities</li> <li>– Rock placement for emergency safety stairs</li> </ul>	Nil

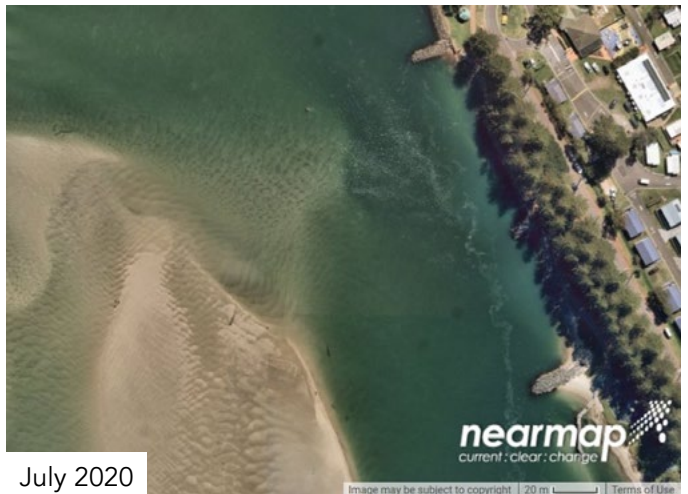
July 2020

Following training of the entrance at Lake Illawarra, tidal flows in the lake increased. This caused a loss of seagrass and erosion in some areas, which then required the installation of groyne and armoring of the foreshore. The two images show before (2011) and after (2020)
