An audit of trained river entrances, armoured harbours and groynes and their multi-use and eco-features in NSW

Queensland border to Stockton (Illustrated Volume I)

Title: An audit of trained river entrances, armoured harbours and groynes and their multi-use and eco-features in NSW: Queensland border to Stockton (illustrated volume I)

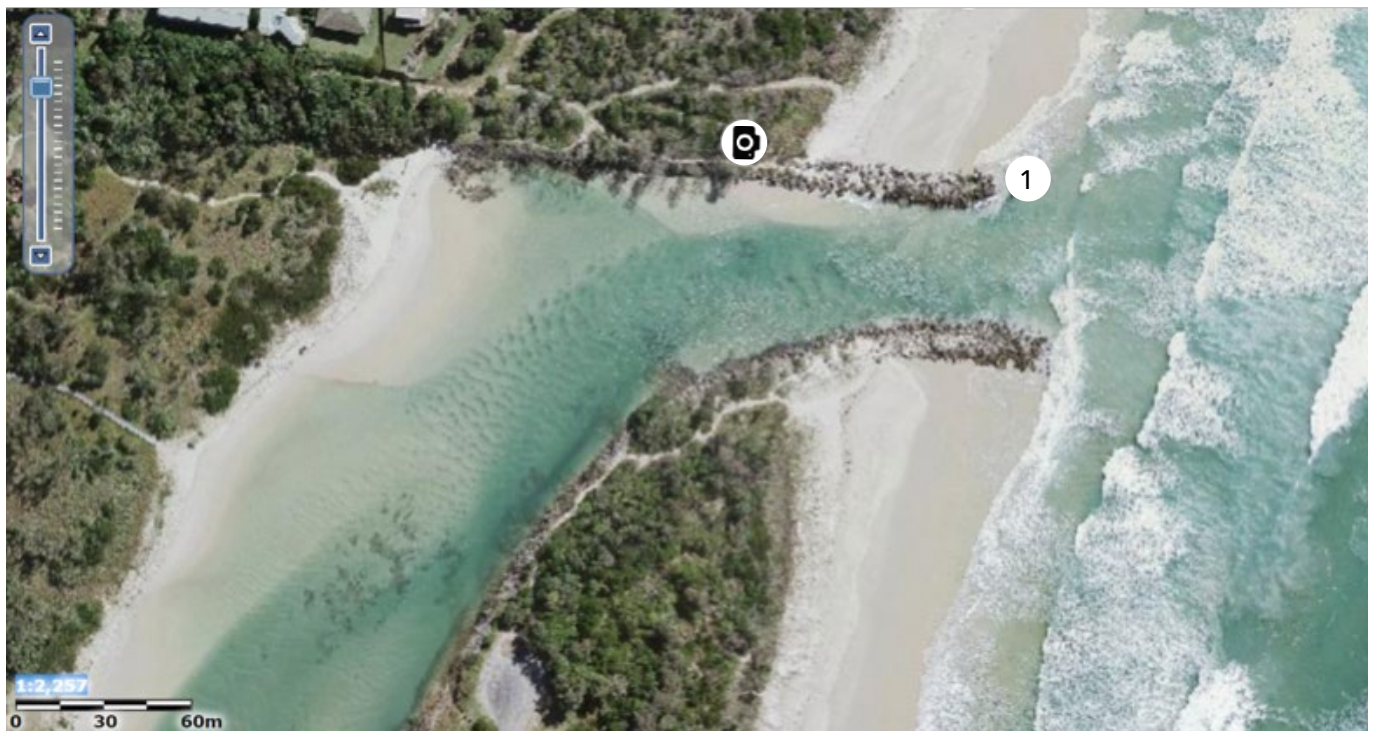
Mooball Creek Northern breakwater (1)

Responsible Authority:	NSW State Government
Built:	1968
Primary purpose when first built:	Trained entrance for flood mitigation of Mooball Creek coastal floodplain
Current uses:	The breakwater has partially collapsed. The WBM (2015) Flood Risk Study found: 'dredging the creek would have limited to negligible improvements on flood magnitude, extent and duration of inundation'

Recommendation: examine and assess primary purpose

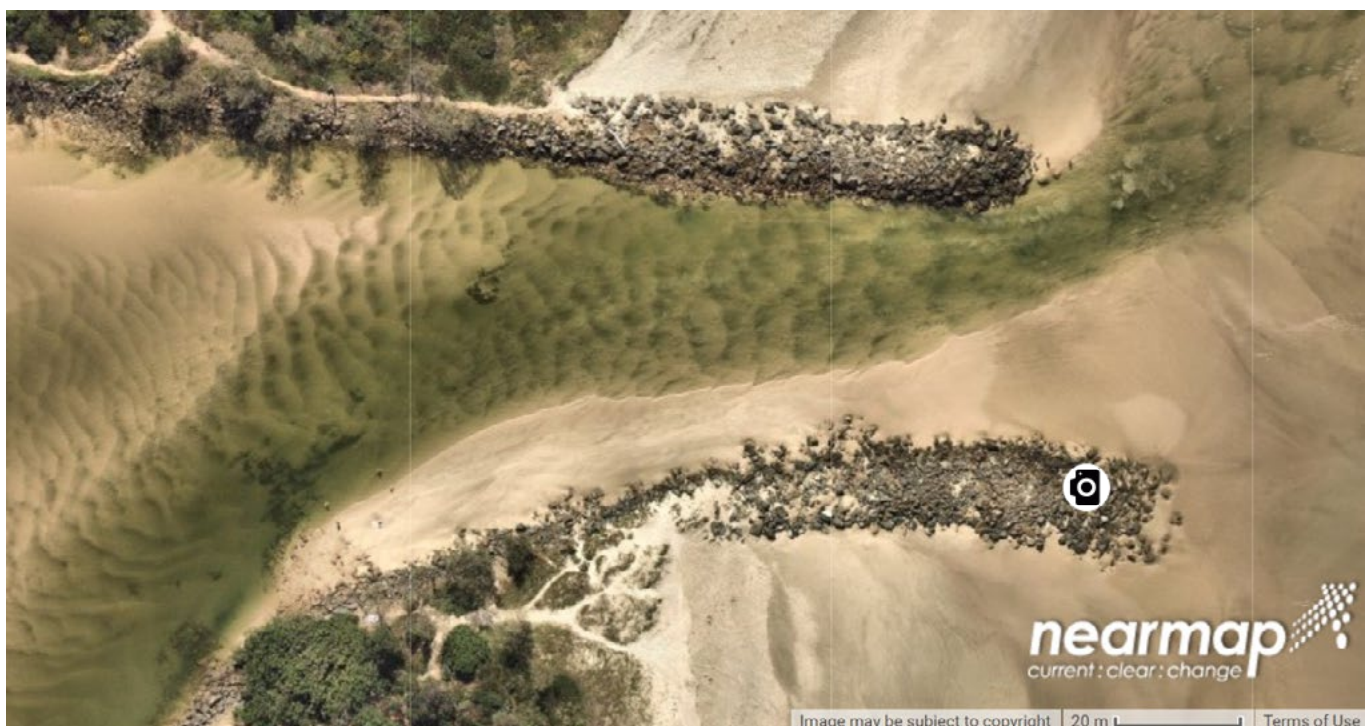
Mooball Creek, sometimes known as Pottsville Creek, southern breakwater *Credit: nearmap*

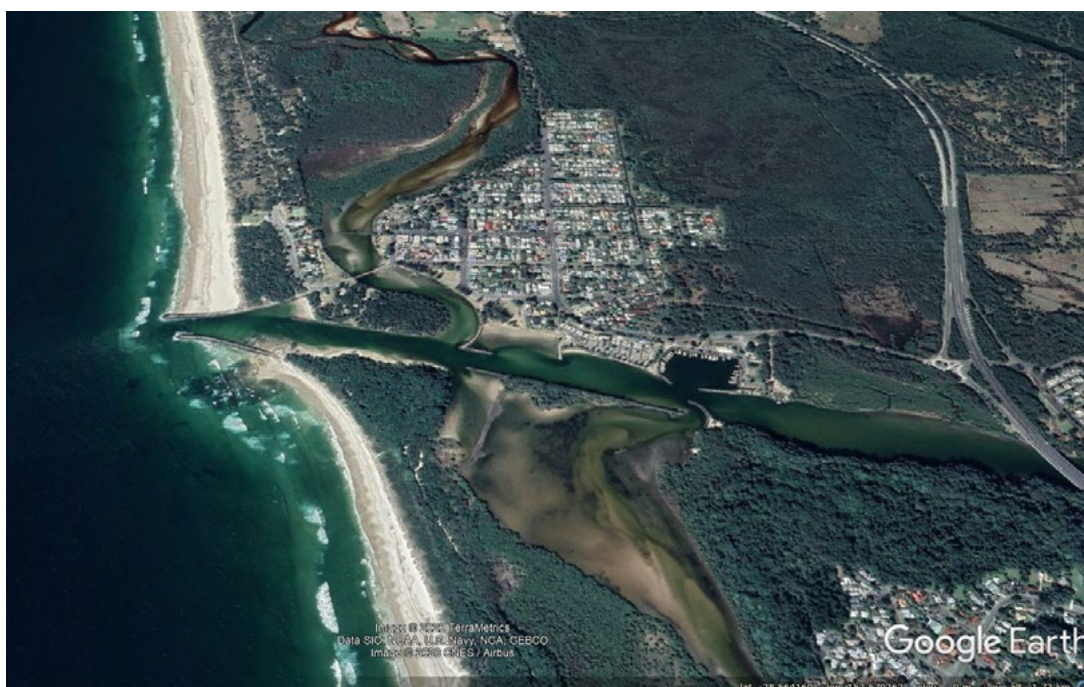
Prior to construction of the Brunswick River trained entrance breakwaters, erosion rates at Sheltering Palms were 0.5 m per year; rates increased to 2.6 m per year after construction (Gordon et al. 1978).

Brunswick River estuary looking south, showing its trained entrance. A carpark near the site of the abandoned village of Sheltering Palms provides access to the northern breakwater.

<p>Future multi-use features</p> <ul style="list-style-type: none"> – Install CoastSnap photo point – Rock placement for emergency safety stairs 	<p>Future eco-features</p> <ul style="list-style-type: none"> – Maintain breakwater fauna refuge area – Key fish habitat enhancement along training wall
---	---

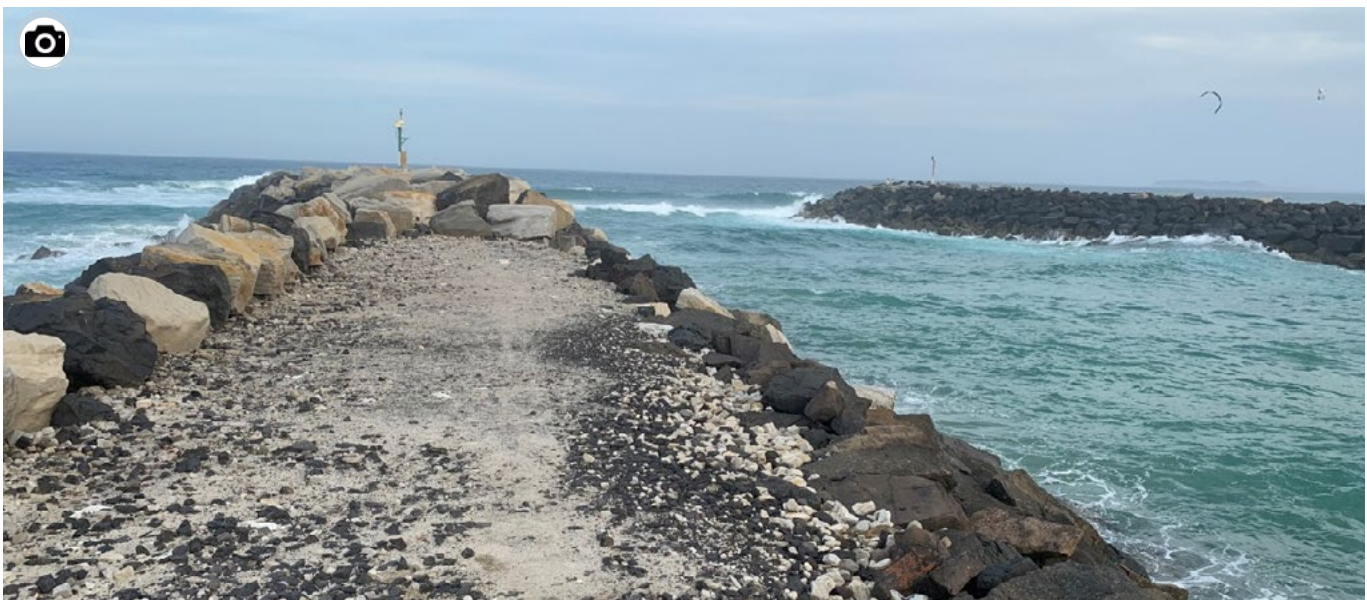
The rough surface of the semi-remote breakwater has been left as large boulders at the head of the breakwater creating a fauna refuge area.

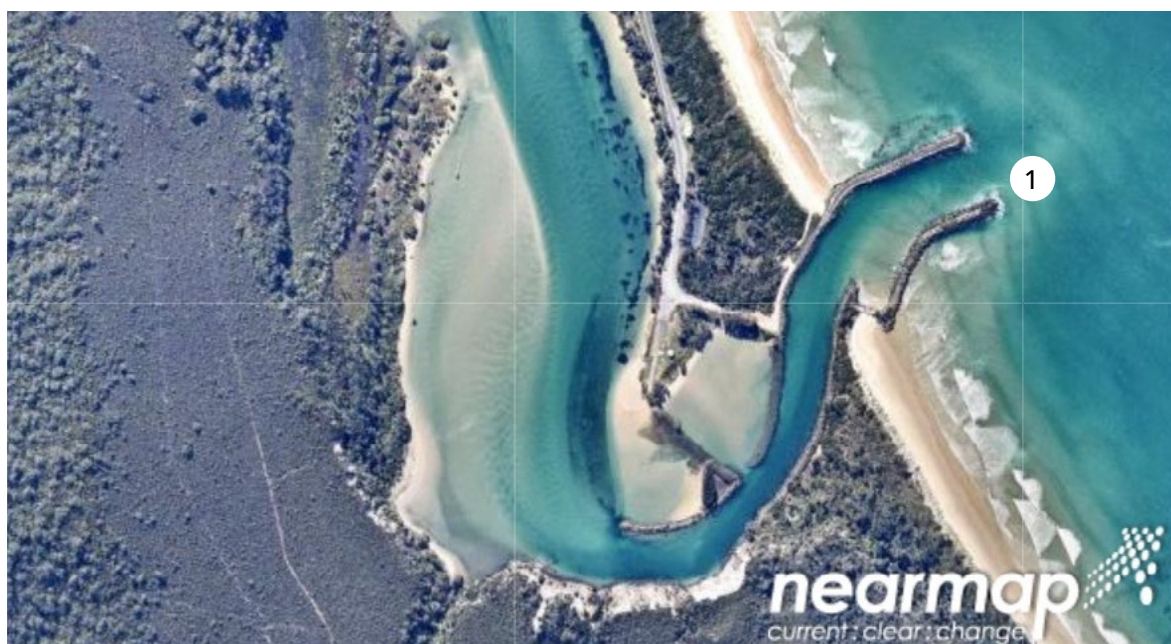
The trained entrance of the Wooli River estuary showing (1) the southern breakwater, the wave-trap beach and the lack of access to the southern breakwater *Credit: nearmap*

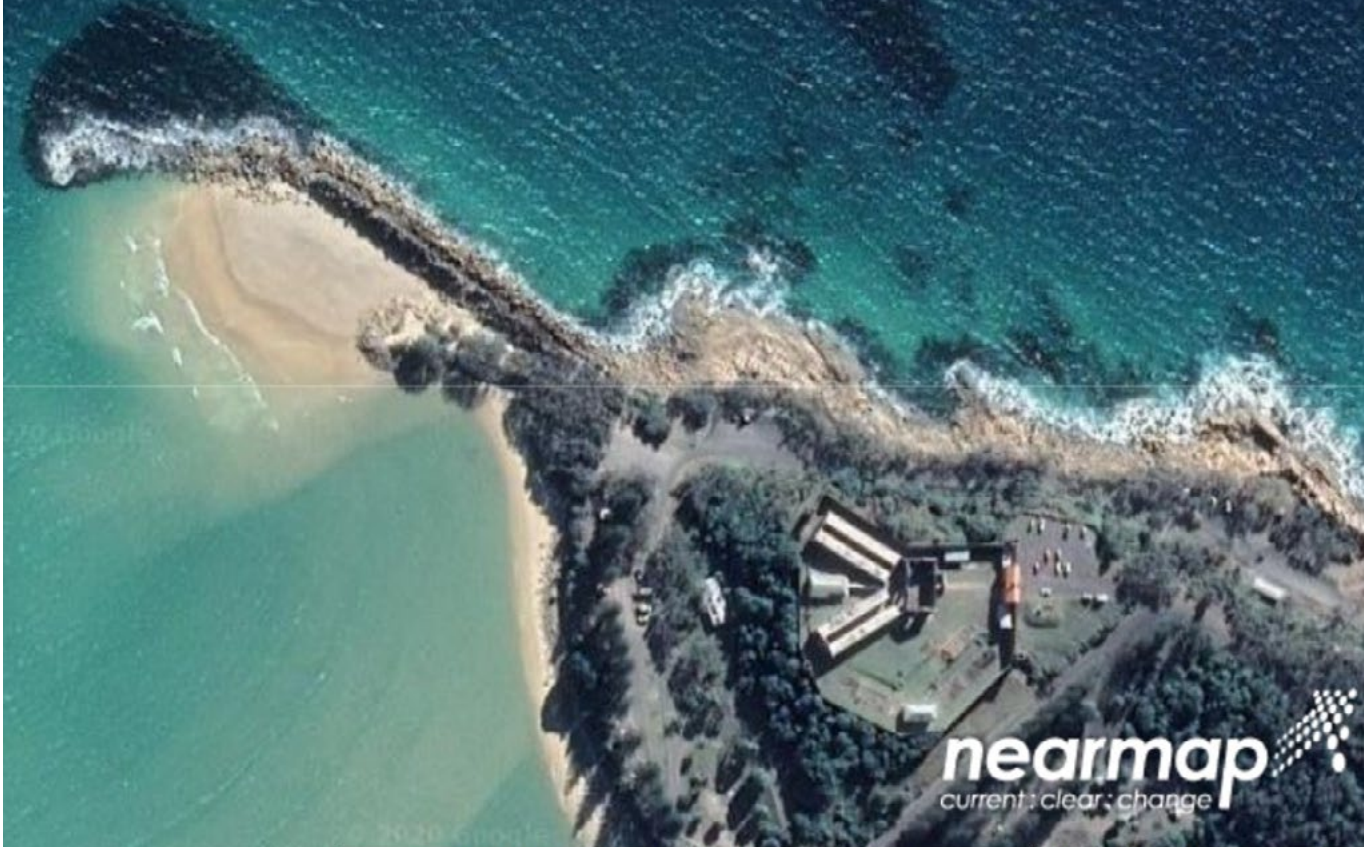
The breakwater was never completed and has resulted in accretion in Trial Bay *Source: nearmap*

Recommendation: evidence-based management to maximise environmental, social, cultural and economic values in the marine, intertidal and reserved estate areas

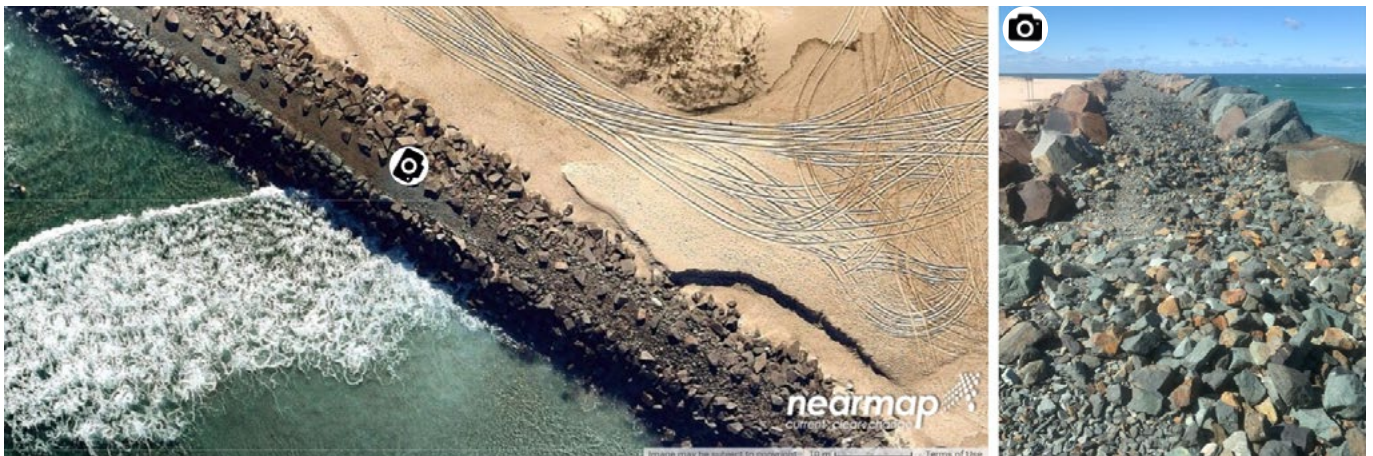
New Brighton Groyne: depending on the state of the beach, the structure is sometimes completely concealed by sand or a prominent feature *Credit: nearmap*
