# Macleay River Floodplain Prioritisation Study: Appendix A – L

WRL TR 2020/07, May 2023

By T A Tucker, D S Rayner, A J Harrison, G Lumiatti,  
P F Rahman, D M Gilbert and W C Glamore

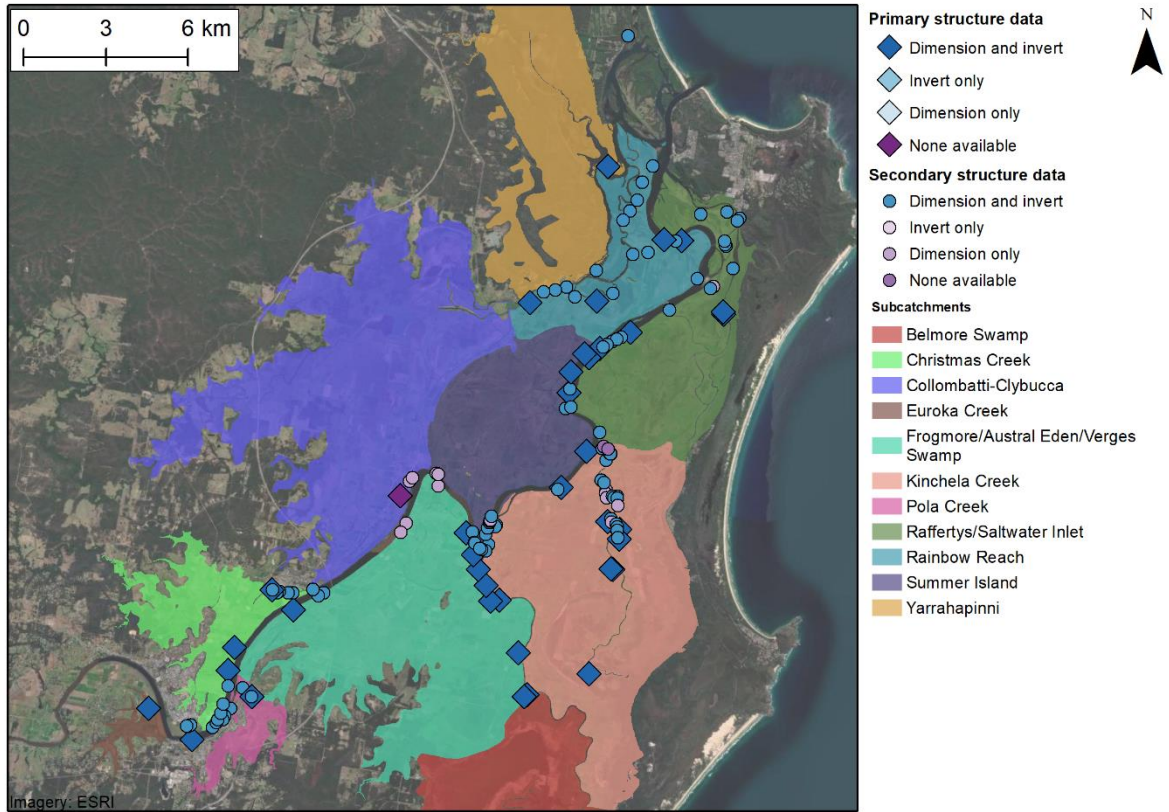
**Figure F-2: Summary of data available for end of system structures of the Macleay River floodplain**

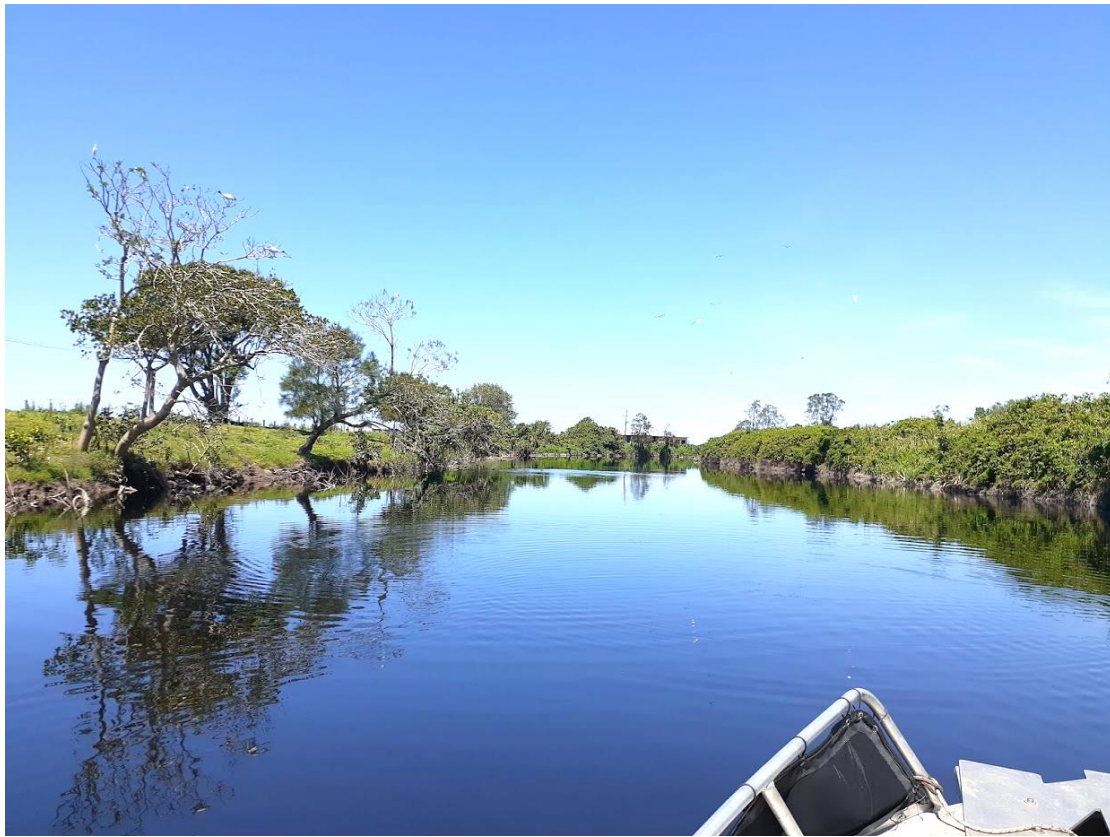
**Figure H-1: Blackwater observed in Kinchela Creek on 2 March 2020 where rugged dissolved oxygen was measured to be 0.00%**
