# Hastings River Floodplain Prioritisation Study: Appendix A – L

WRL TR 2020/08, May 2023

# Appendix A Floodplain waterways

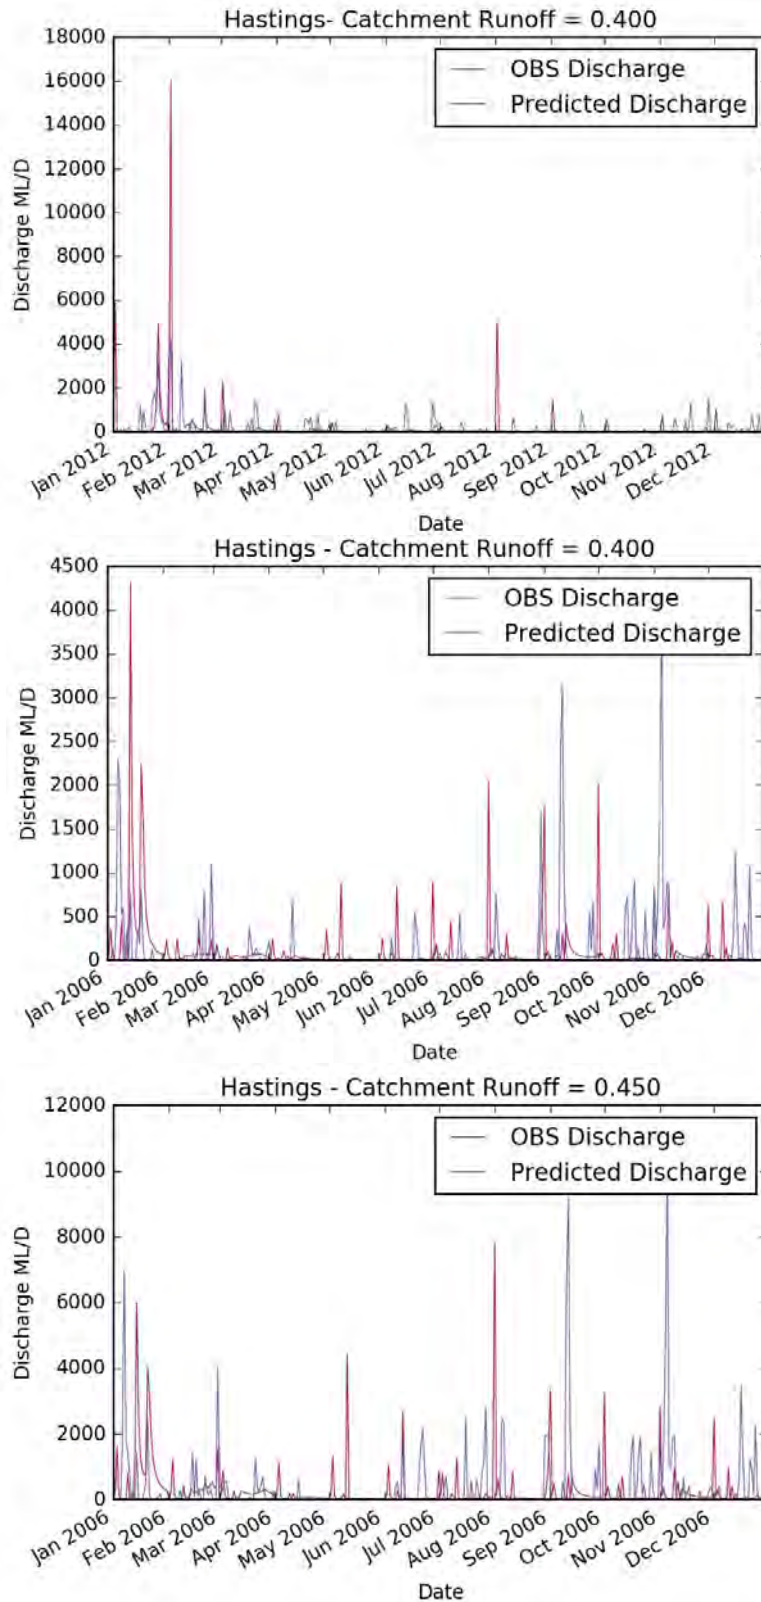
**Figure B-3: Predicted and observed runoff for the catchment area upstream of river gauging station 207017 (top), station 207010 (middle) and station 207014 (bottom)**

The runoff co-efficient was selected by comparing the annual time-series of streamflow data for the predicted runoff volume calculated for the selected gauging stations. Figure B-3 shows an example time-series of predicted and observed runoff for 2012. This analysis yielded an estimated runoff coefficient of 0.40 and 0.45, which was applied to Hastings floodplain subcatchments for the acid prioritisation assessment.

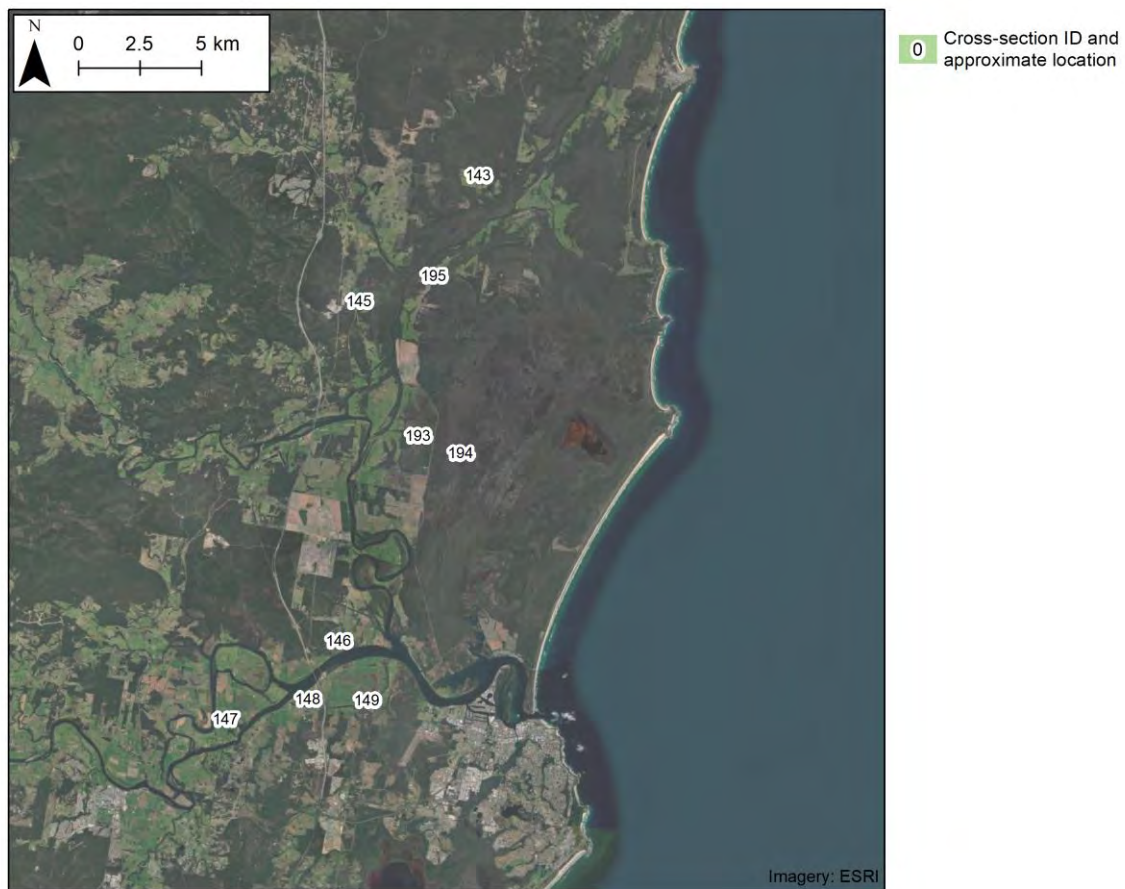
**Figure G-1: General location of cross-sections surveyed on the Hastings River floodplain**

During field investigations, floodplain drainage channels and waterways were surveyed opportunistically. Measurements were taken using Trimble GNSS RTK survey equipment as specified in Appendix A of the Methods report (Rayner et al., 2023). Locations of cross-sectional measurements surveyed across the Hastings River floodplain are shown in Figure G-1. All sections were surveyed from left bank to right bank (when looking downstream). Table G-1 provides the start and end coordinates for each cross-section, and individual cross-section profiles are shown from Figure G-2 to Figure G-10.
