Manning River Floodplain Prioritisation Study: Appendix A – J

WRL TR 2020/09, May 2023

UNSW
Water Research
Laboratory

Appendix A Floodplain waterways

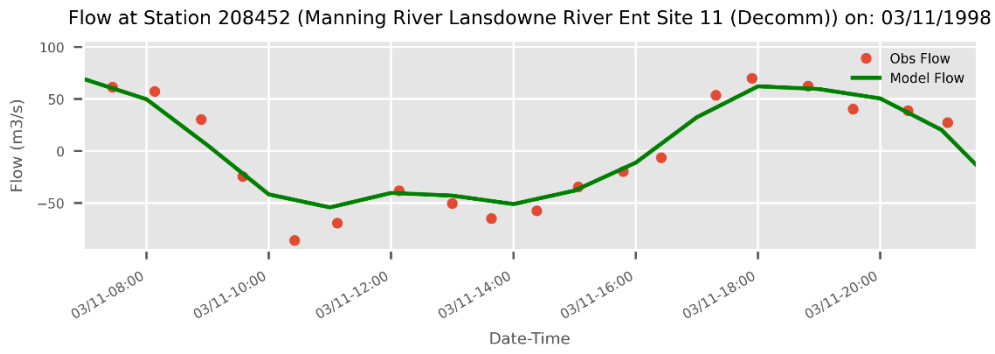
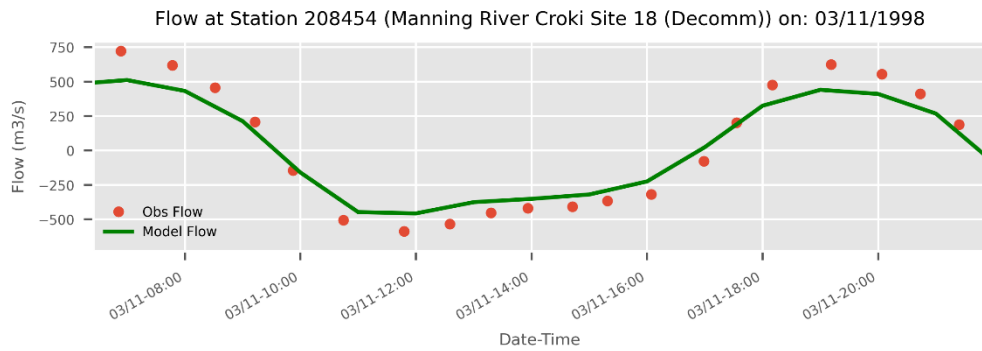
The main internal model parameters for hydrodynamic calibrations in the RMA-2 model are eddy viscosity and friction (applied as Manning's n). The model was calibrated by adjusting the Manning's n value to match the observed flow, tidal ranges and phasings throughout the estuary. A Manning's n value of 0.23 was adopted throughout the entire model domain.

The flow calibration results are shown in Figure H-5 to Figure H-10. The water level calibration results for an 8-day window during this period are shown in Figure H-11 and Figure H-15. The model was calibrated (for dry weather periods) to less than 0.2 m for the entire estuary.

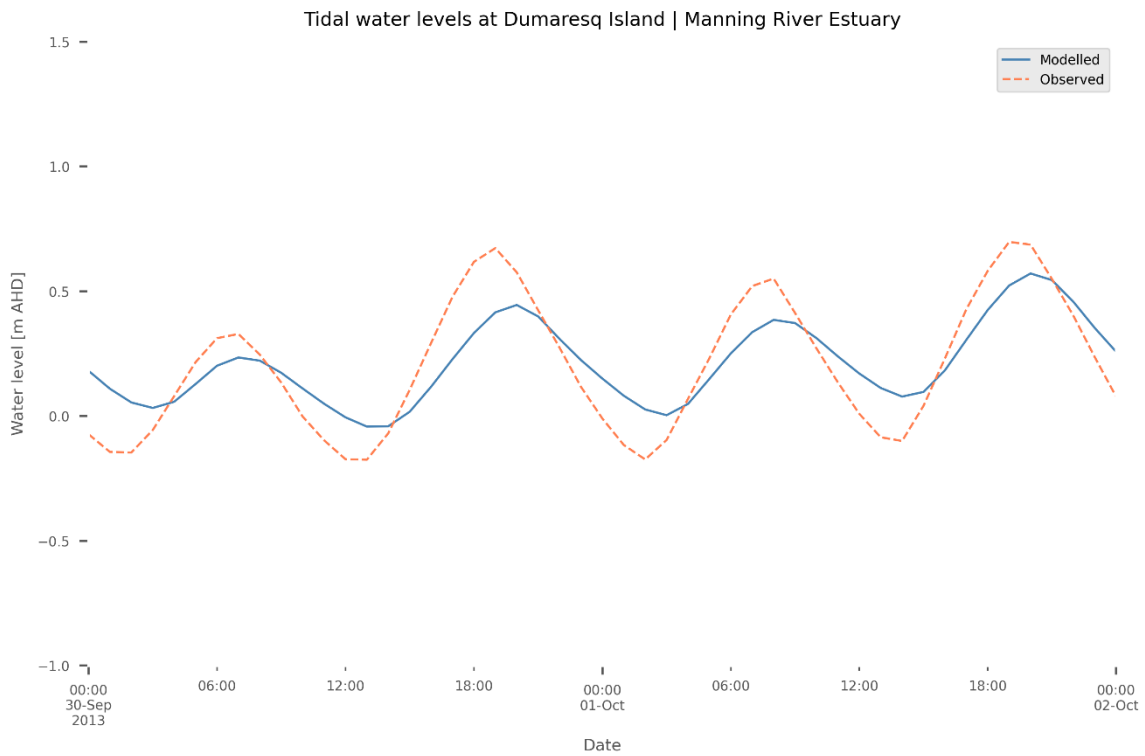
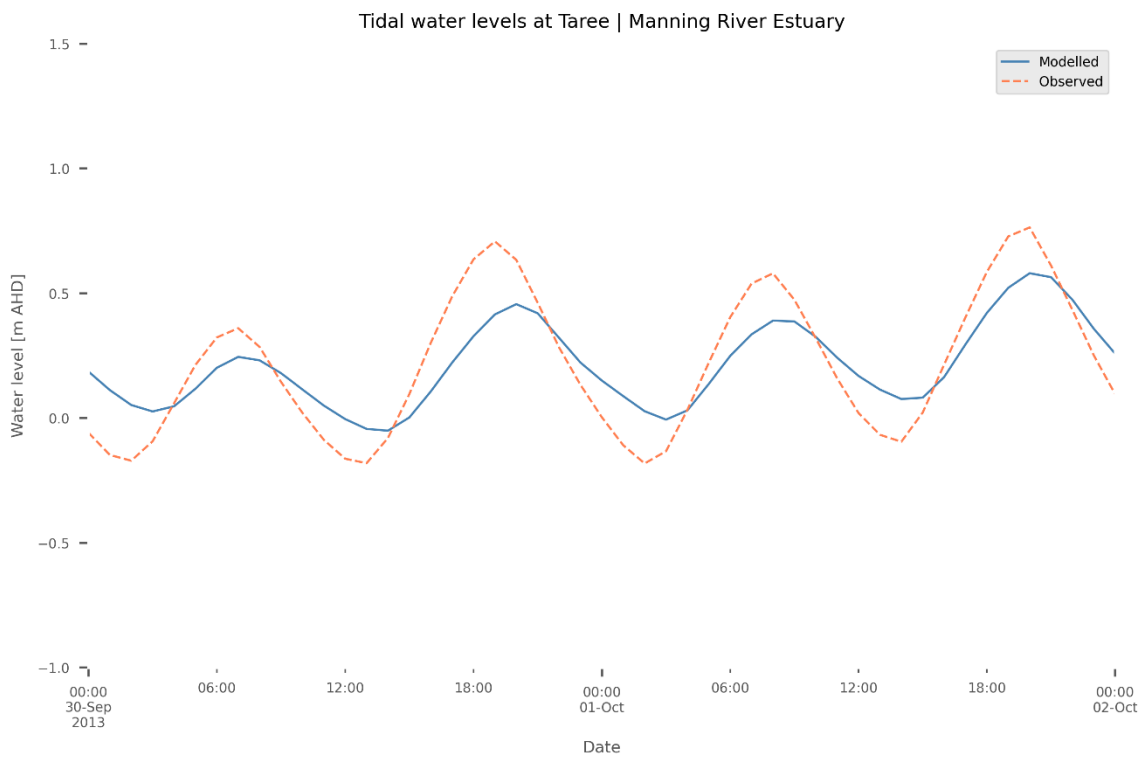
The calibrated model was then used to simulate a representative ‘wet’ year (i.e. more rain than average across the catchment) and a representative ‘dry’ year (i.e. less rain than average across the catchment) based on analysis of BOM rainfall records in Northern NSW. For this study, 2013 and 2019 were selected as the wet and dry years respectively. The model results from these simulations were then used to verify the tidal water calibrations throughout the estuary. Tidal water level verification plots for a 10-day window for the Manning Estuary for 2013 and 2019 are provided in Figure H-16 and Figure H-22.
