An audit of trained river entrances, armoured harbours and groynes and their multi-use and eco-features in NSW

Shellharbour to the Victorian border (Illustrated Volume III)

Title: An audit of trained river entrances, armoured harbours and groynes and their multi-use and eco-features in NSW: Shellharbour to the Victorian border (illustrated volume III)

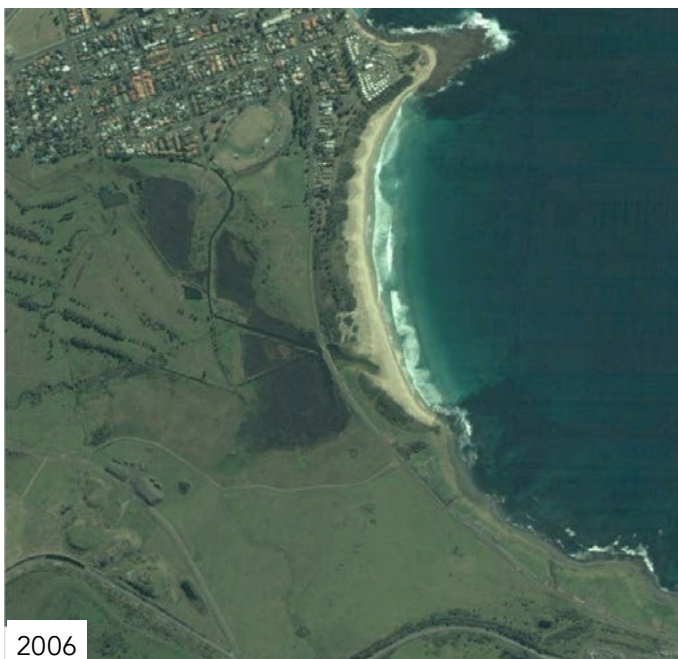
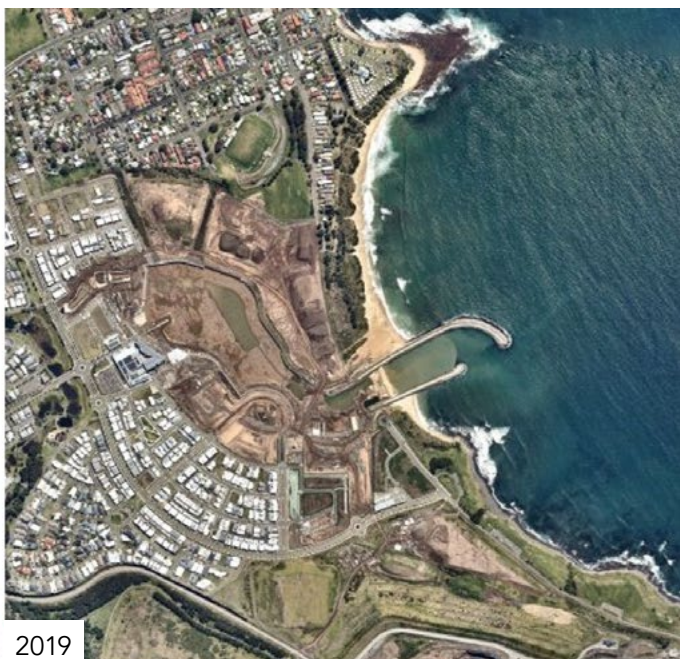
The Shellharbour Wetlands before (2006) and after construction of entrance breakwaters (2009)
Credit: Google Earth (2006) and nearmap (2019)

- Maintain pedestrian walkway surface
- Rock placement for seating and fishing opportunities
- Rock placement for emergency safety stairs

- Increase submerged habitat complexity

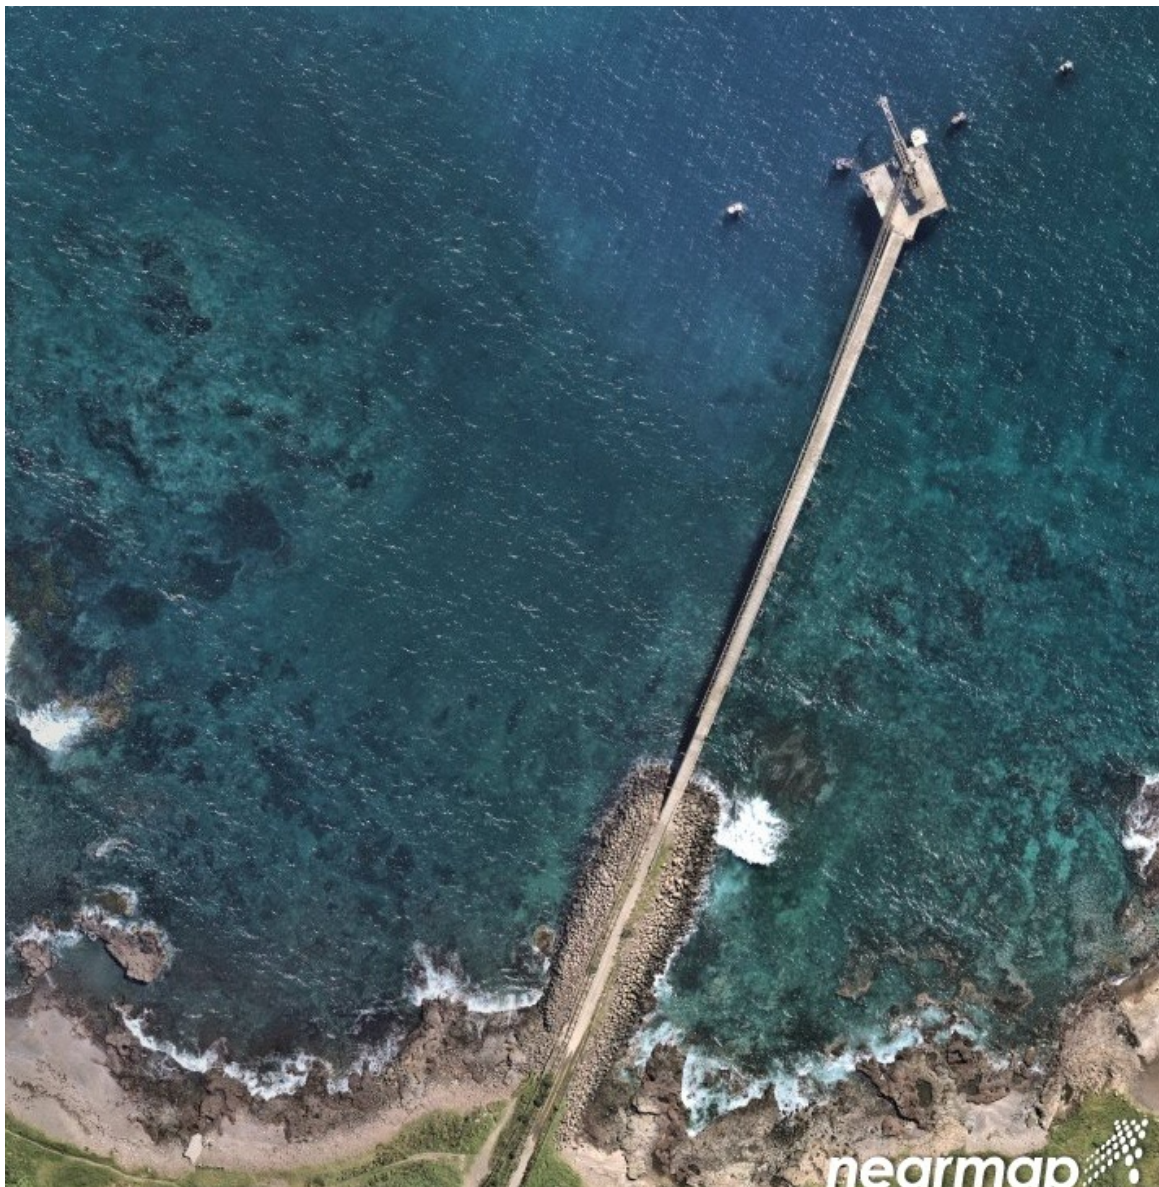
The Bass Point groyne ship loading jetty *Credit: nearmap*

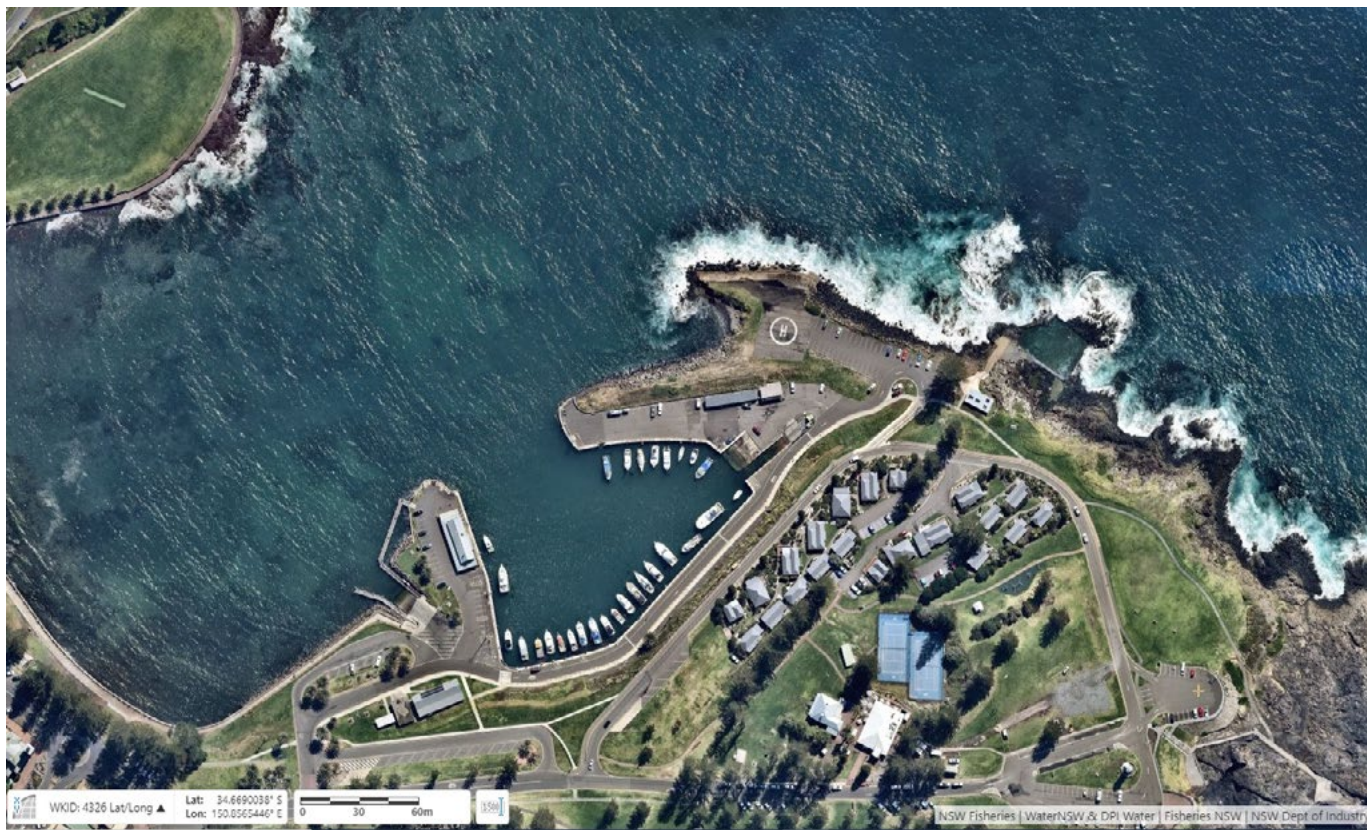
Kiama Harbour Credit: nearmap

Recommendations for possible inclusion in future maintenance or upgrade works	
<p>Future multi-use features</p> <ul style="list-style-type: none"> – Rock placement for seating and fishing opportunities 	<p>Future eco-features</p> <p>Nil</p>

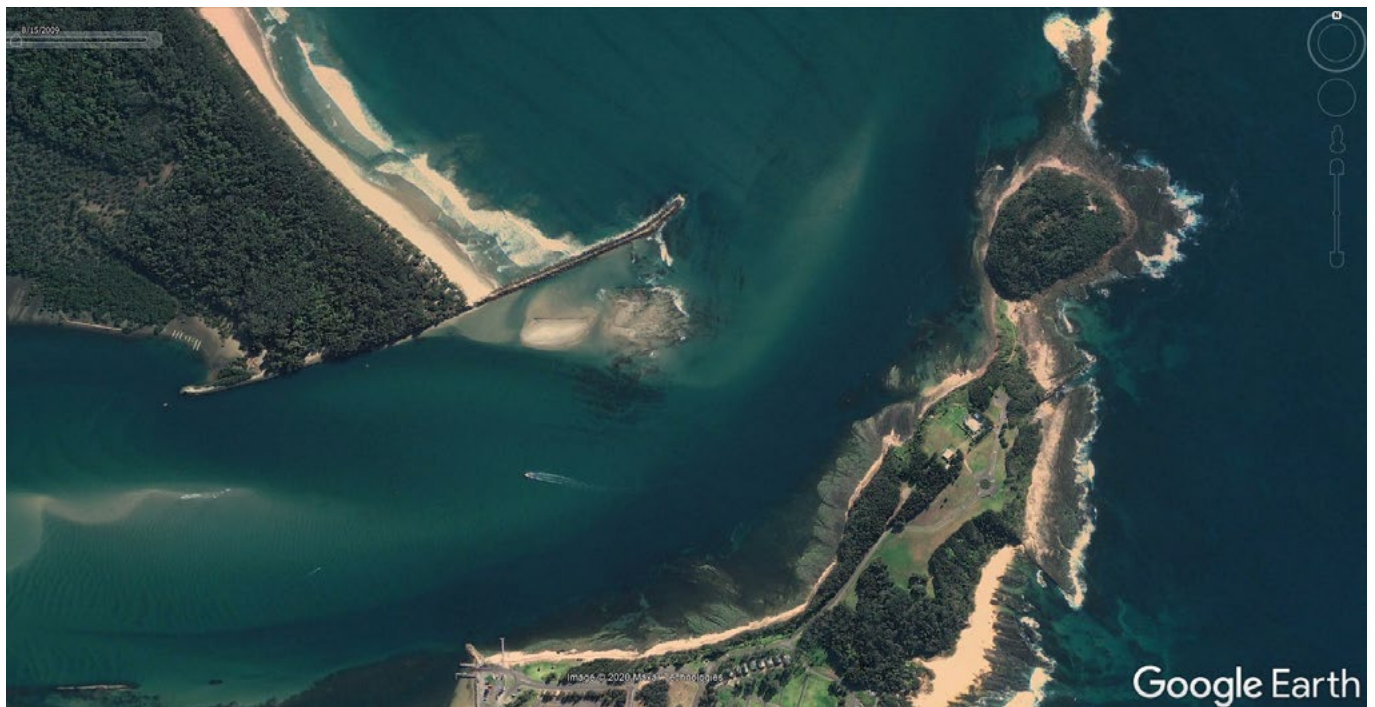
The Crookhaven breakwater *Credit: Google Earth*

Recommendations for possible inclusion in future maintenance or upgrade works	
Future multi-use features	Future eco-features
– Rock placement for emergency safety stairs	– Maintain breakwater fauna refuge area – Adjacent osprey tower

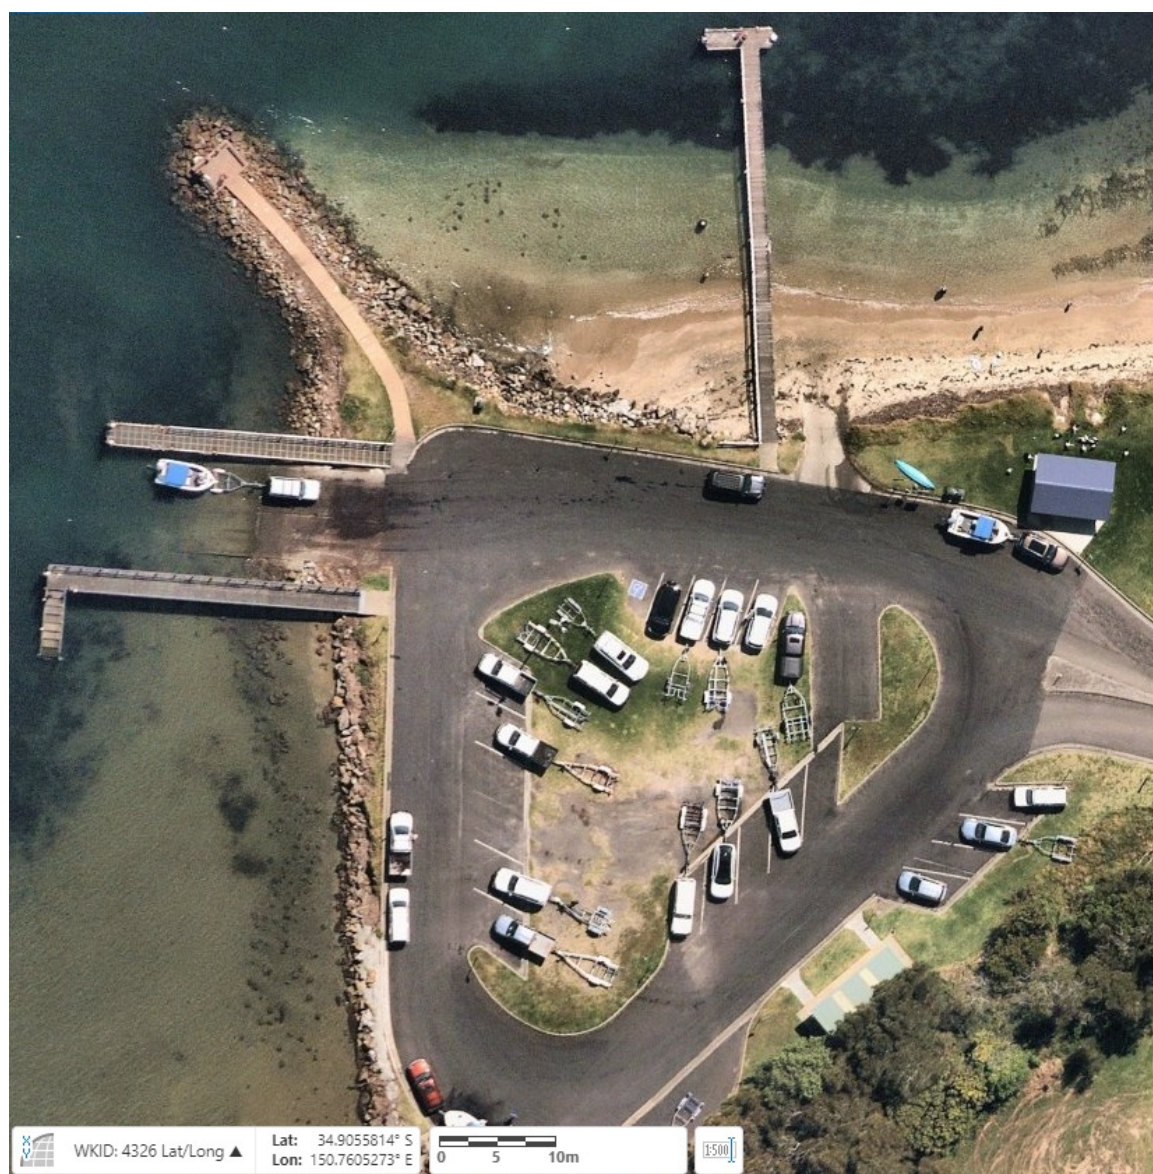
The Crookhaven regional boat ramp and breakwater

- Increase submerged habitat complexity
- Key fish habitat enhancement along training walls

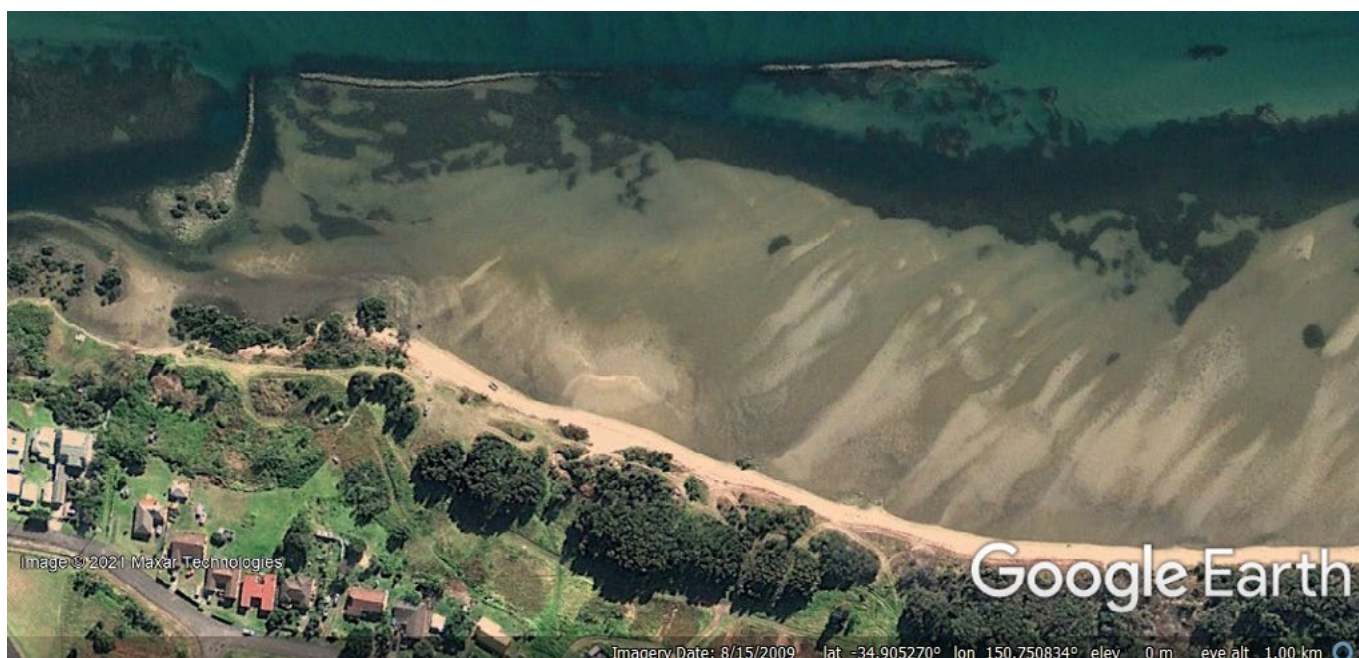
The remnant training wall adjacent to First Street, Orient Point that was installed in the early 1900s *Credit: Google Earth*

– Key fish habitat enhancement along training wall

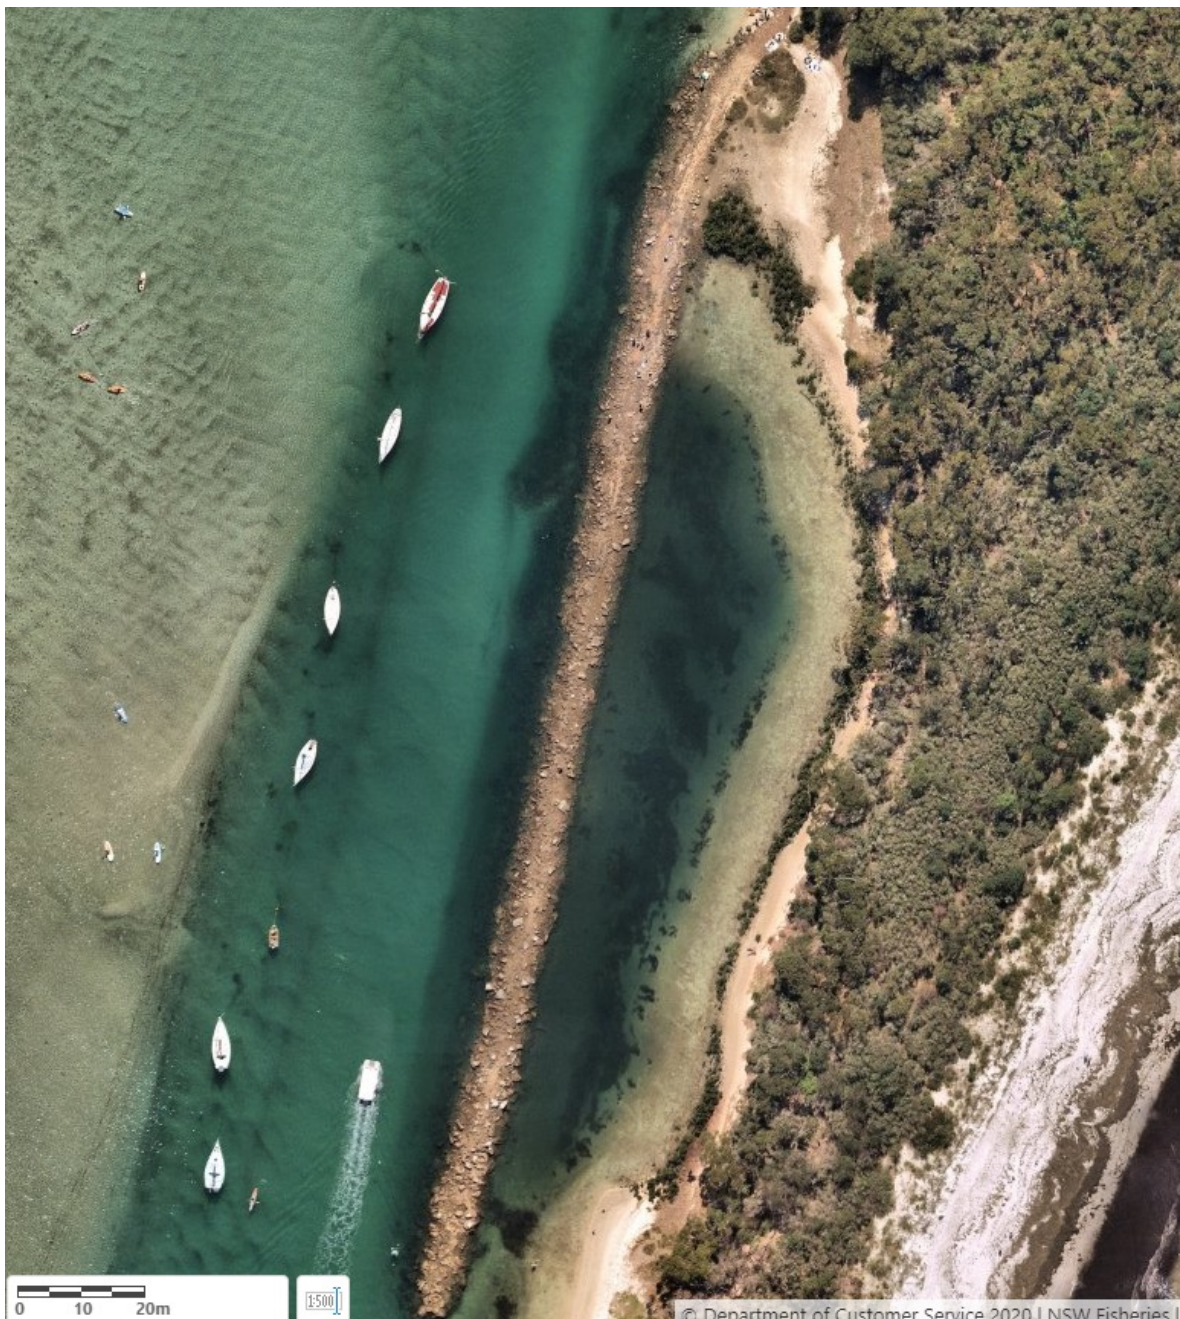
The Currambene Creek, Myola estuarine training wall *Credit: nearmap*

- Key fish habitat enhancement along training wall

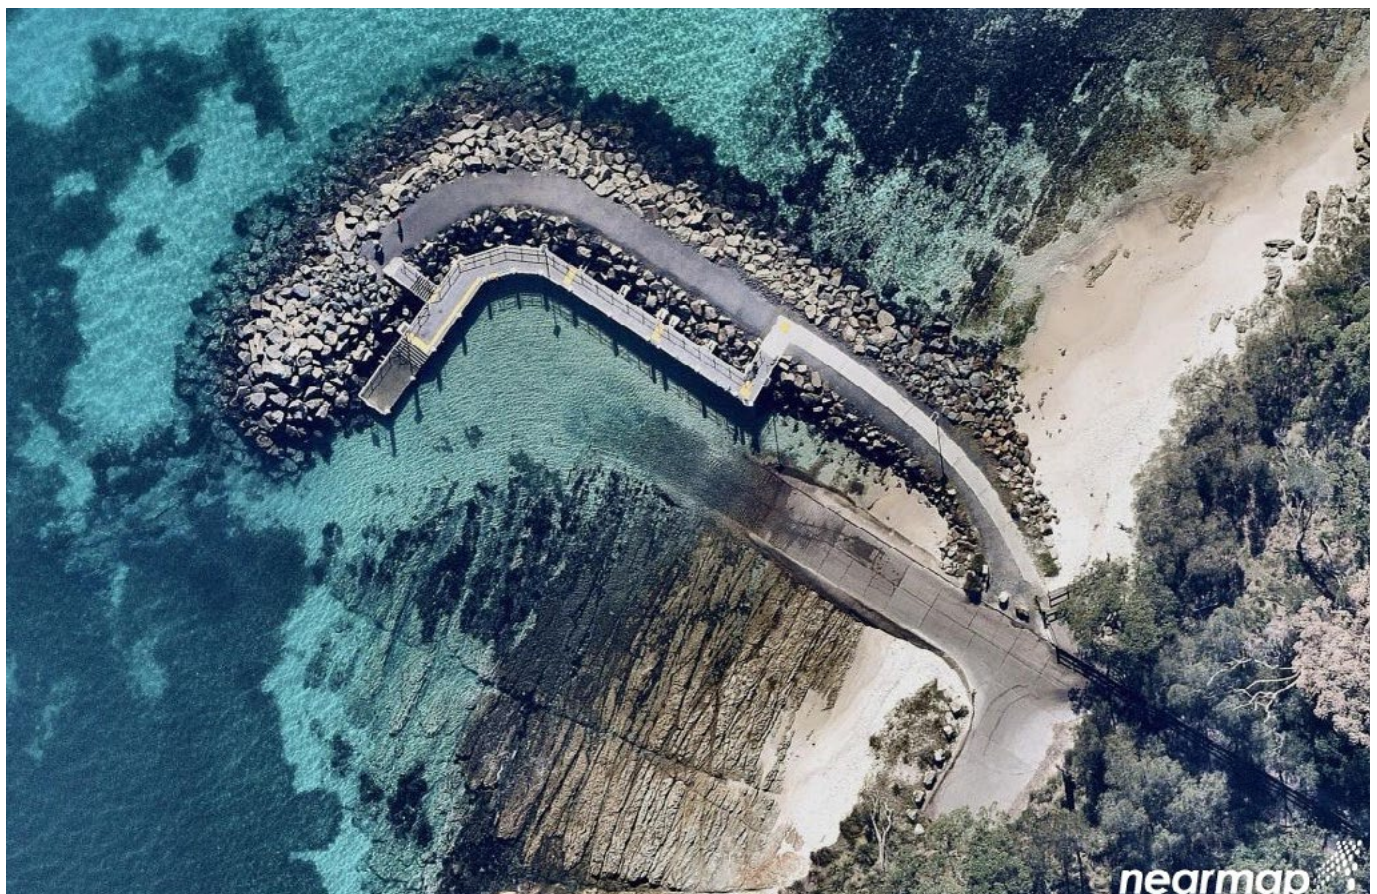
The Murrays Beach boat ramp breakwater in Jervis Bay Credit: nearmap

- Increase submerged habitat complexity

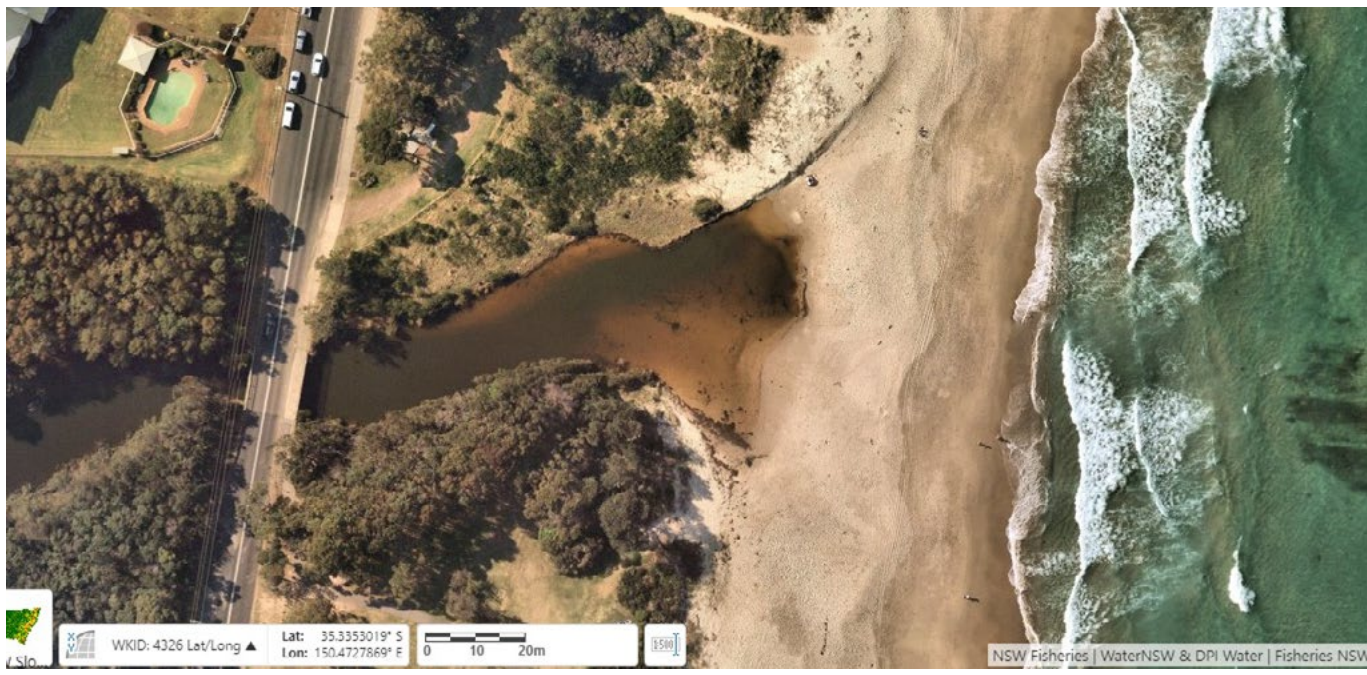
Nearmap image showing of Blackwater Creek, Mollmook, where the entrance is trained by buried geotextile sandbags.

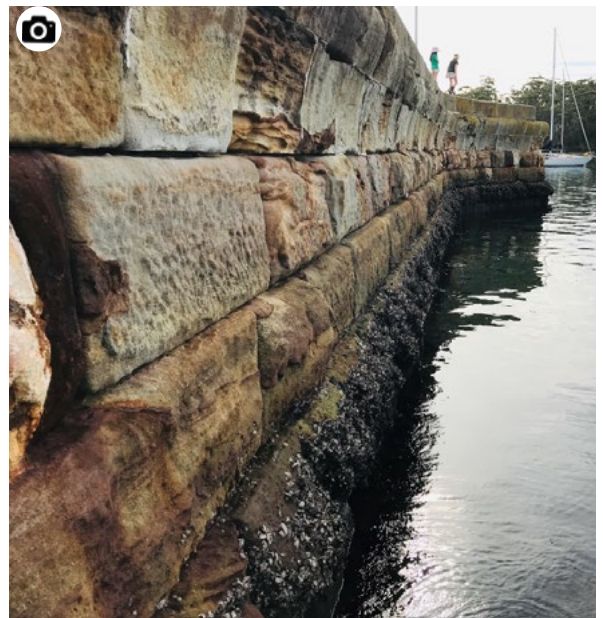
The heritage stone pier on the southern side of Ulladulla Harbour is encrusted in oysters, which provide a natural filtering of the Harbour’s waters

– Sewage pump out facilities are required

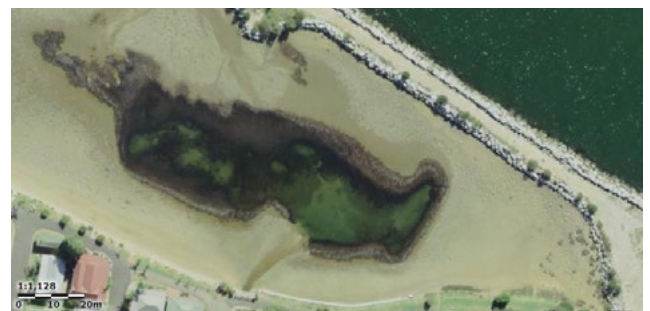
Inlet with key fish habitats that could be improved

- Enhance key fish habitat by improving flushing along parts of the training wall, especially where a stormwater outlet discharges into a backwater

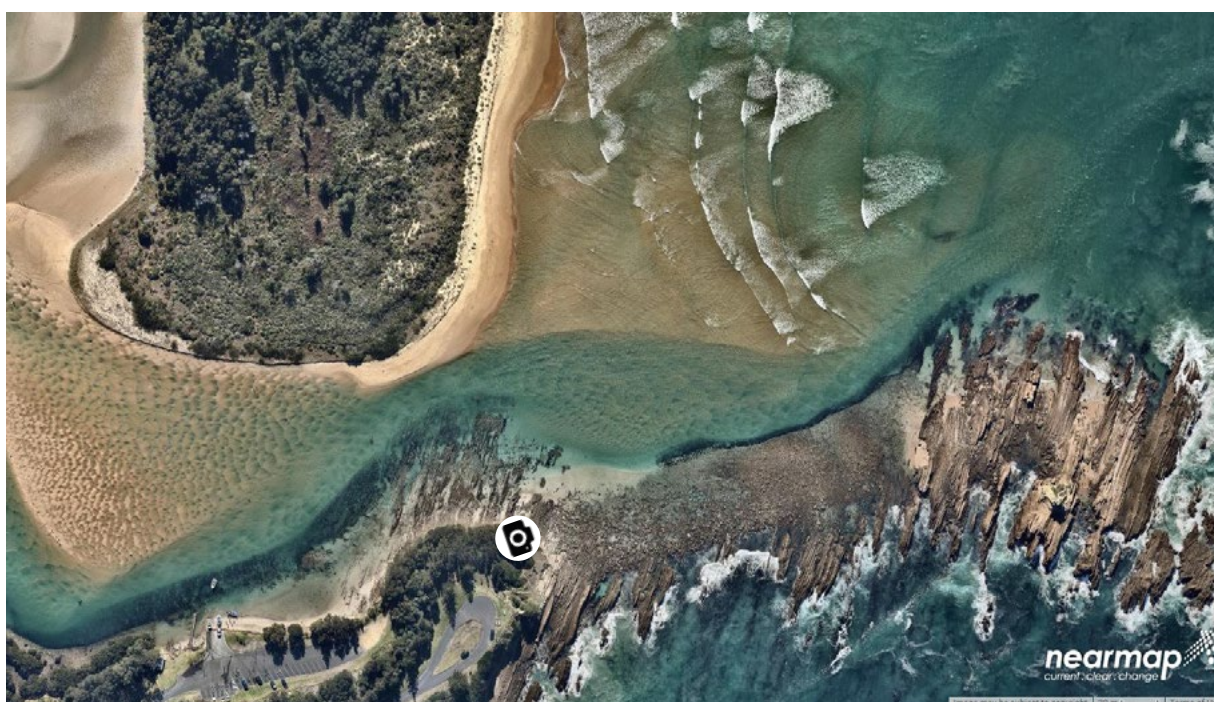
Multi-use features: – Heritage item of local significance
Eco-features: – Within 50 m of natural reef
The State Heritage Inventory listing for the site explains that the material in the ballast dump breakwater comes from a variety of locations including South America. The structure includes rails used to carry the ballast and extend the breakwater along the point.

The Tomaga River, Mossy Point rock ballast heritage breakwater *Credit: nearmap*

Future multi-use features
– Document and recognise heritage values

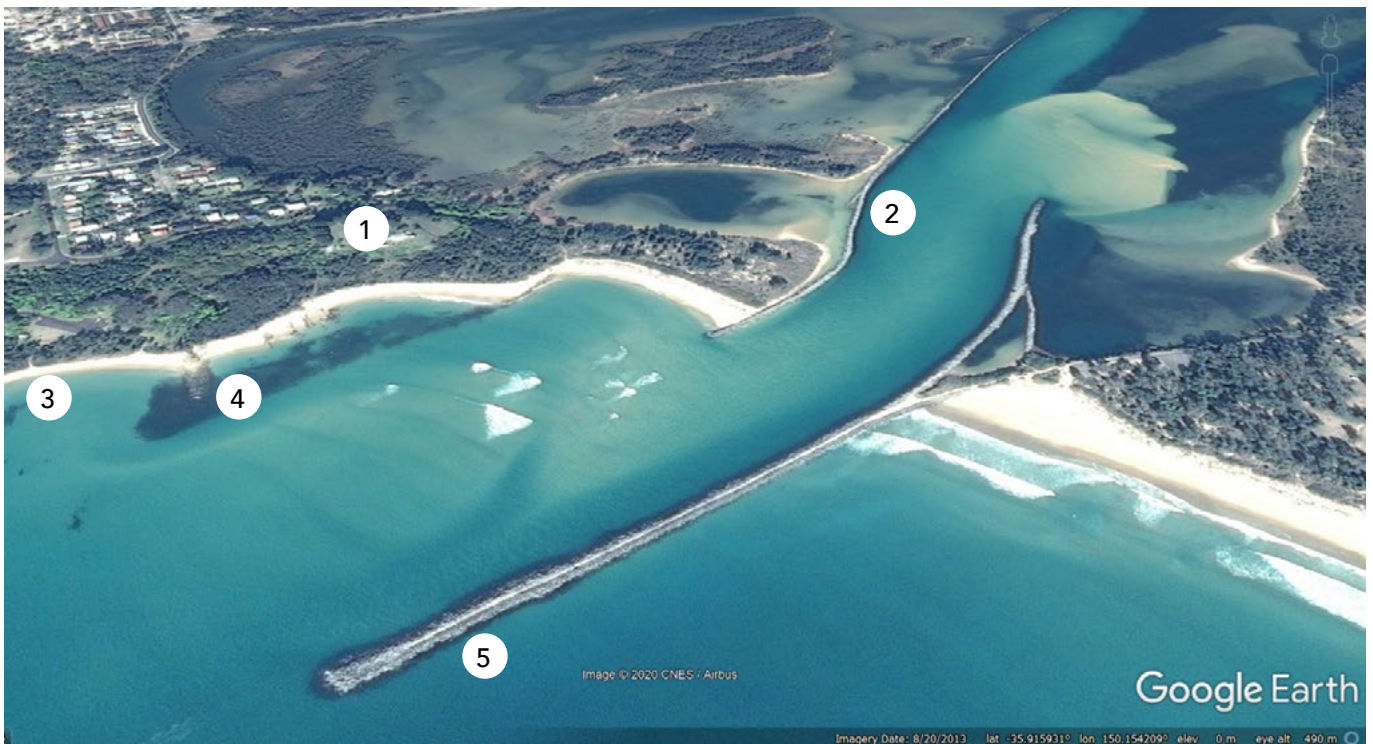
The Moruya River and its trained entrance: (1) the Meteorological Station; (2) end of the original southern training wall; (3) Shelly Beach; (4) abandoned southern breakwater; (5) northern breakwater. *Source: Google Earth*

The breakwater is accessible. It is close to parking and greenspace. An estuarine training wall extends upstream for 120 m. An inlet supports seagrass, saltmarsh, and wader and migratory bird habitats.

- Maintain pedestrian walkway surface
- Install CoastSnap photo point
- Rock placement for emergency safety stairs

- Adjacent osprey tower
- Increase submerged habitat complexity
- Key fish habitat enhancement along training wall

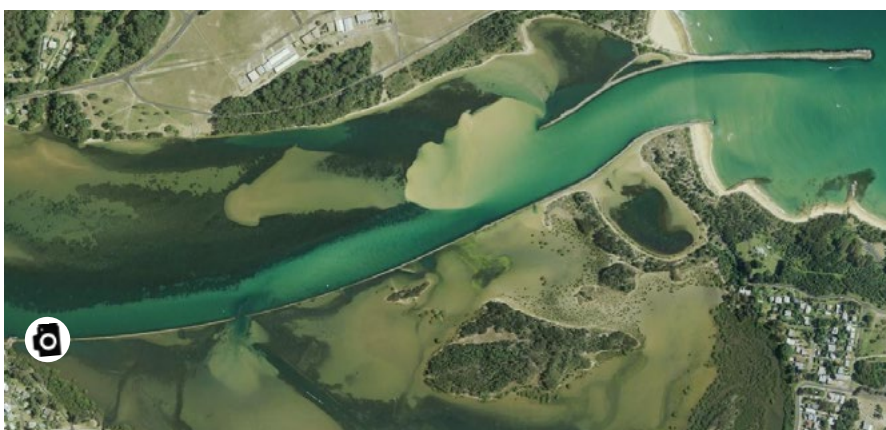
The breakwater is remote. An estuarine training wall extends 1.5 km upstream with inlets that support seagrass, mangrove, saltmarsh, and wader and migratory bird habitats. The upstream end of the training wall is close to parking, amenities, greenspace and an urban area.

The Moruya River southern breakwater and training wall

- Maintain breakwater fauna refuge area
- Increase submerged habitat complexity
- Key fish habitat enhancement along training walls

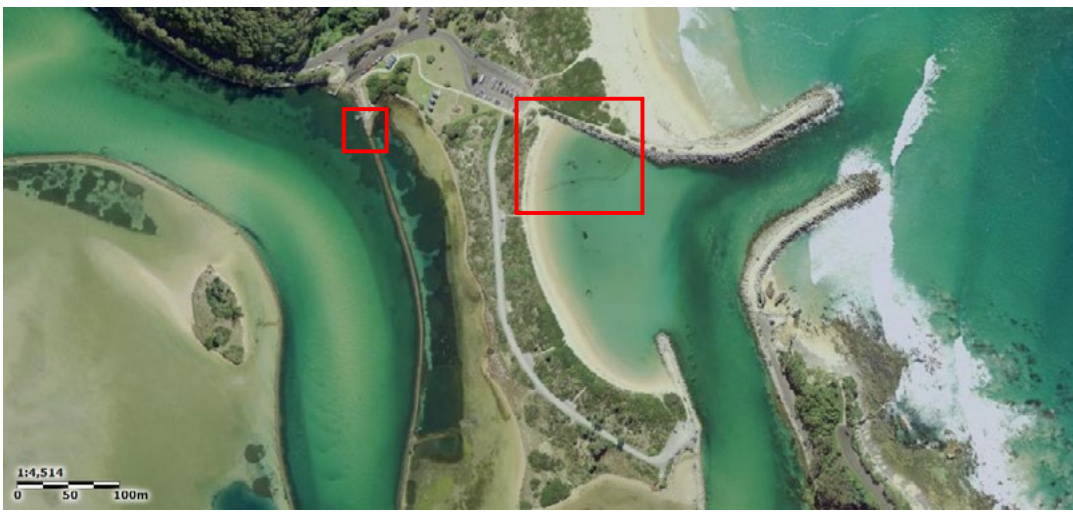
The breakwater and training wall network in the Wagonga Inlet at Narooma. *Credit: Six Maps*

<p>Future multi-use features</p> <ul style="list-style-type: none"> – Maintain pedestrian walkway surface – Install CoastSnap photo point – Rock placement for emergency safety stairs 	<p>Future eco-features</p> <ul style="list-style-type: none"> – Adjacent osprey tower – Increase submerged habitat complexity – Key fish habitat enhancement along training walls – Sewage pump-out facilities are required
--	--

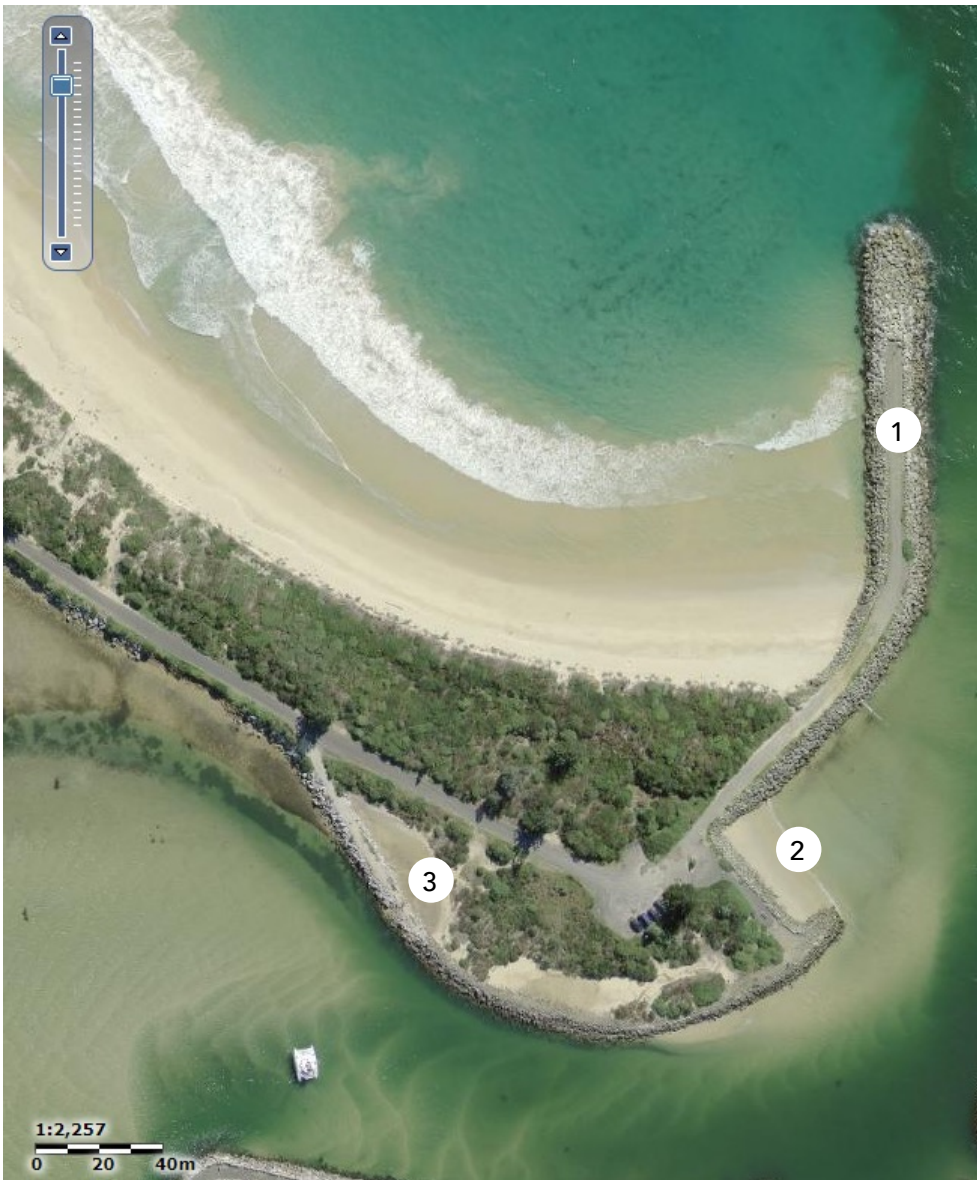
Multi-use features:	<ul style="list-style-type: none">– Walking pathway– Wave-trap beach
Eco-features:	Nil
The breakwater is very accessible. It is close to parking, amenities, greenspace and urban areas. An estuarine training wall extends upstream for 270 m. Inlets support saltmarsh, and wader and migratory bird habitats.

The Bermagui River northern breakwater: (1) northern breakwater; (2) northern wave-trap beach; (3) an area where tidal flows through the training wall create an intertidal that could be enhanced for a small area of fish or bird forage habitat *Credit: Six Maps*

Recommendations for possible inclusion in future maintenance or upgrade works	
Future multi-use features	Future eco-features
<ul style="list-style-type: none">– Maintain pedestrian walkway surface– Install CoastSnap photo point– Rock placement for emergency safety stairs	<ul style="list-style-type: none">– Increase submerged habitat complexity– Key fish habitat enhancement along training walls

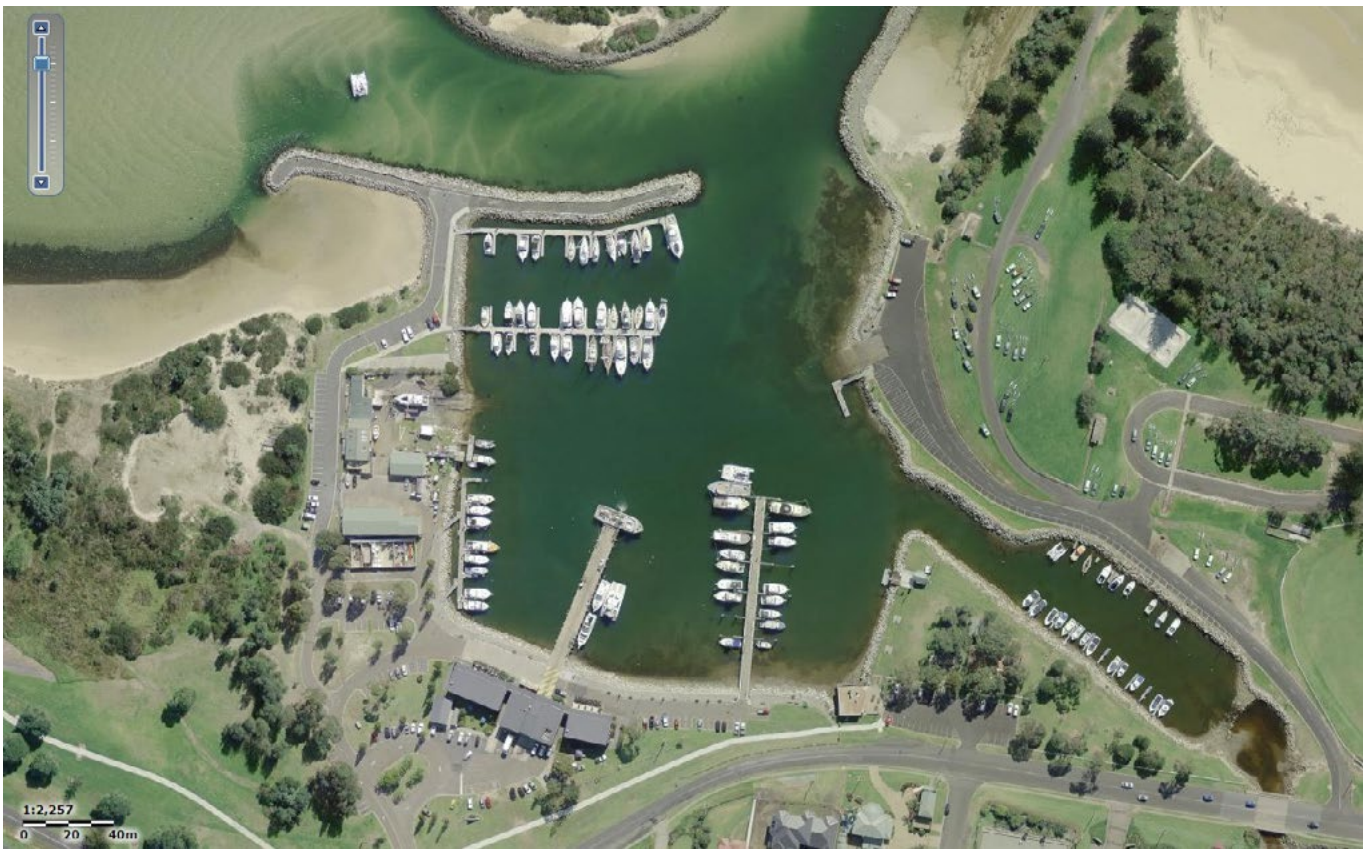
Responsible authority:	NSW State Government	Multi-use features:	– Walking pathway – Wave-trap beach
Built:	1958–1959	Eco-features:	Nil
Primary purpose when first built:	Boat harbour for fishing and tourism	The boat harbour is an important precinct with parking, amenities and greenspace.	
Current uses:	– Boat harbour and ocean access for boating

The Bermagui Boat Harbour *Credit: Six Maps*

Recommendations for possible inclusion in future maintenance or upgrade works	
Future multi-use features	Future eco-features
– Maintain pedestrian walkway surface	– Sewage pump-out facilities are required
