# An audit of trained river entrances, armoured harbours and groynes and their multi-use and eco-features in NSW

Stockton to Shellharbour (Illustrated Volume II)

First published December 2021

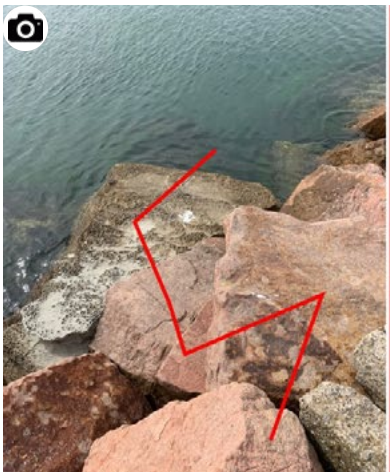
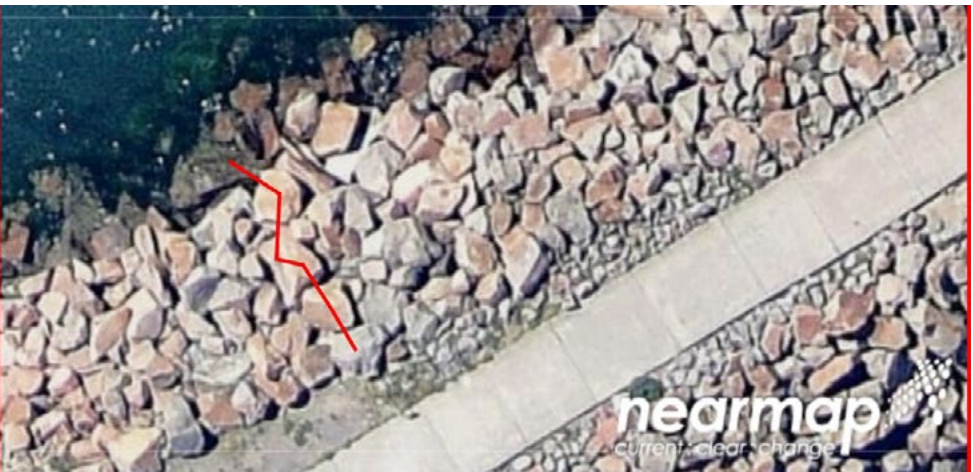
Safety stairs have been installed to assist divers accessing the shipwrecks adjacent to the Hunter River northern breakwater (detail from the top aerial image) Credit: nearmap

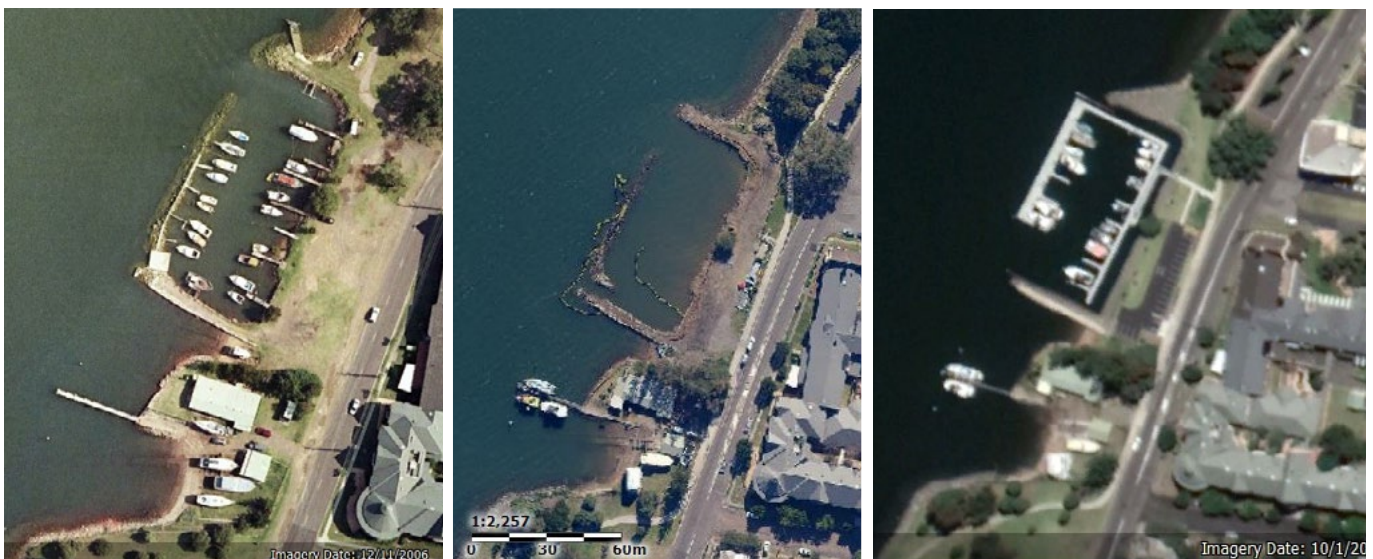
Aerial photo of the Hereford Street Harbour in the Hunter estuary showing recent upgrade works that incorporated retaining heritage values and maximising boating values Credit: Six Maps

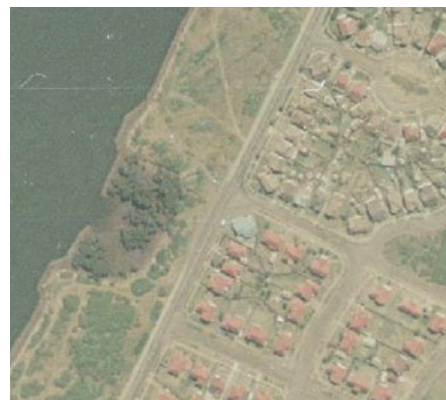
Mangroves had recruited into the inlet before 1954 and are still visible in this 1976 photo

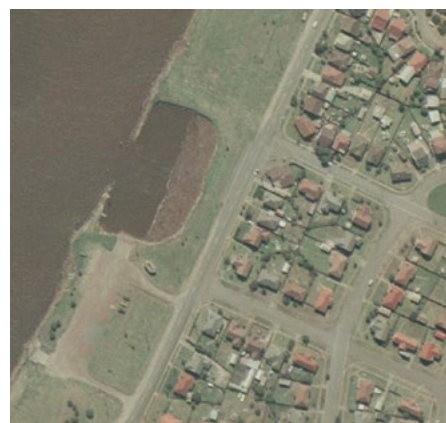
The mangroves were cleared from the inlet in about 1984, when the boat ramp was installed.

Recent upgrade works at the Griffith Avenue Harbour improved its value for recreational boating with (1) the installation of the jetty. Other works added environmental value to the site and involved installing (2) rock fillets as part of the training wall upstream. These sheltered areas provide ideal conditions for establishment of mangroves *Credit: Six Maps*

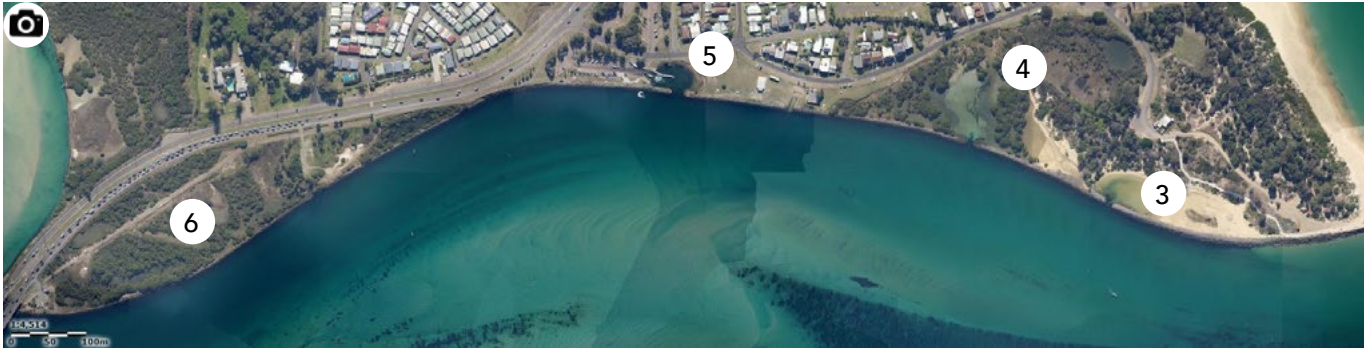
Lake Macquarie northern training wall: (3) Grannys Pool; (4 and 6) intertidal inlet with seagrass, mangroves and saltmarsh; (5) inlet with boat ramp *Credit: Six Maps*

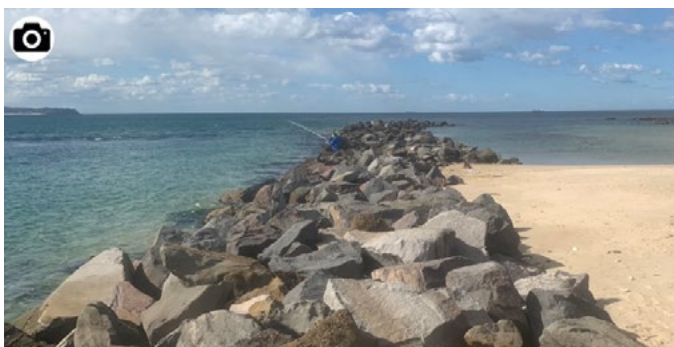
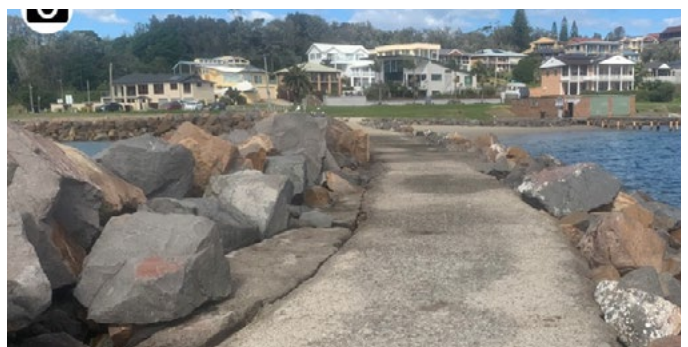
The rubble crest surface of the southern breakwater and the concrete surface of Lucys Groyne

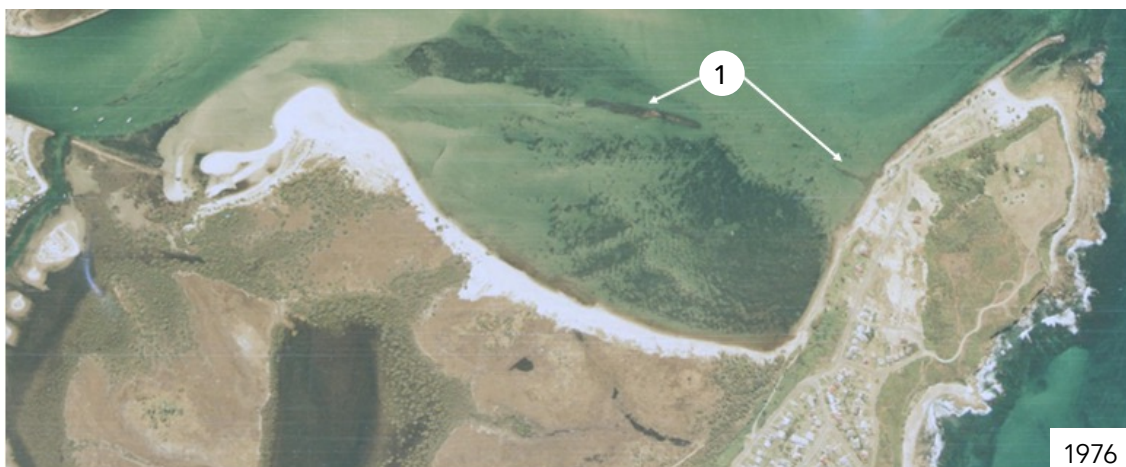
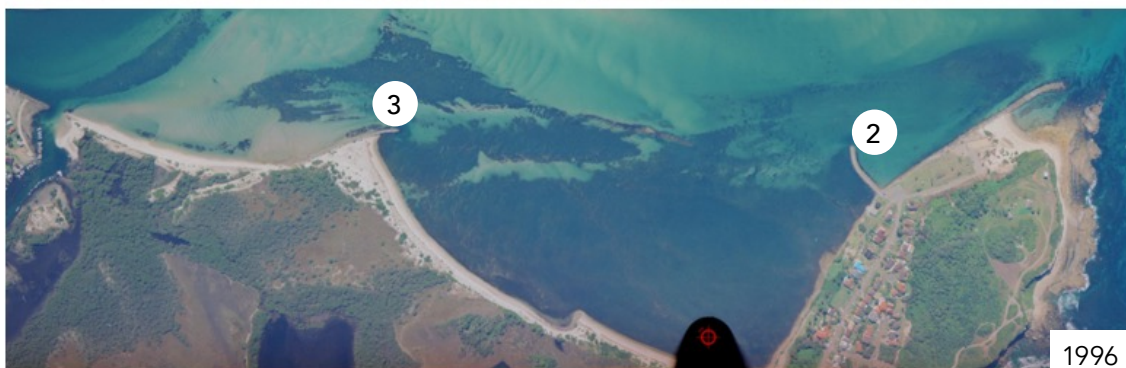
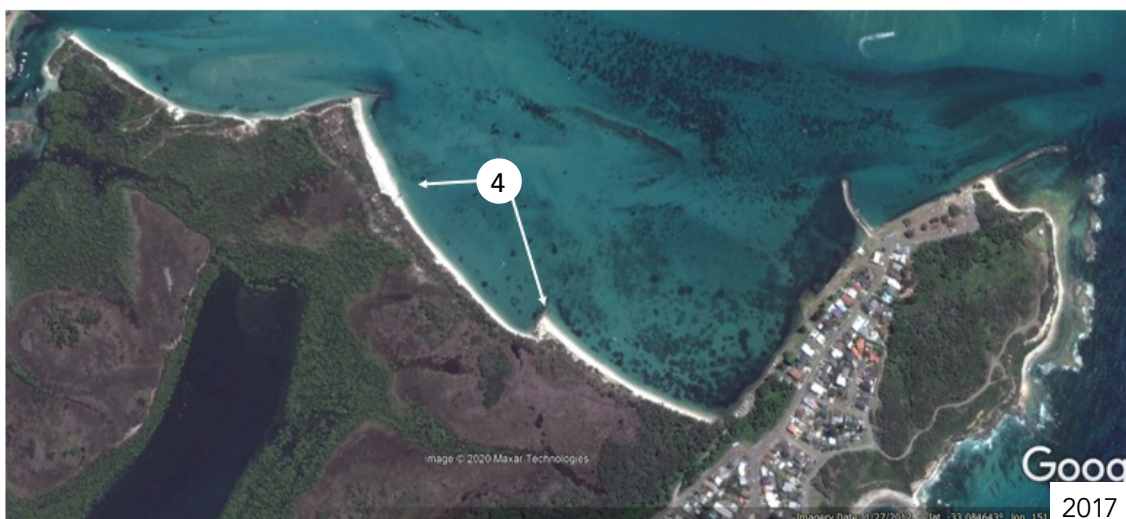
Aerial photo of Salts Bay: (1) Remnant erosion protection works; (2) Lucys Groyne; (3) Mats Groyne; (4) Salts Bay Groynes *Credit: Crown Lands*

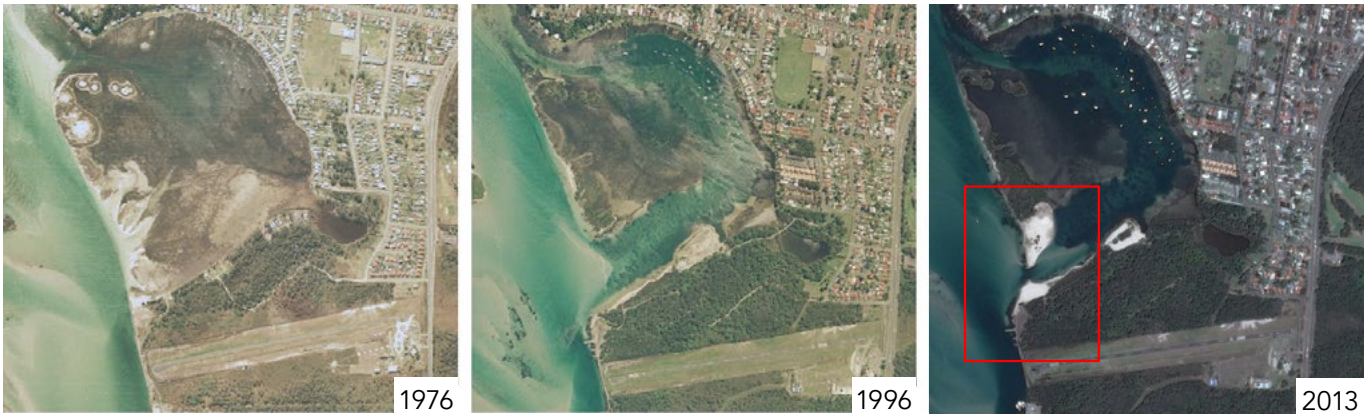
Aerial photo images of Swan Bay in 1976; in 1996 a large channel that formed in response to commercial dredging; and, after the channel was narrowed by installing two groynes Credit: Crown Lands

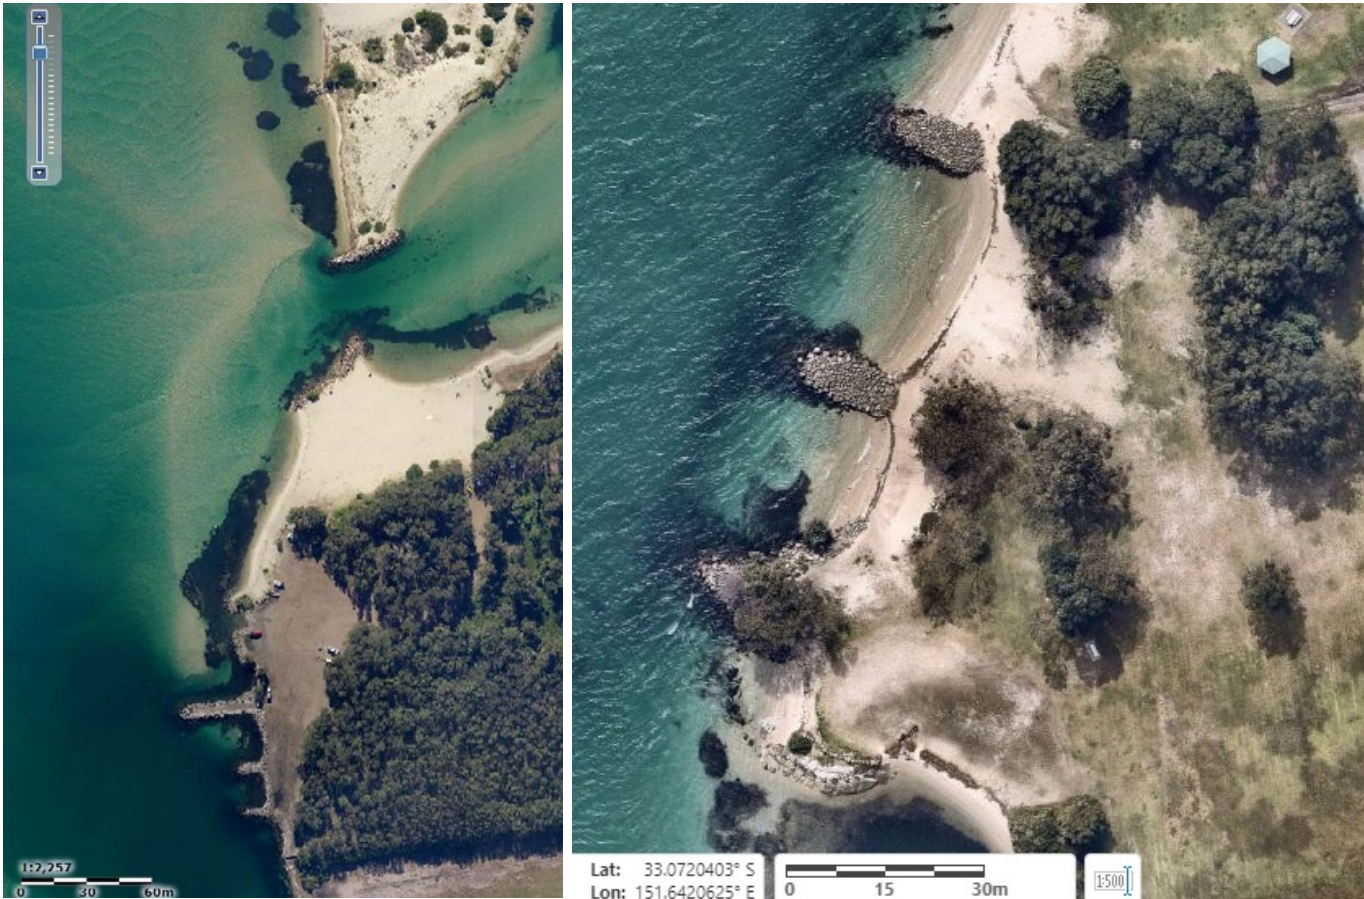
Detail of Swan Bay entrance in 2013 after groynes were used to narrow the entrance to the Bay (left) and control erosion downstream near Pelican Inlet (right) Credit: Six Maps

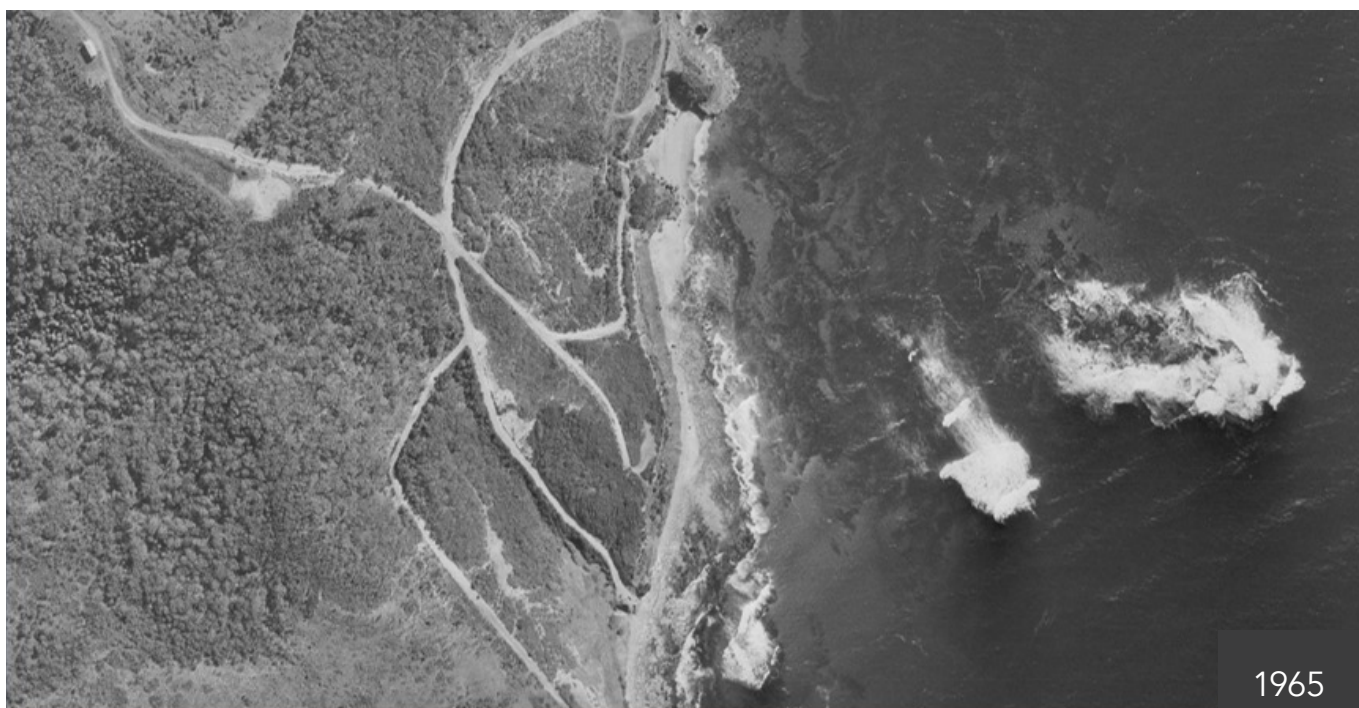
1965

<b>Responsible authority:</b>	Unknown	<b>Multi-use features:</b>	Nil
<b>Built:</b>	1968	<b>Eco-features:</b>	- Within 50 m of natural reef
<b>Primary purpose when first built:</b>	Installed as the first stage of a harbour that was not finished	The breakwater was built using overburden from a nearby mine site. The structure is abandoned and is deteriorating.	
<b>Current uses:</b>	Nil

Aerial photo of Mawsons breakwater Credit: Crown Lands and Six Maps

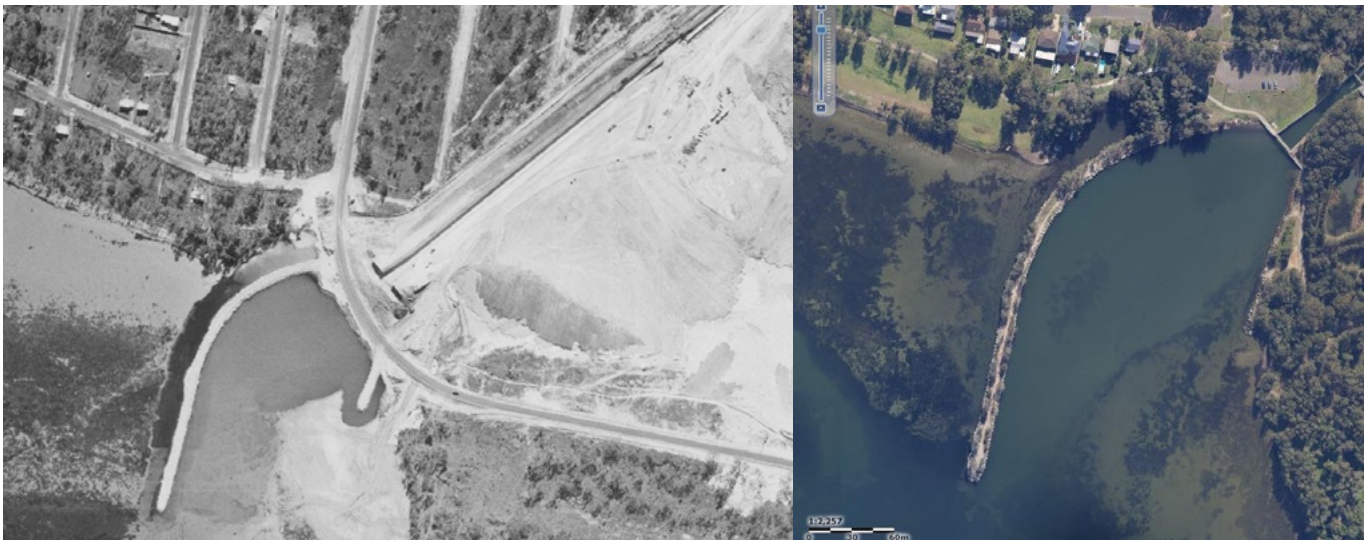
The San Remo breakwater at Budgewoi Lake directs water releases from the Colongra gas-fired power station into Budgewoi Lake. The images show the breakwater in 1965 (left) and 2017 (right) *Credit: Crown Lands and Google Earth*

Recommendations for possible inclusion in future maintenance or upgrade works	
<b>Future multi-use features</b>	<b>Future eco-features</b>
<ul style="list-style-type: none"> <li>- Maintain and improve pedestrian walkway surface</li> <li>- Rock placement for seating and fishing opportunities</li> </ul>	Nil

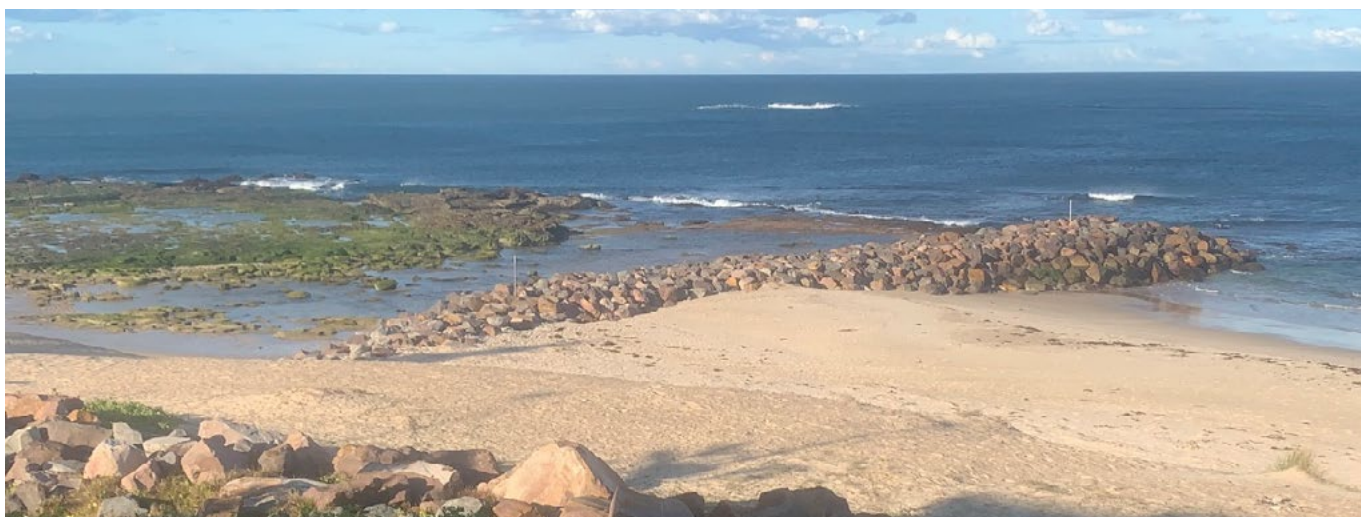
The Tuggerah Lakes groyne at the northern end of Roberts Beach

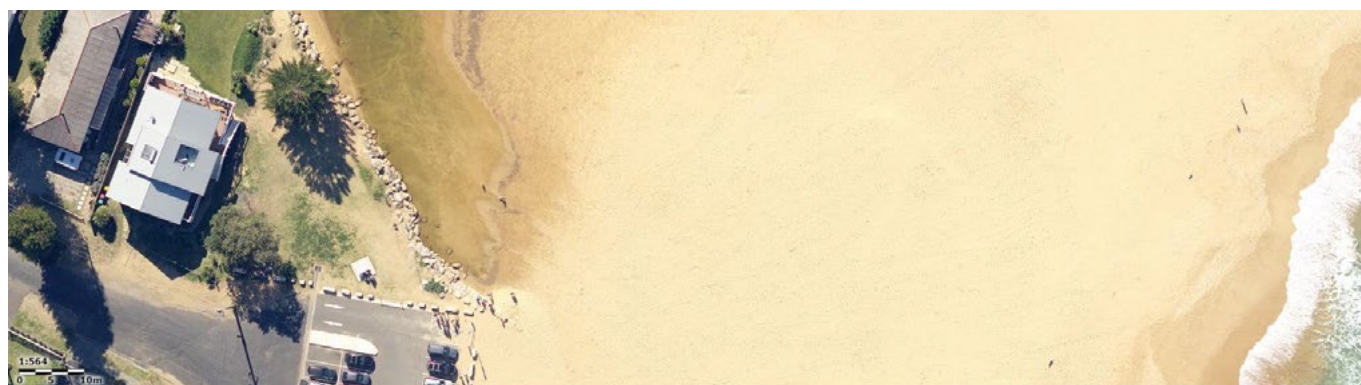
The rocks on the southern bank of the entrance channel were installed to limit the channel undermining the car park area

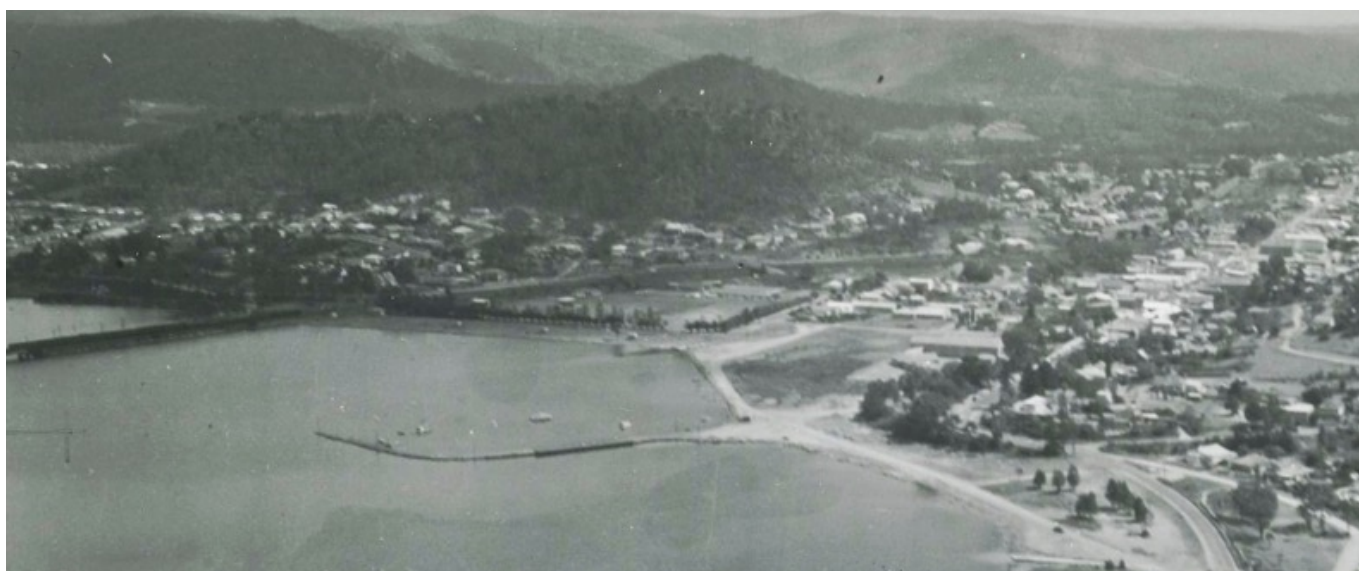
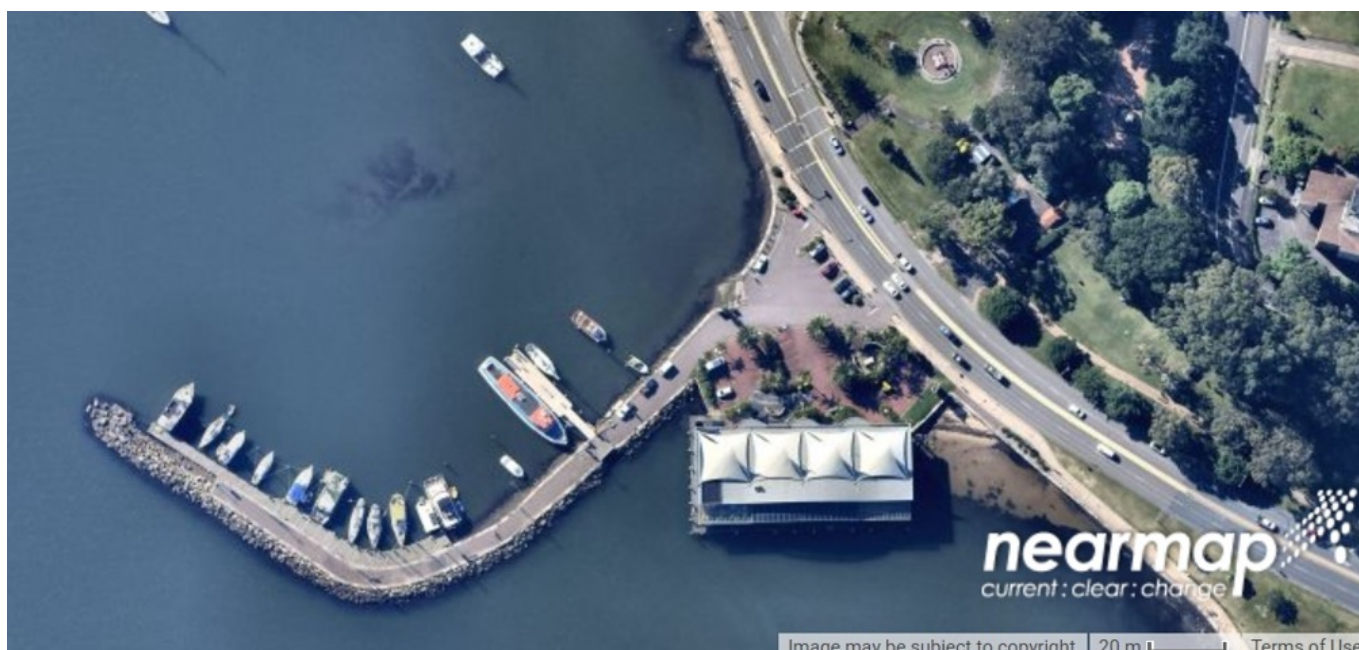
The breakwater is located on the site of the original Gosford Wharf. Gosford breakwater is accessible. It is close to parking, amenities and a walking pathway.

- Maintain pedestrian walkway surface

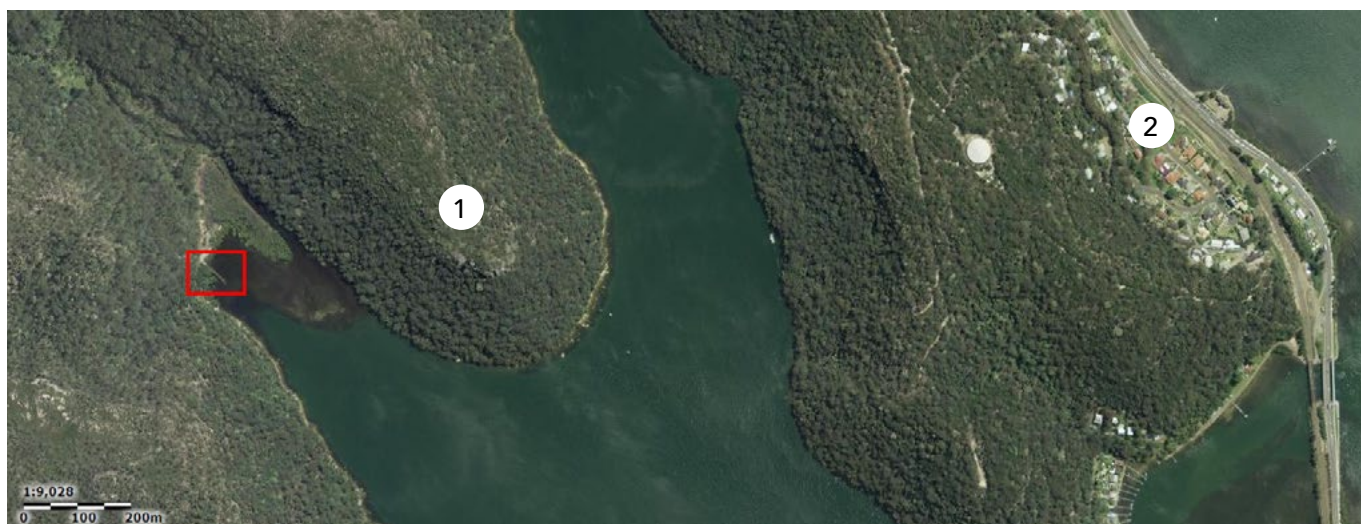
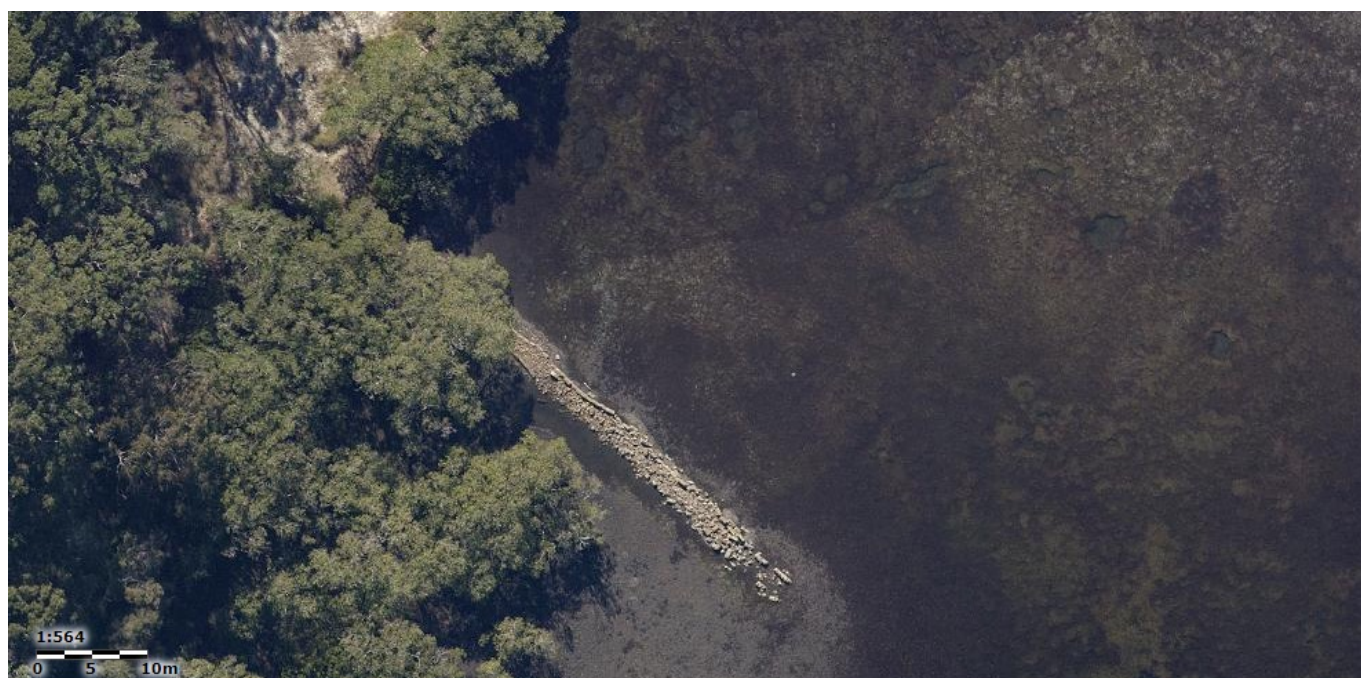
**Multi-use features:** Nil  
**Eco-features:** Nil  
The rock jetty may have been first built by RJ Scott, the nearby landholder, to obtain supplies. Records suggest it was upgraded or repaired in the 1920s to improve access to a walking path to the nearby lookout, Spion Kop, which has spectacular view of Woy Woy and beyond.

- Maintain pedestrian walkway surface
- Heritage

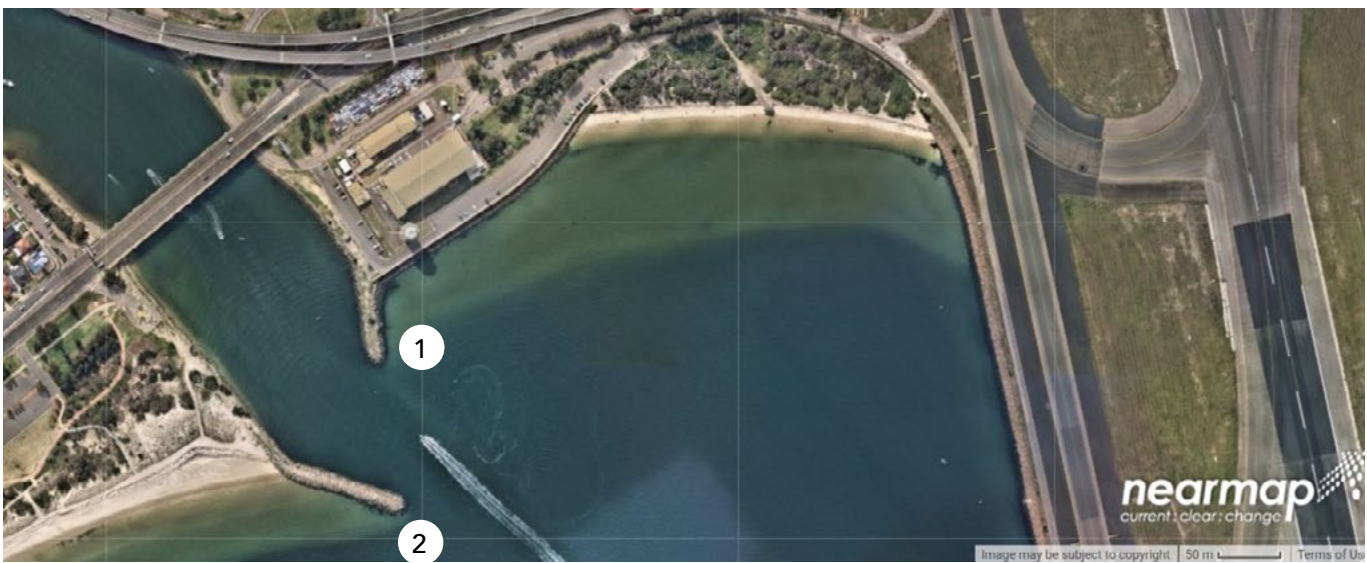
The new entrance of the Cooks River with (1) northern and (2) southern training walls  
 Credit: nearmap

<b>Future multi-use features</b>	<b>Future eco-features</b>
<ul style="list-style-type: none"> <li>– Upgrade crest surface to a pedestrian walkway surface</li> <li>– Rock placement for seating and fishing opportunities</li> <li>– Rock placement for emergency safety stairs</li> </ul>	Nil

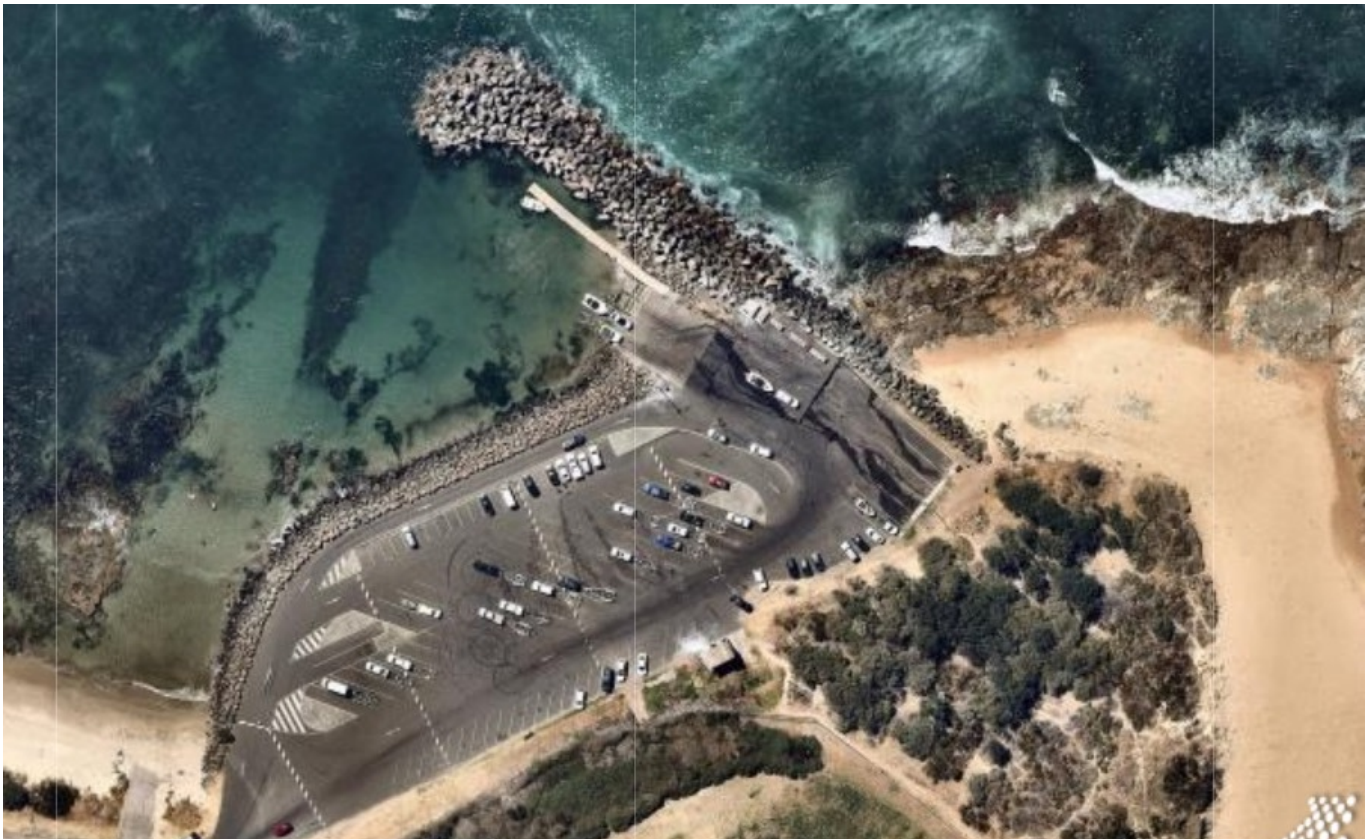
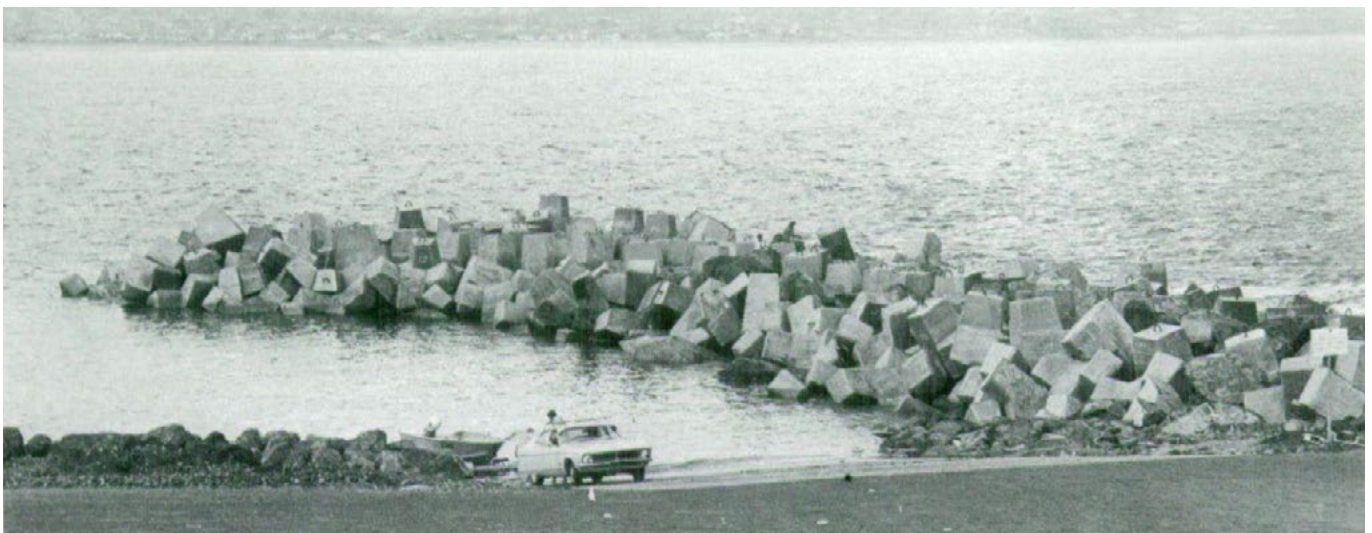
<b>Responsible authority:</b>	NSW State Government	<b>Multi-use features:</b>	Nil
<b>Built:</b>	1979	<b>Eco-features:</b>	- Within 50 m of natural reef
<b>Primary purpose when first built:</b>	Breakwater for fishing and tourism	The breakwater is very accessible. It is close to parking, amenities, greenspace and urban areas.	
<b>Current uses:</b>	- Ocean access for boating

Recommendations for possible inclusion in future maintenance or upgrade works	
<b>Future multi-use features</b>	<b>Future eco-features</b>
- Rock placement for seating and fishing opportunities	Nil

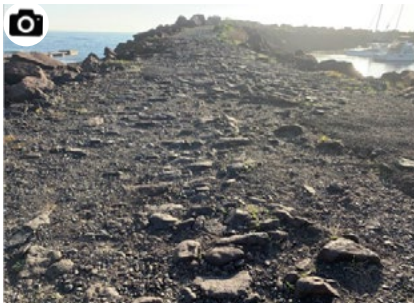
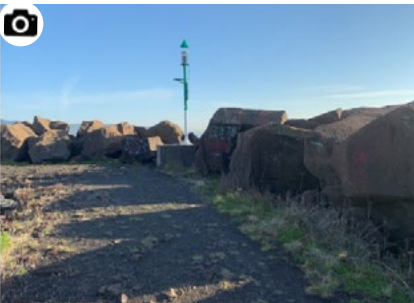
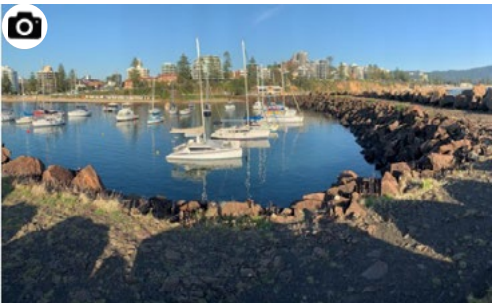
While the breakwater is located next to Wollongong’s famous ‘Blue Mile Walk’, the rubble surface of the breakwater (left) reduces the number of people walking out onto the breakwater. The height of the crown rock (centre picture) obscures opportunities to enjoy the view for those who do walk out onto the breakwater. The value of the existing structure could be improved by making the structure accessible to all, improving amenity and adding other multi-use features.

<p><b>Future multi-use features</b></p> <ul style="list-style-type: none"> <li>- Improve opportunities to enjoy the view</li> <li>- Upgrade crest surface to a pedestrian walkway surface</li> <li>- Rock placement for seating and fishing opportunities</li> <li>- Rock placement for emergency safety stairs</li> </ul>	<p><b>Future eco-features</b></p> <p>Nil</p>
--	--

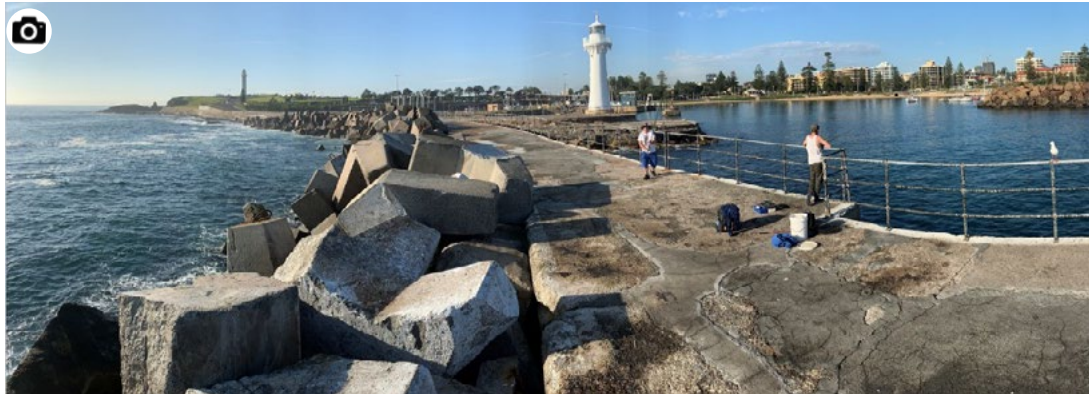
Fishing from the eastern breakwater back into Wollongong Harbour

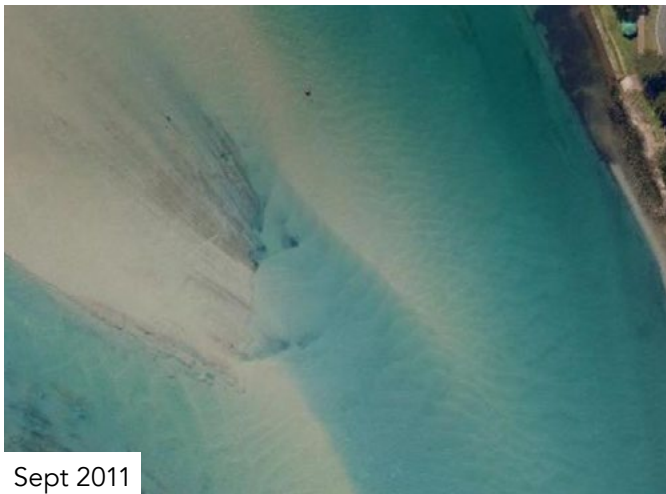
Sept 2011

The changed tidal flows have caused erosion around parts of the lake, including the northern banks. Some key fish habitats have been lost, and some built infrastructure has needed to be strengthened, relocated or removed.

Following training of the entrance at Lake Illawarra, tidal flows in the lake increased. This caused a loss of seagrass and erosion in some areas, which then required the installation of groyne and armoring of the foreshore. The two images show before (2011) and after (2020)

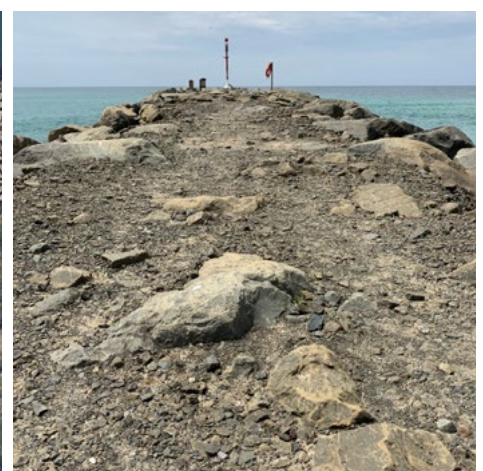
The rubble crest surface of the southern breakwater limits accessibility for some people

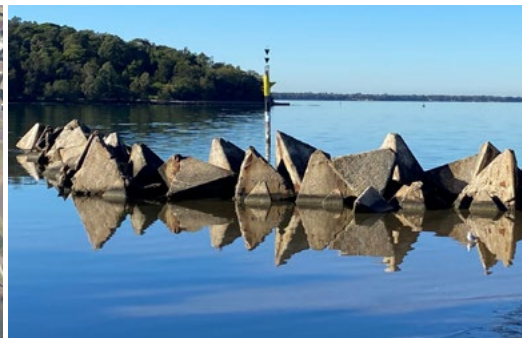
Repurposed tank trap tetra-hedrons used to form the original breakwater are still evident in the structure  
 Credit: Carla Ganassin
