An audit of trained river entrances, armoured harbours and groynes and their multi-use and eco-features in NSW

Queensland border to Stockton (Illustrated Volume I)

Title: An audit of trained river entrances, armoured harbours and groynes and their multi-use and eco-features in NSW: Queensland border to Stockton (illustrated volume I)

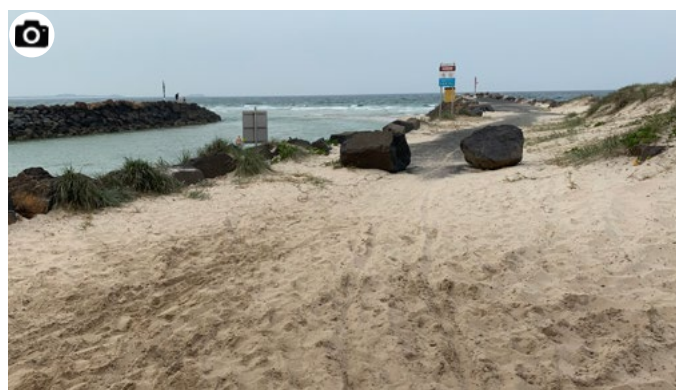
Sandy across part of the Cudgen Creek southern breakwater can restrict access for some people

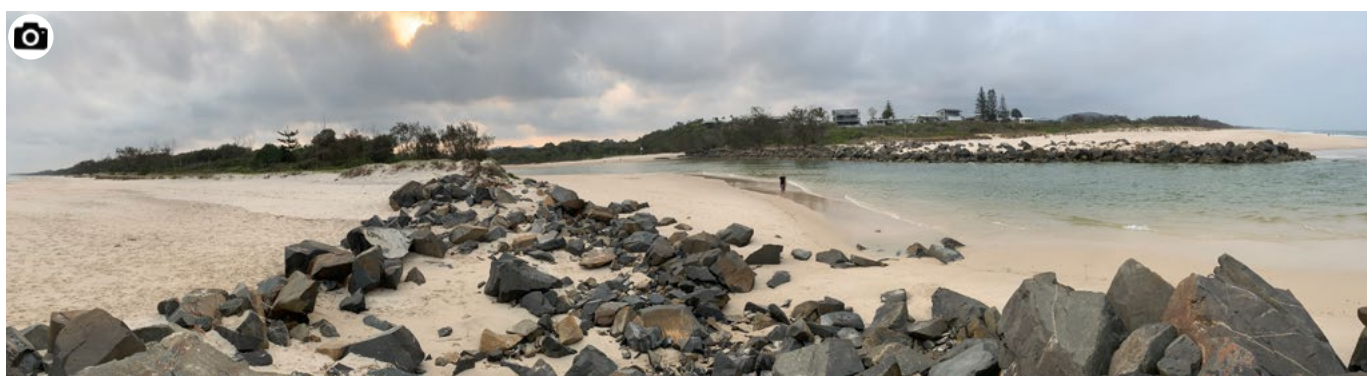
Responsible Authority:	NSW State Government
Built:	1968
Primary purpose when first built:	Trained entrance for flood mitigation of Mooball Creek coastal floodplain
Current uses:	The breakwater has partially collapsed. The WBM (2015) Flood Risk Study found: 'dredging the creek would have limited to negligible improvements on flood magnitude, extent and duration of inundation'

The collapsed Mooball Creek southern breakwater

Recommendation: examine and assess primary purpose

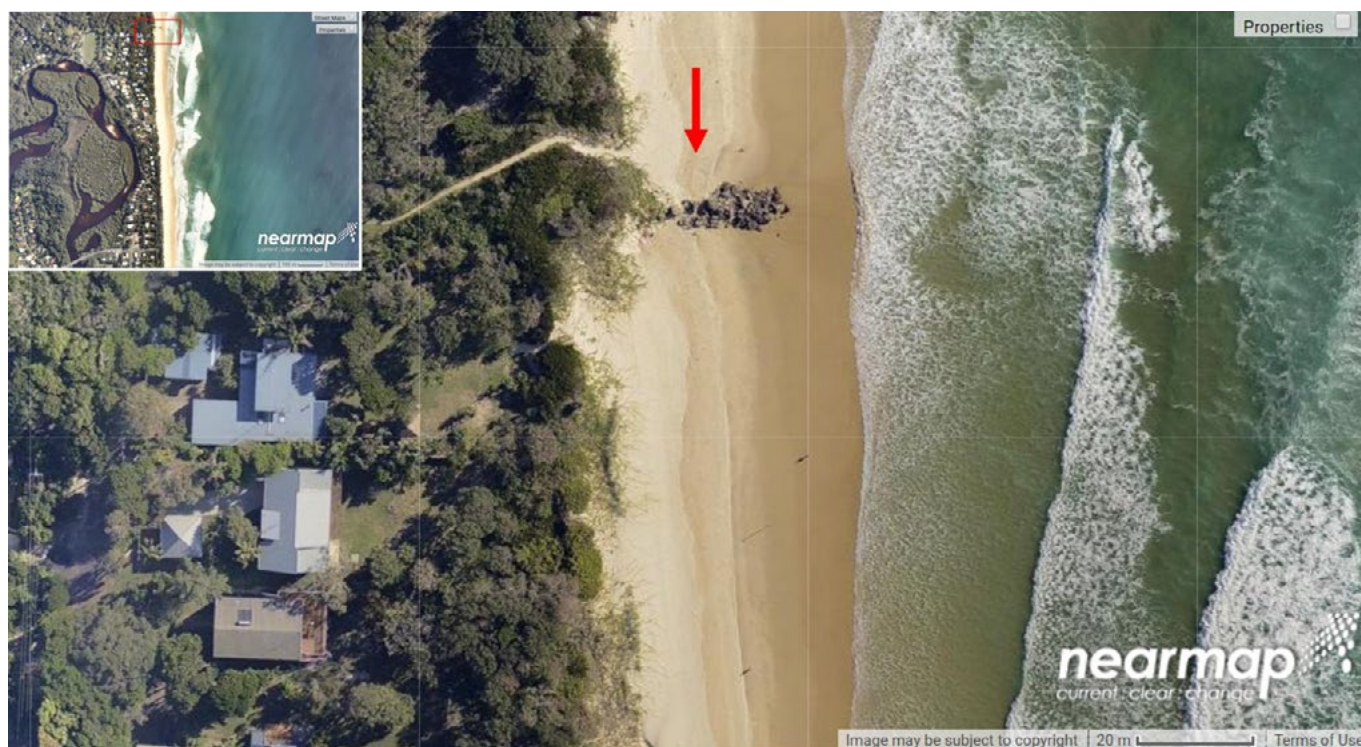
New Brighton Groyne: depending on the state of the beach, the structure is sometimes completely concealed by sand or a prominent feature *Credit: nearmap*

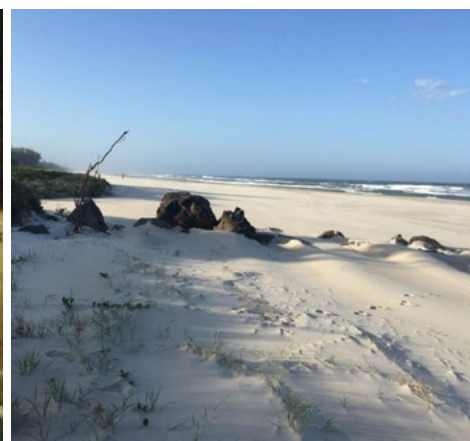
The partially buried groyne in 2020
Photo: Rebecca Philps

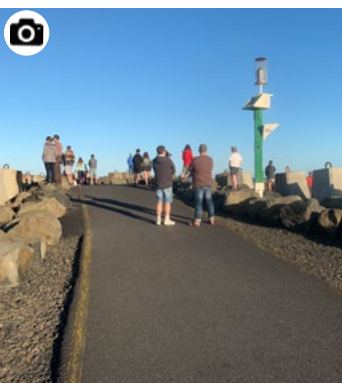
A raised walkway crest on North Wall maintains the spectacular view

<p>Future multi-use features</p> <ul style="list-style-type: none"> – Maintain pedestrian walkway surface – Rock placement for seating and fishing opportunities – Rock placement for emergency safety stairs 	<p>Future eco-features</p> <ul style="list-style-type: none"> – Increase submerged habitat complexity – Key fish habitat enhancement along training wall
---	---

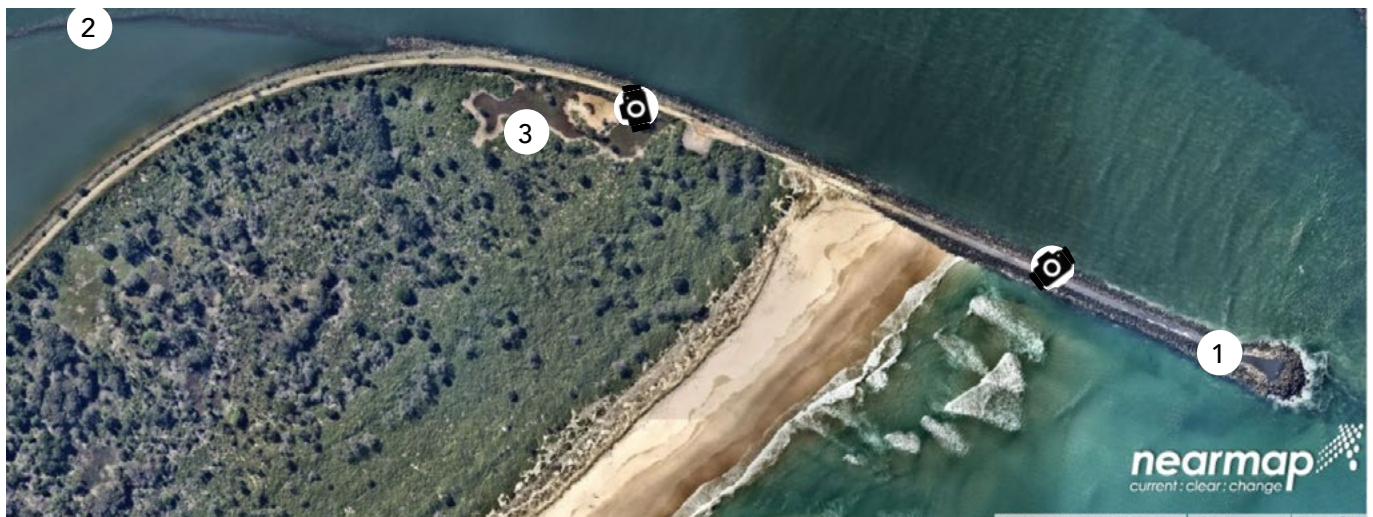
Aerial photo showing: (1) southern breakwater; (2) a half-tide training wall; (3) saltmarsh community reliant on tidal flushing through the breakwater *Credit: nearmap*

- Adjacent osprey tower
- Increase submerged habitat complexity
- Key fish habitat enhancement along training wall

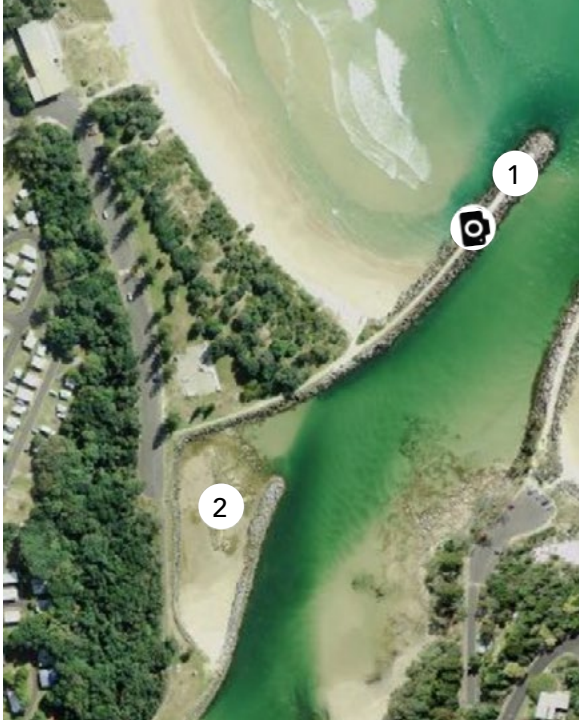
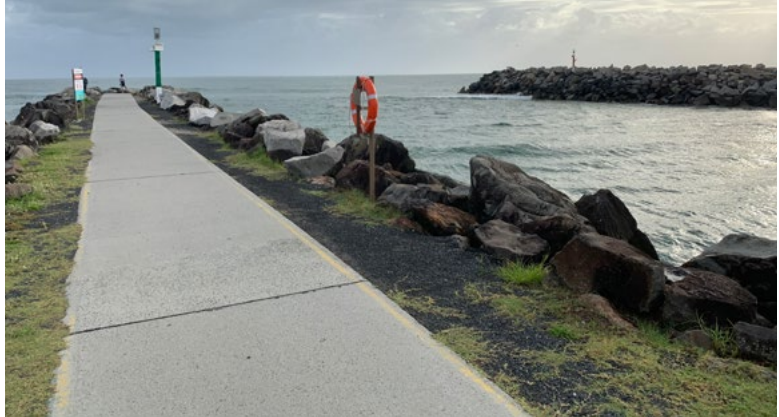
Smooth walking pathway and an angel ring

Evans River Breakwater: (1) the Northern breakwater; (2) wave-trap beach with part of the rocky shelf that was blasted to deepen the entrance *Credit: Six Maps*

<p>Future multi-use features</p> <ul style="list-style-type: none"> - Maintain pedestrian walkway surface - Install CoastSnap photo point - Rock placement for emergency safety stairs 	<p>Future eco-features</p> <ul style="list-style-type: none"> - Increase submerged habitat complexity - Retain rocky wave-trap beach as a habitat refuge
--	---

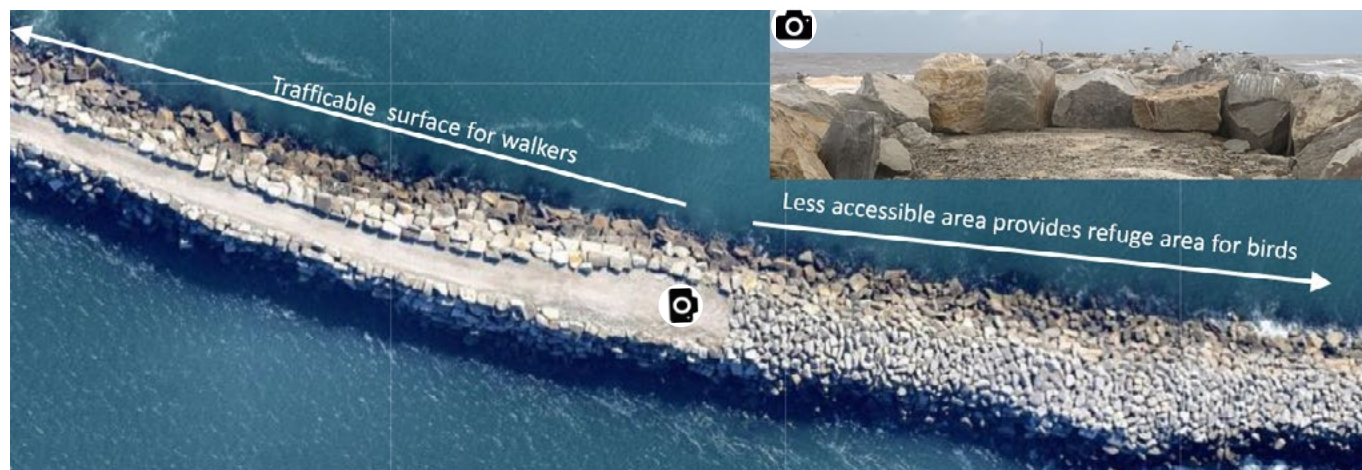
The last 250 metres of the breakwater is inaccessible, and this creates a refuge for breakwater fauna
Credit: nearmap

- Maintain breakwater fauna refuge area
- Adjacent osprey tower
- Increase submerged habitat complexity
- Key fish habitat enhancement along training wall

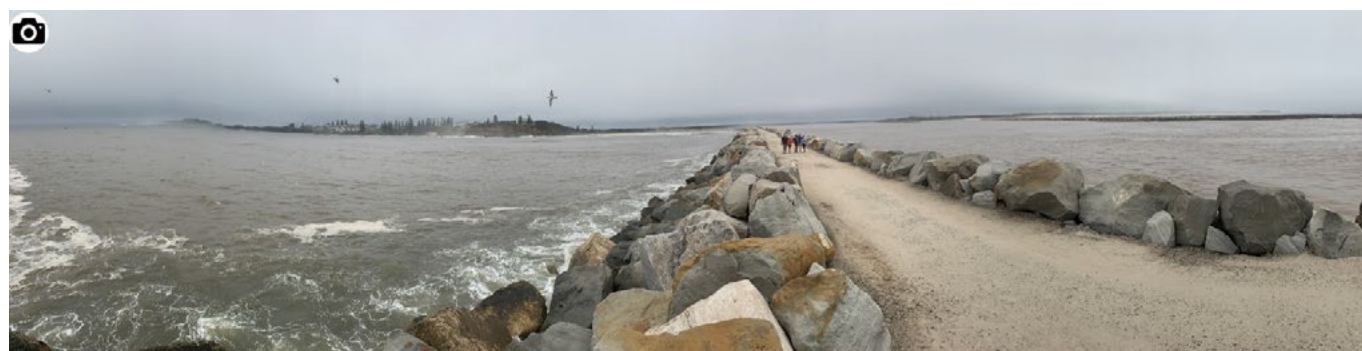
The view back to land from the end of the Clarence River southern breakwater provides a unique perspective as sea birds arc and dive for fish. The first two-thirds of the breakwater has a smooth, tar-finished trafficable surface and the last third is a coarser gravel.

- Adjacent osprey tower
- Increase submerged habitat complexity
- Key fish habitat enhancement along training wall

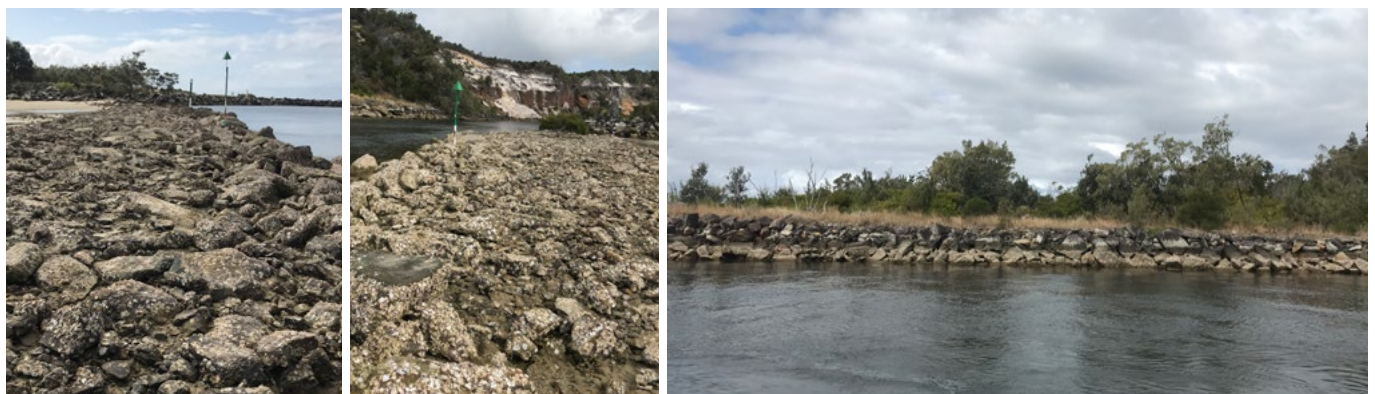
Wooli breakwater rubble has been colonised by oysters to create a valuable oyster reef habitat

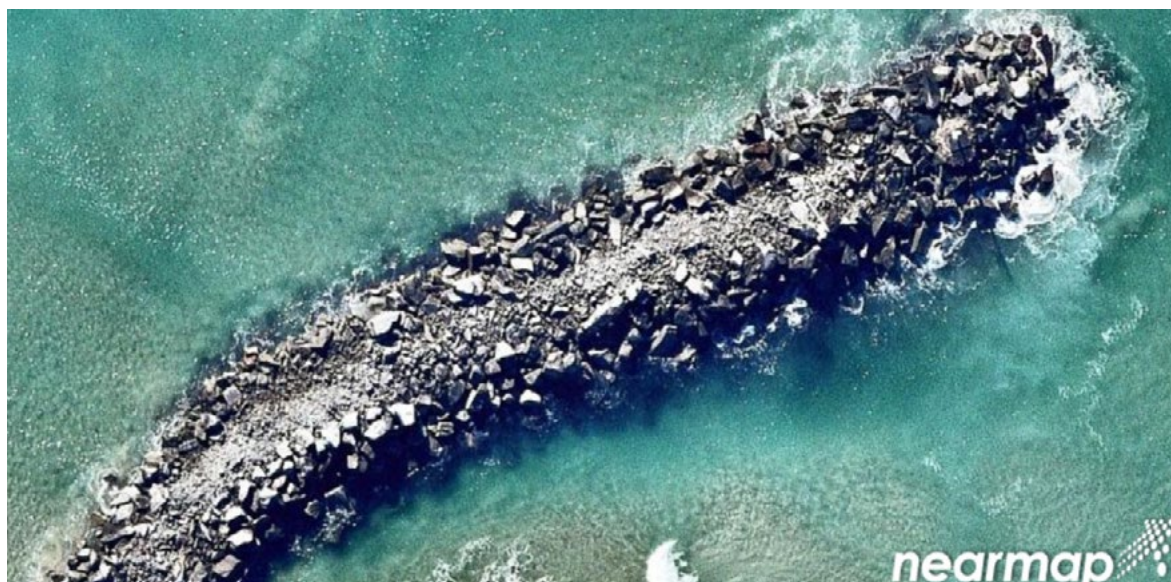
The Wooli River southern breakwater does not have a smooth surface for walking *Credit: nearmap*

- Key fish habitat enhancement along training wall

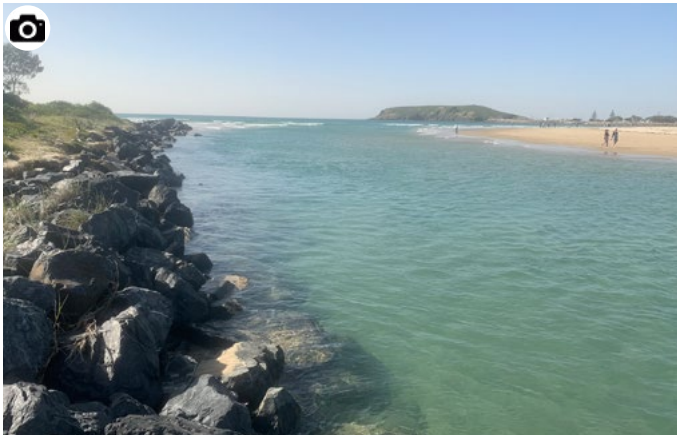
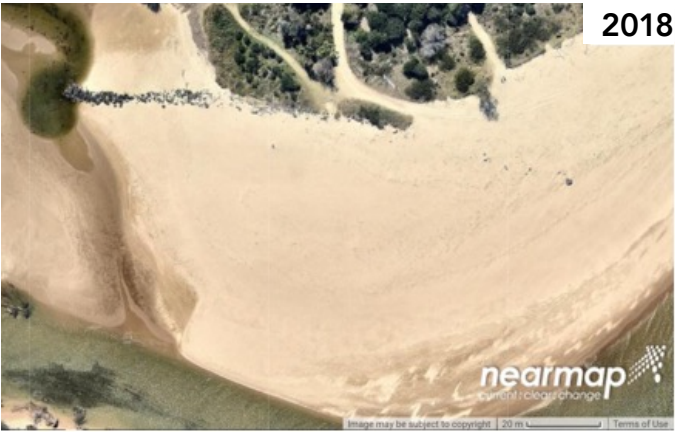
Shifting sands in Coffs Creek sometimes bury the northern training wall and expose it at other times.

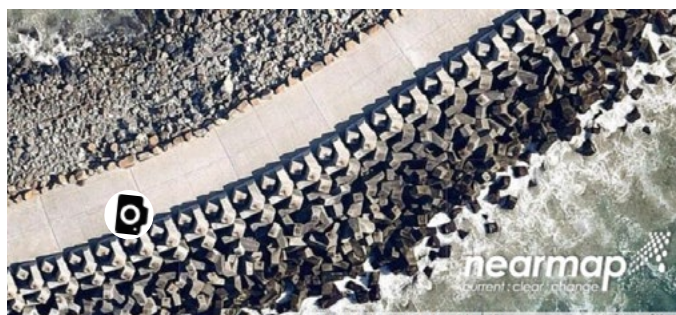
Aerial photo of the Coffs eastern breakwater Credit: nearmap

The breakwater is accessible and part of the Coffs Harbour 'jetty' precinct with nearby parking, restaurants, amenities, marina services.

- Install CoastSnap photo point at Gallows Beach
- Improve opportunities to enjoy the view
- Maintain the pedestrian walkway surface
- Rock placement for seating and fishing opportunities
- Rock placement for emergency safety stairs

- Increase submerged habitat complexity
- Improved sand management

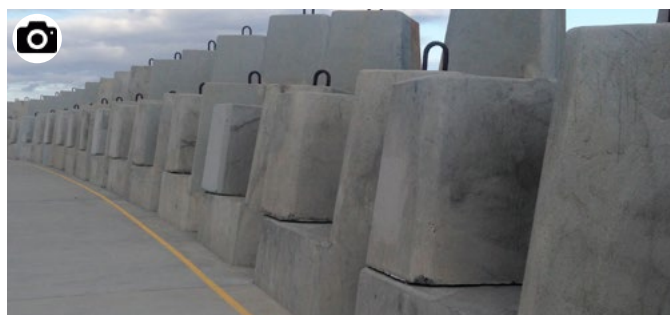
Concrete Hanbar units with attached lifting hooks on the eastern breakwater limit opportunities to enjoy the view to the south east over Korffs Islet

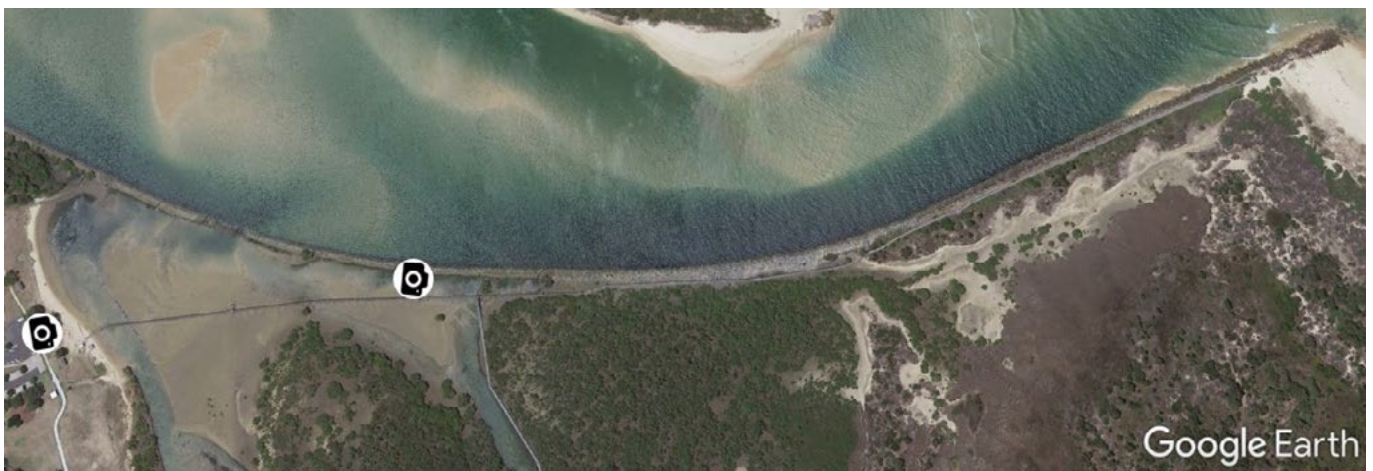
The Bellinger River southern breakwater *Credit: Google Earth*

The breakwater is very accessible. It is close to parking, amenities, greenspace and the Urunga central business district. An estuarine training wall network extends upstream for 1.9 km and includes inlets that support seagrass, mangrove, saltmarsh, and wader and migratory bird habitats.

- Adjacent osprey tower
- Increase submerged habitat complexity
- Key fish habitat enhancement along training walls

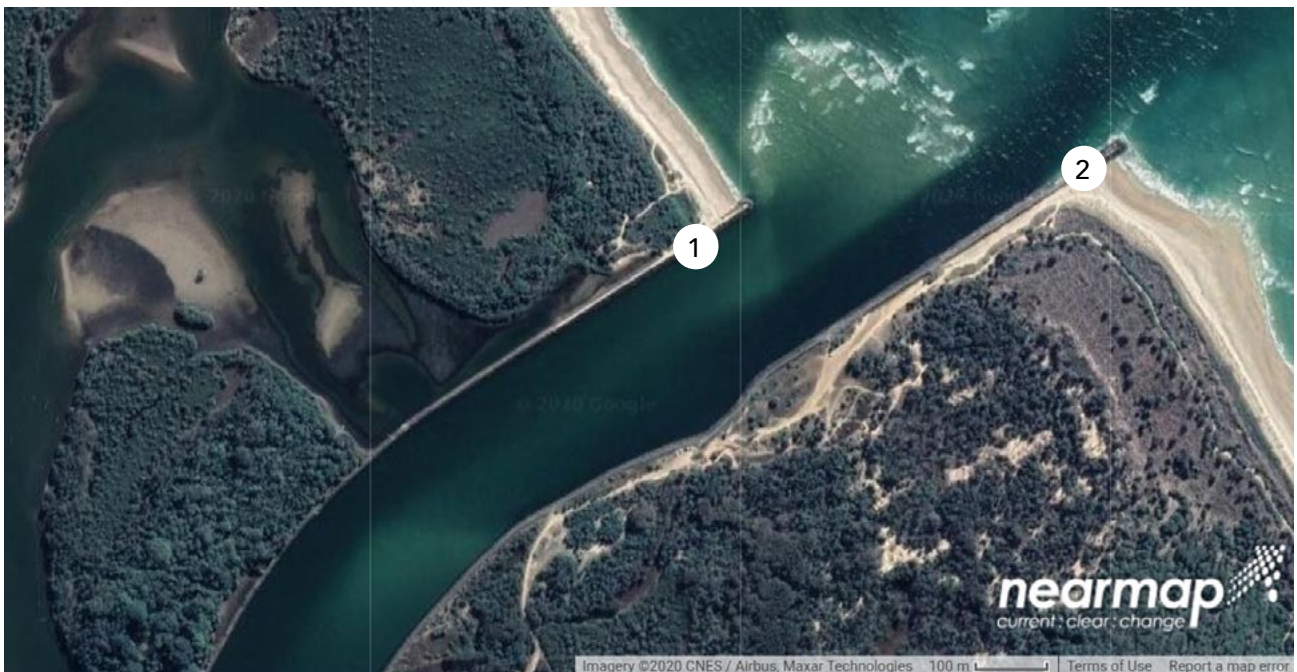
The Macleay River estuary trained entrance with the (1) northern and (2) southern breakwaters *Credit: nearmap*

Responsible Authority:	NSW State Government	Multi-use features:	Nil
Built:	1896–1906	Eco-features:	– Estuarine intertidal inlets
Primary purpose when first built:	Trained entrance for coastal shipping	The breakwater is inaccessible. It requires access along the beach from Grassy Head to the north.	
Current uses:	– Ocean access for boating	An estuarine training wall extends upstream for 2.3 km and includes inlets that support seagrass, mangrove, saltmarsh, and wader and migratory bird habitats.

Recommendations for possible inclusion in future maintenance or upgrade works	
Future multi-use features	Future eco-features
– Rock placement for emergency safety stairs	– Adjacent osprey tower
	– Increase submerged habitat complexity
	– Key fish habitat enhancement along training walls

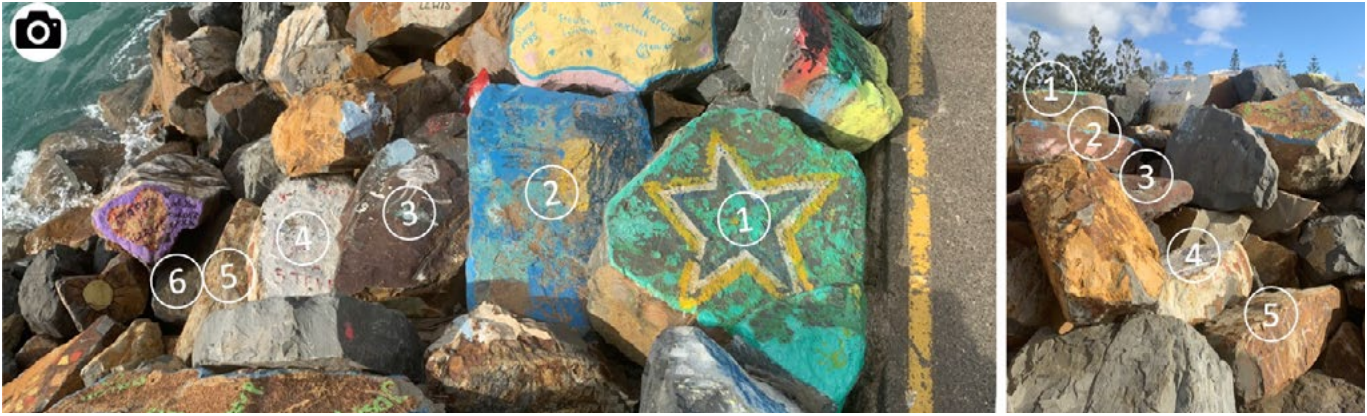
Emergency safety stairs created through careful rock placement during maintenance of the Hastings southern breakwater

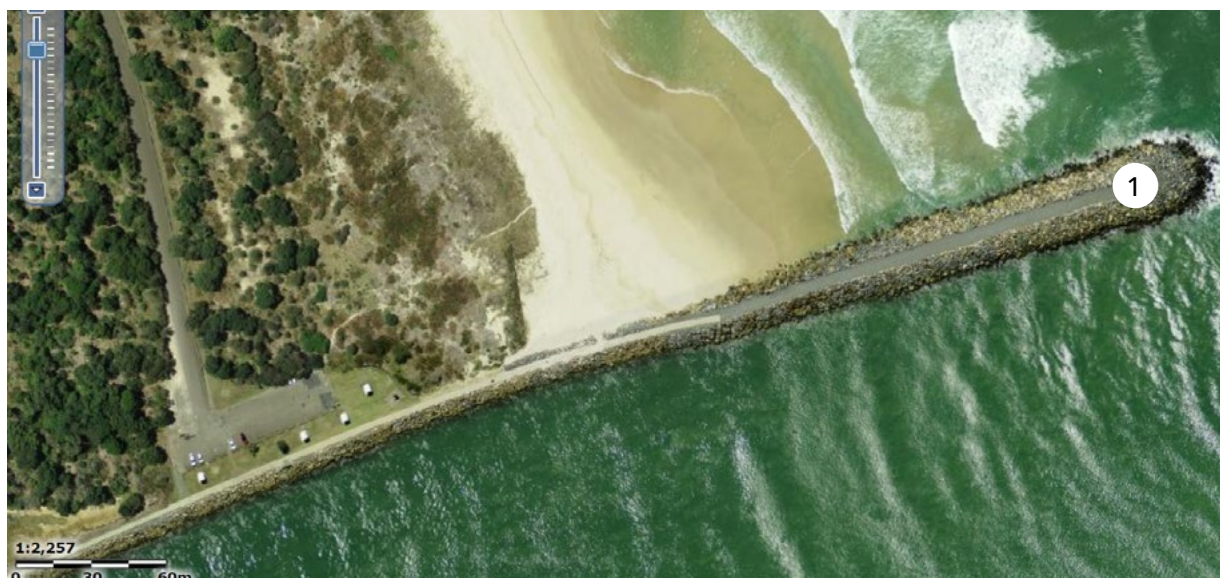
Aerial photo of the Camden Haven northern breakwater

Multi-use features: – Walking pathway elevated
Eco-features: – Estuarine intertidal inlet
The breakwater is accessible. It is close to parking, amenities, greenspace and urban areas. An estuarine training wall extends 1.5 km upstream, including the Camden Haven Ocean Drive Harbour.

- Maintain elevated pedestrian walkway surface
- Install CoastSnap photo point
- Rock placement for seating opportunities
- Rock placement for emergency safety stairs

- Adjacent osprey tower
- Increase submerged habitat complexity
- Key fish habitat enhancement along training walls

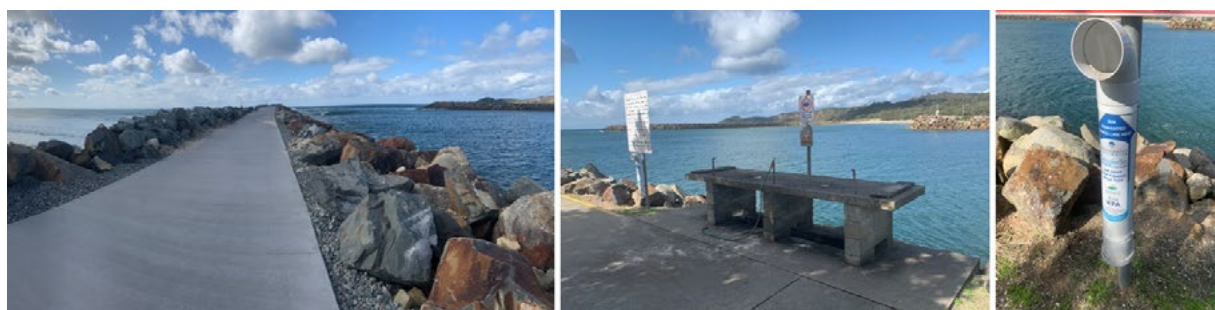
A pathway accessible to all; fish cleaning table; fishing line collection bin

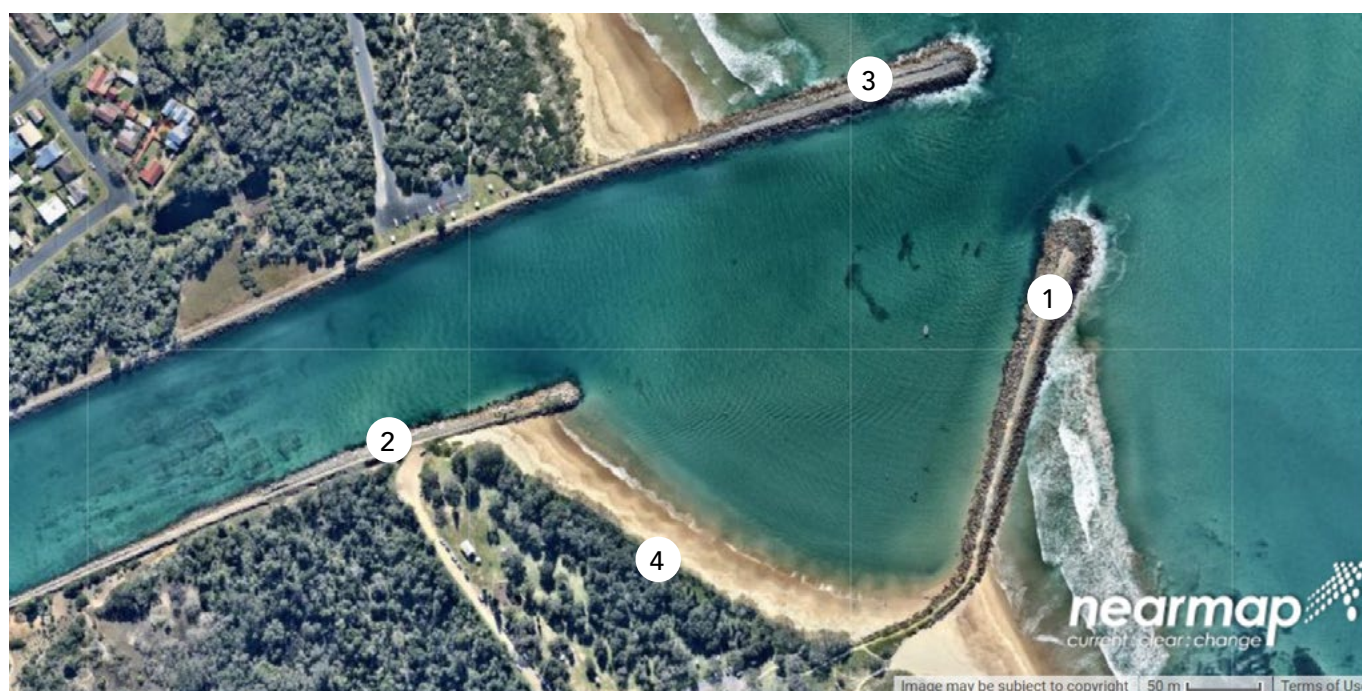
The breakwater is accessed by an unsealed road to nearby parking. An estuarine training wall extends upstream for 2.1 km. It defines Gogleys Lagoon and includes a netted swimming enclosure at Dunbogan Reserve.

Aerial photo of the Camden Haven breakwaters: (1) new southern breakwater constructed in 1960s; (2) original southern breakwater; (3) northern breakwater; (4) Pilot Beach, a wave-trap beach reliant on the breakwater network

- Adjacent osprey tower
- Increase submerged habitat complexity
- Key fish habitat enhancement along training walls

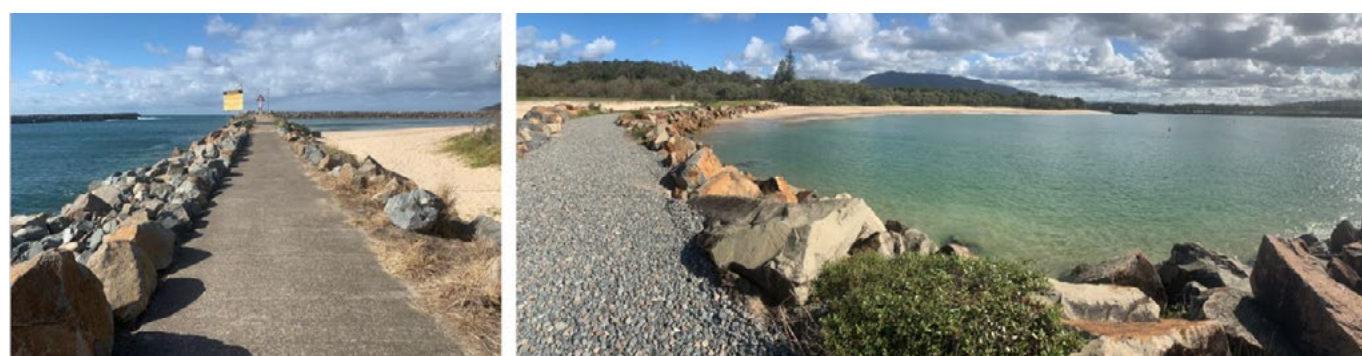
The popular wave-trap Pilot Beach just inside the original southern wall (left) and the new southern breakwater with a crushed pebble surface (right)

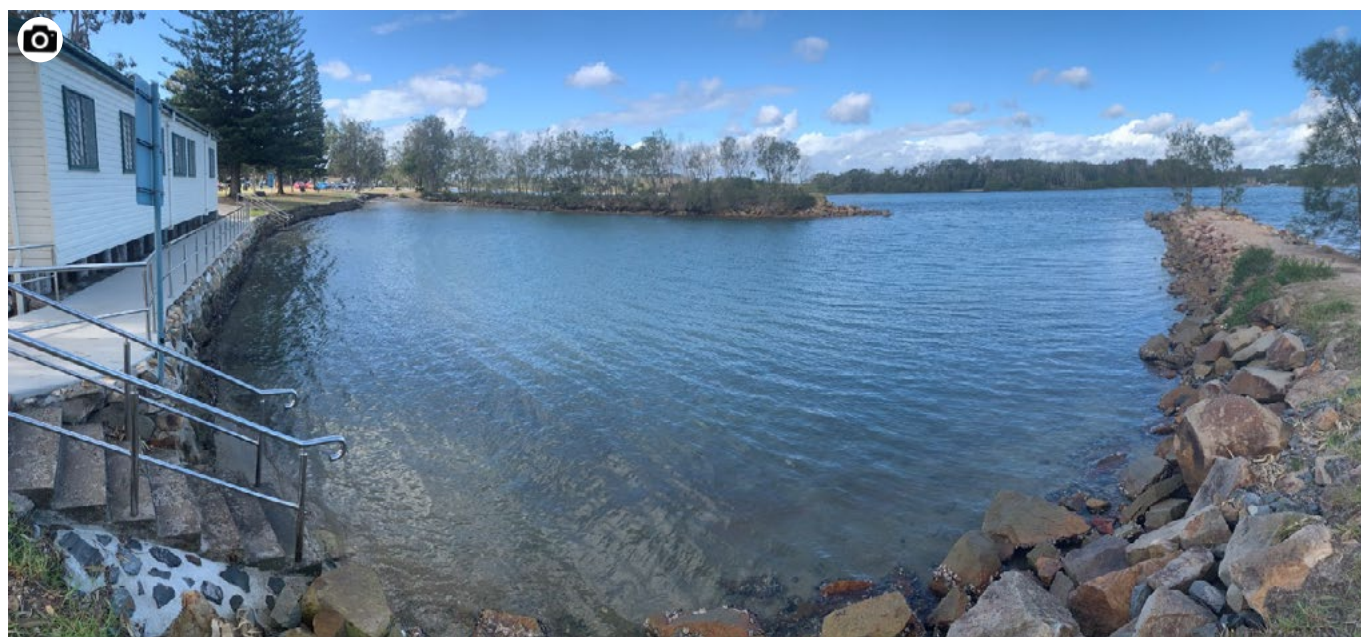
Popular North Haven swimming enclosure. The shape of the breakwater creates the enclosure and a net is fitted to span the entrance to the Camden Haven River estuary.

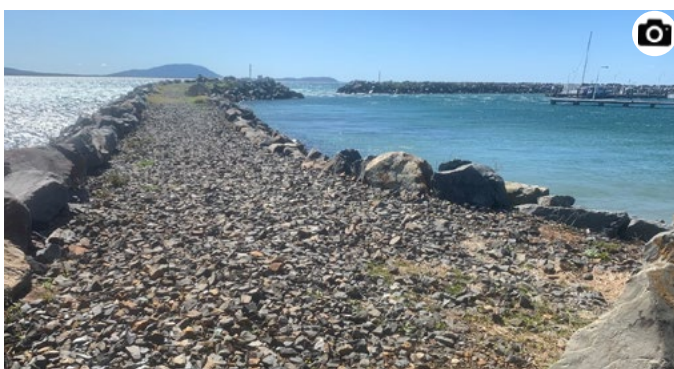
Rubble crest surface on the Crowdy Bay western breakwater

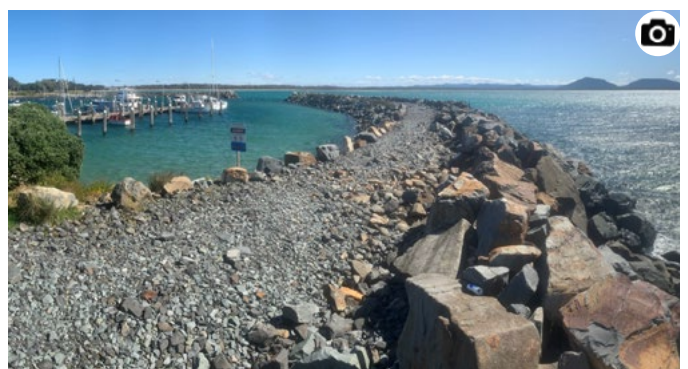
Rubble crest surface on the Crowdy Bay eastern breakwater

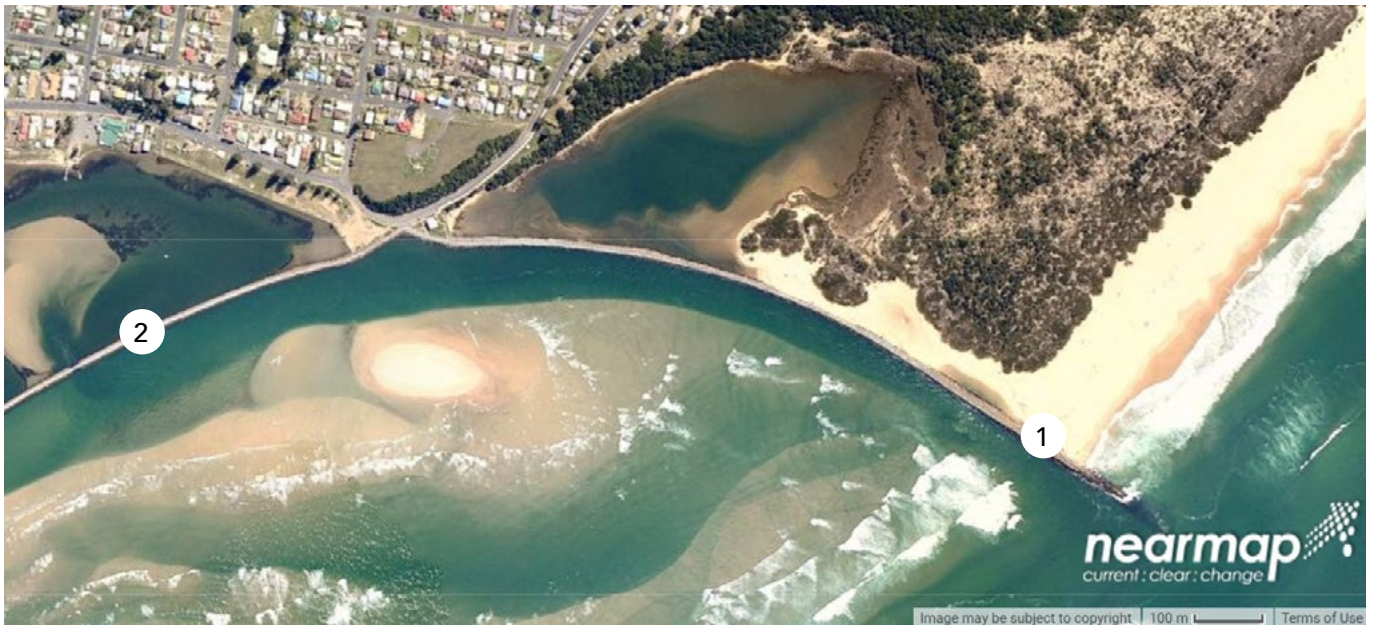
Aerial photo 2011 of the Manning River northern breakwater with the river following the training wall *Credit: nearmap*

- Maintain breakwater fauna refuge area
- Adjacent osprey tower
- Increase submerged habitat complexity
- Fish habitat enhancement along training wall

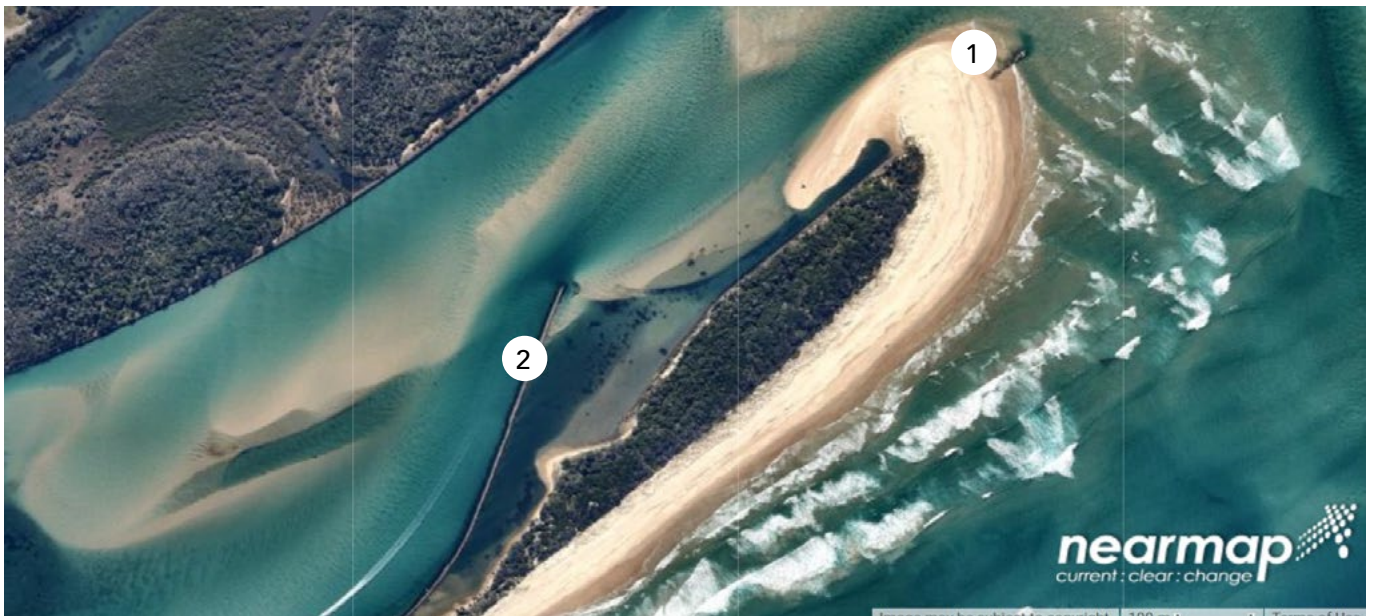
Aerial photo 2019 of (1) the Manning southern training wall and (2) the Manning southern wall spur wall constructed in the 1920s *Credit: nearmap*

- Maintain training wall fauna refuge area
- Key fish habitat enhancement along training walls

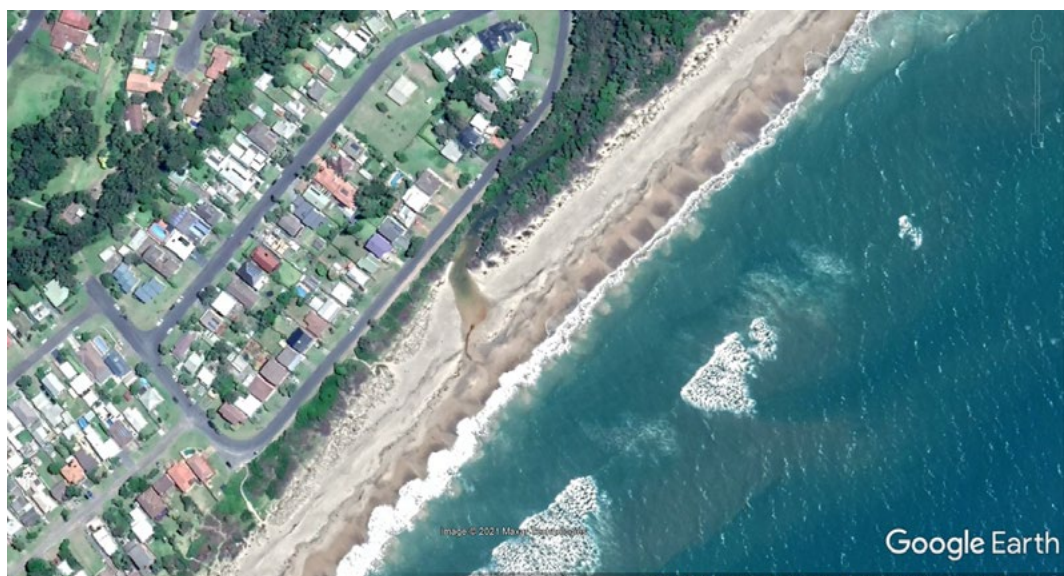
A 2021 aerial photo showing the approximately 200-m northward retreat of the Racecourse Creek entrance in response to foreshore erosion

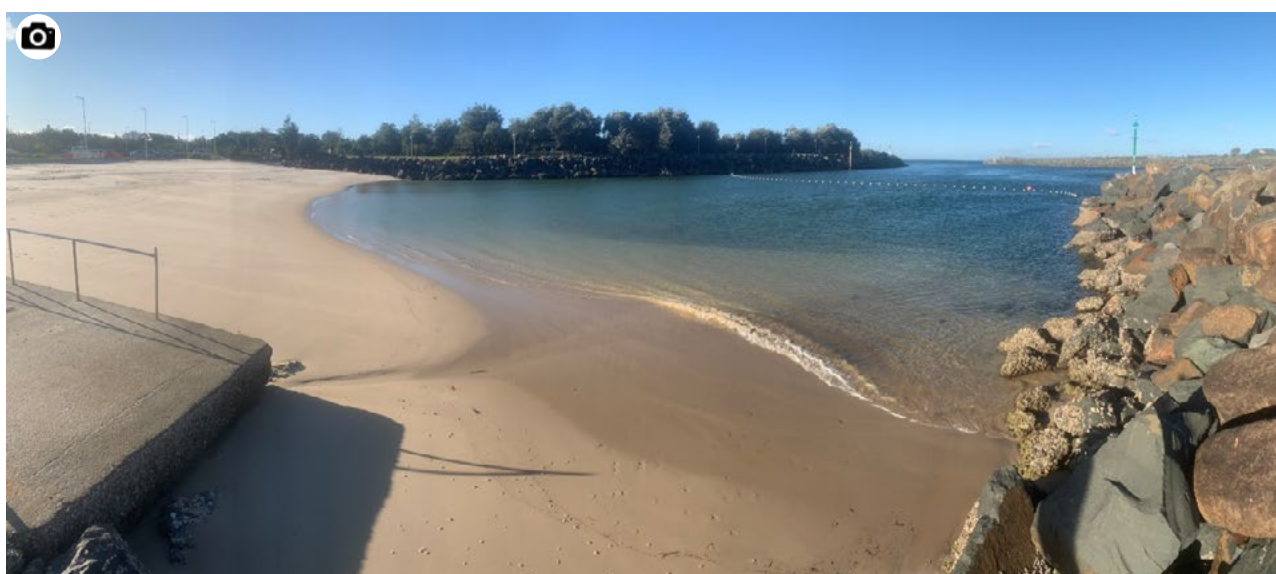
Popular wave-trap beach with an enclosed swimming area just inside the Wallis Lake northern breakwater, although maintenance is required to maintain functionality of access opportunities for people with disability.

- Adjacent osprey tower

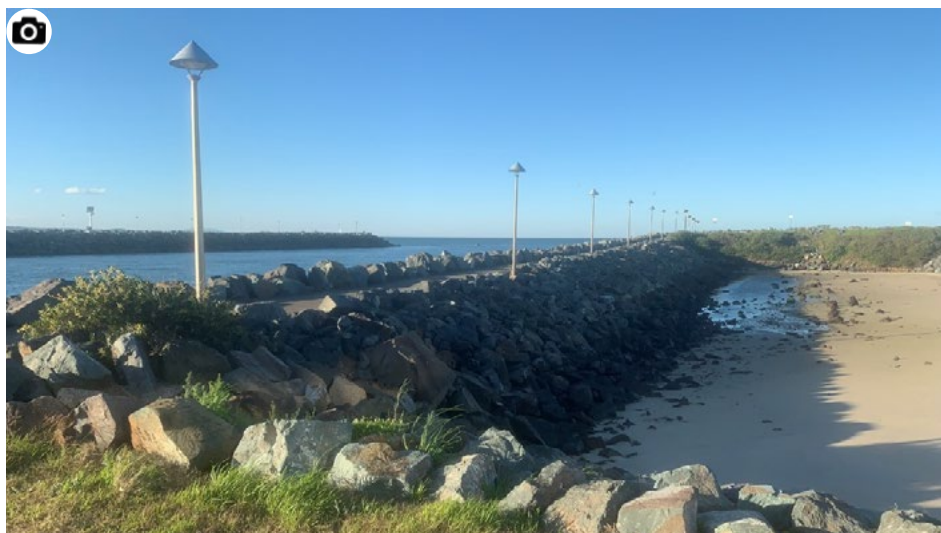
The backwater wading pool relies on tidal flows filtering through the breakwater

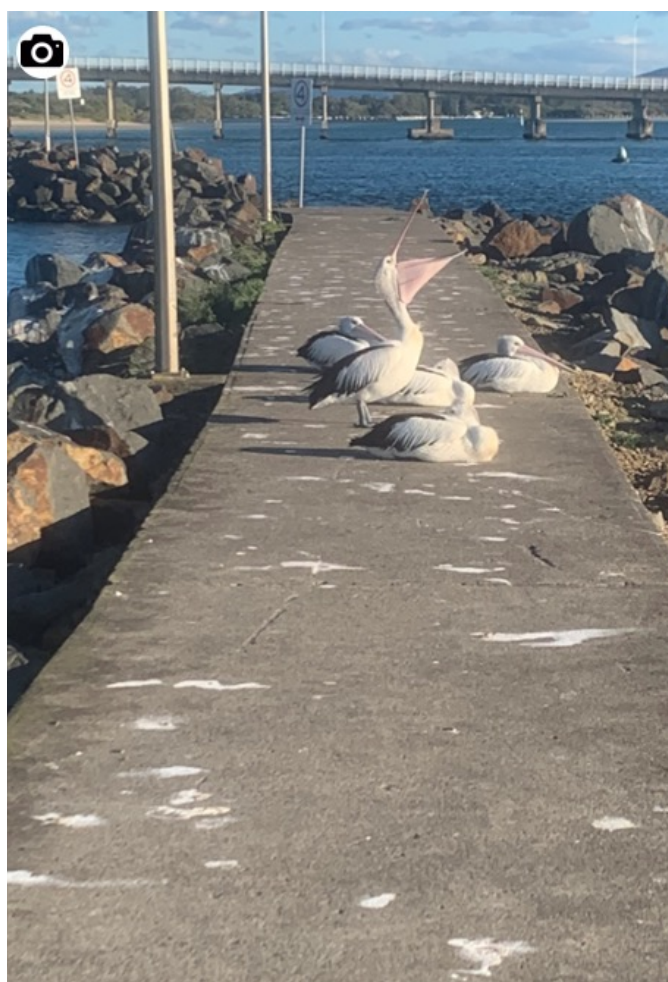
Pedestrian walkway surface and views at the Forster Boat Harbour.

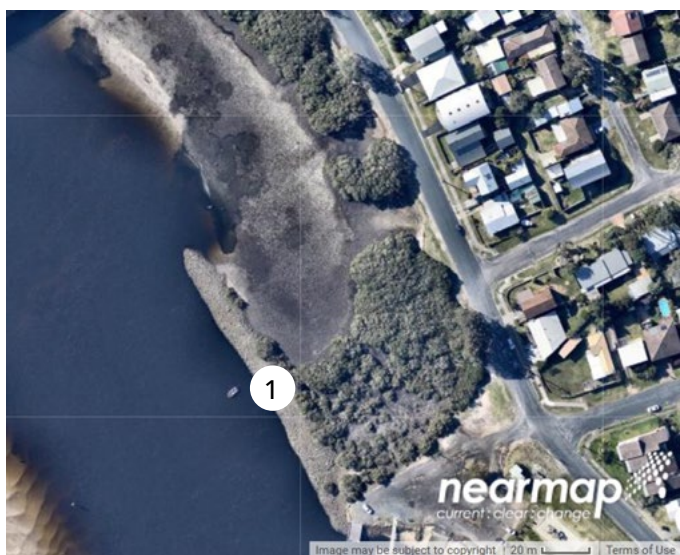
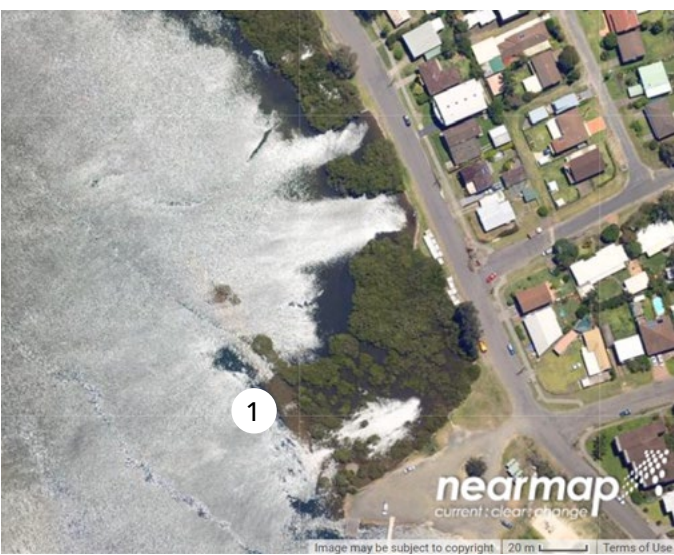
The Hawks Nest breakwater, which is (1) visible at low tide and (2) submerged during the highest tides *Credit: nearmap*

Recommendations for possible inclusion in future maintenance or upgrade works	
Future multi-use features	Future eco-features
Nil	<ul style="list-style-type: none"> - Adjacent key fish habitat enhancement

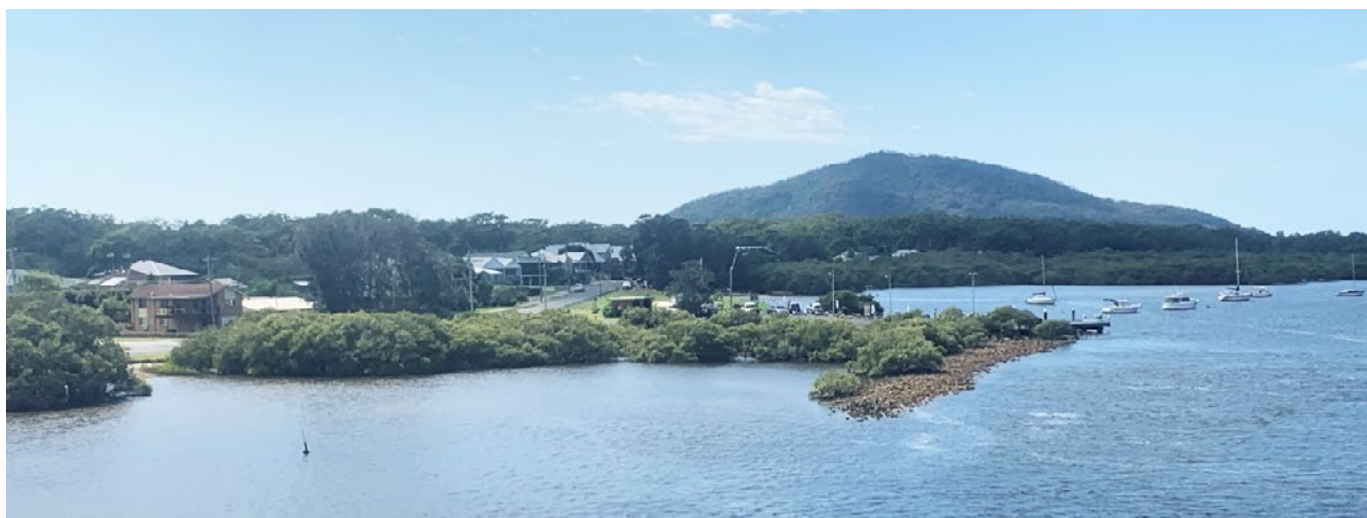
View of the breakwater and the sheltered intertidal area it creates from the Myall Street bridge crossing the Myall River into Hawks Nest.

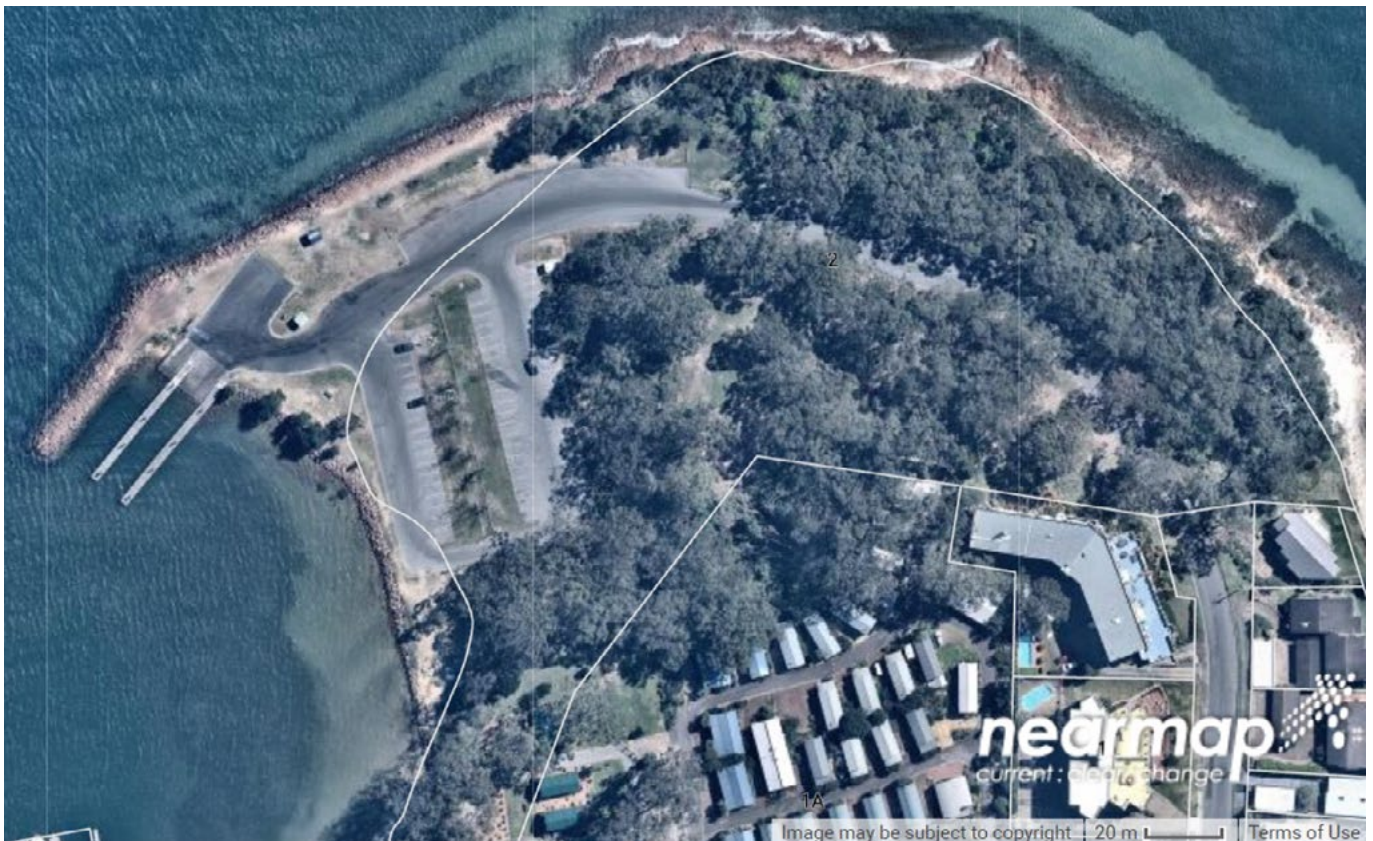
The Soldiers Point boat ramp breakwater. The white line shows the cadastral boundary and mean high water boundary when the area was first surveyed. It indicates that some of the area protected by the breakwater was reclaimed.

– Increase submerged habitat complexity
