# Clarence River Floodplain Prioritisation Study: Appendix A – L

WRL TR 2020/06, May 2023

# Appendix A Floodplain waterways

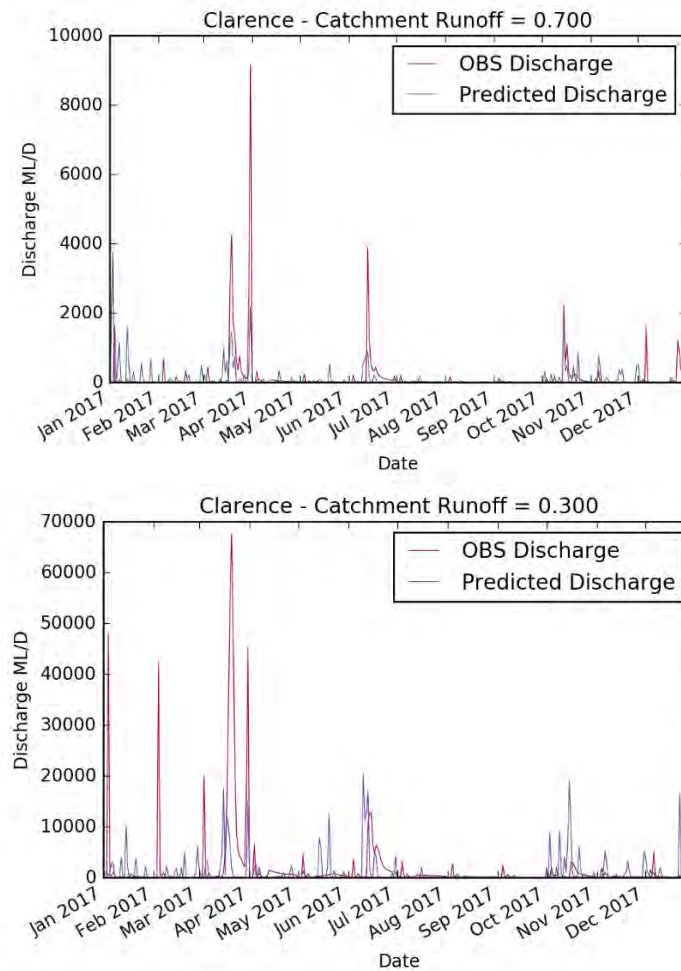
**Figure B-3: Predicted and observed runoff for the catchment area upstream of river gauging station 204041 (top) and station 204055 (bottom)**

The runoff co-efficient was selected by comparing the annual time-series of streamflow data for the predicted runoff volume calculated for the selected gauging stations. Figure B-3 shows an example time-series of predicted and observed runoff for 2017. This analysis yielded an estimated runoff coefficient of 0.7 and 0.3 which were applied to Clarence Floodplain subcatchments for the acid prioritisation assessment.

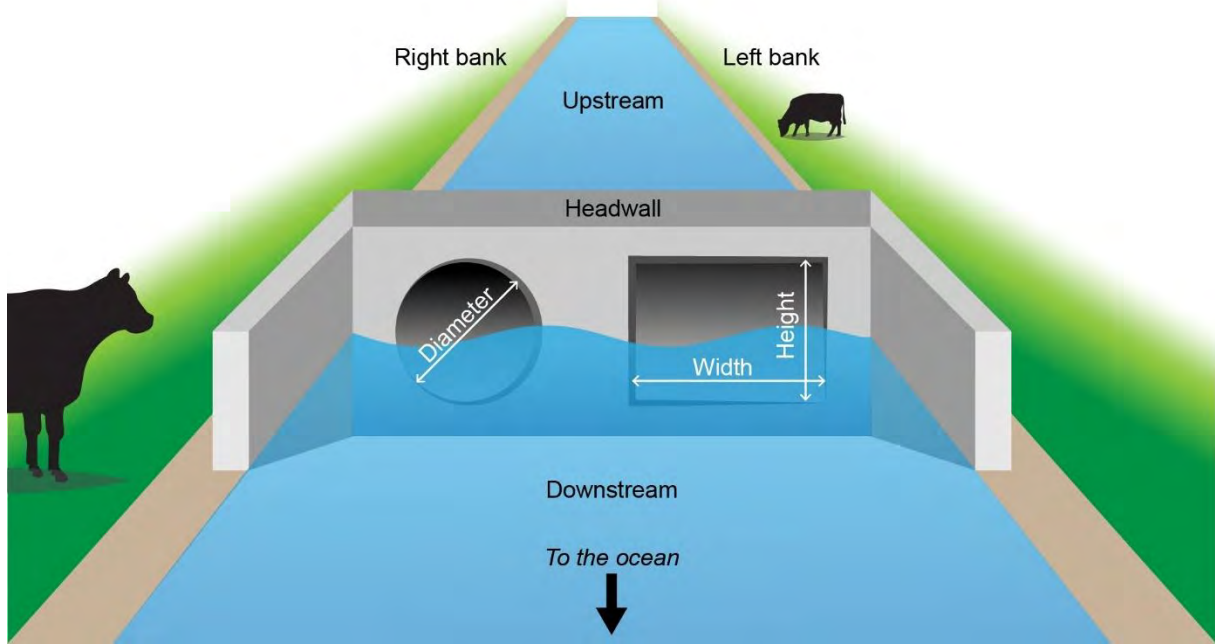
Figure F-5: Example of culverts controlling water in an agricultural drain

The following section provides a number of figures which describe common types of floodplain infrastructure used to control water movement across the floodplain. These figures include descriptions for common terminology used to describe infrastructure.

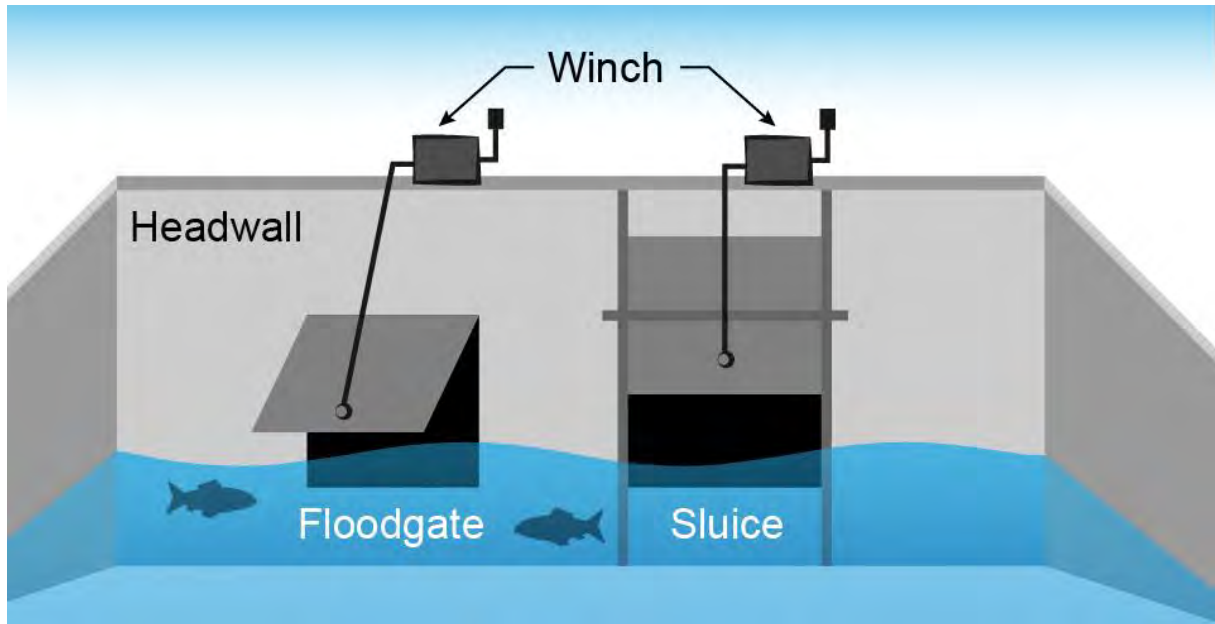
Figure F-6: Example of floodgate and sluice structures which can be fitted to culverts to control flow using a winch

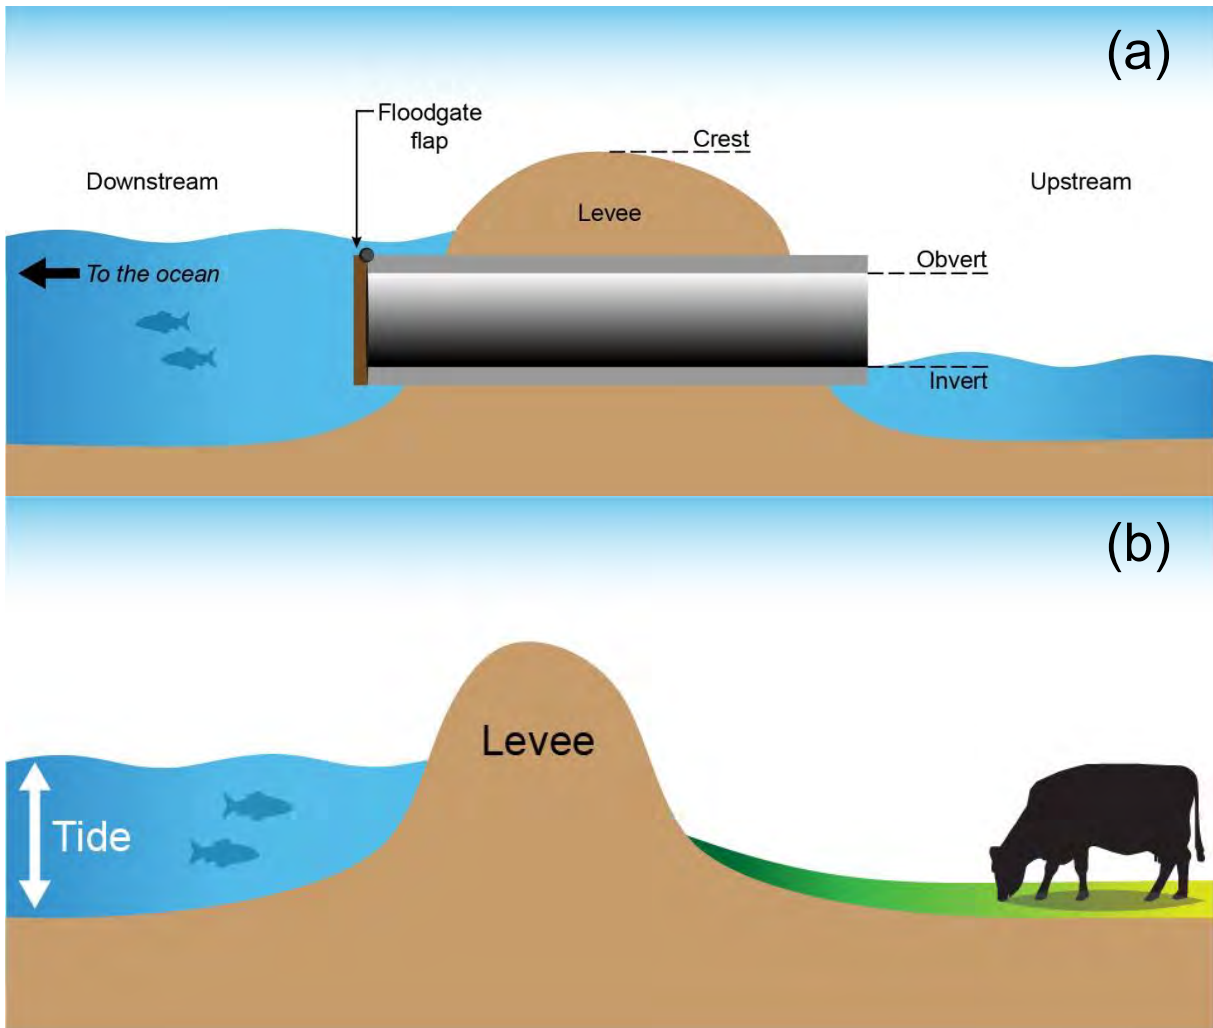
Figure F-7: Example of (a) a floodgate structure ensuring water levels upstream of a levee remain at the low tide level and (b) a levee preventing tidal inundation of the floodplain

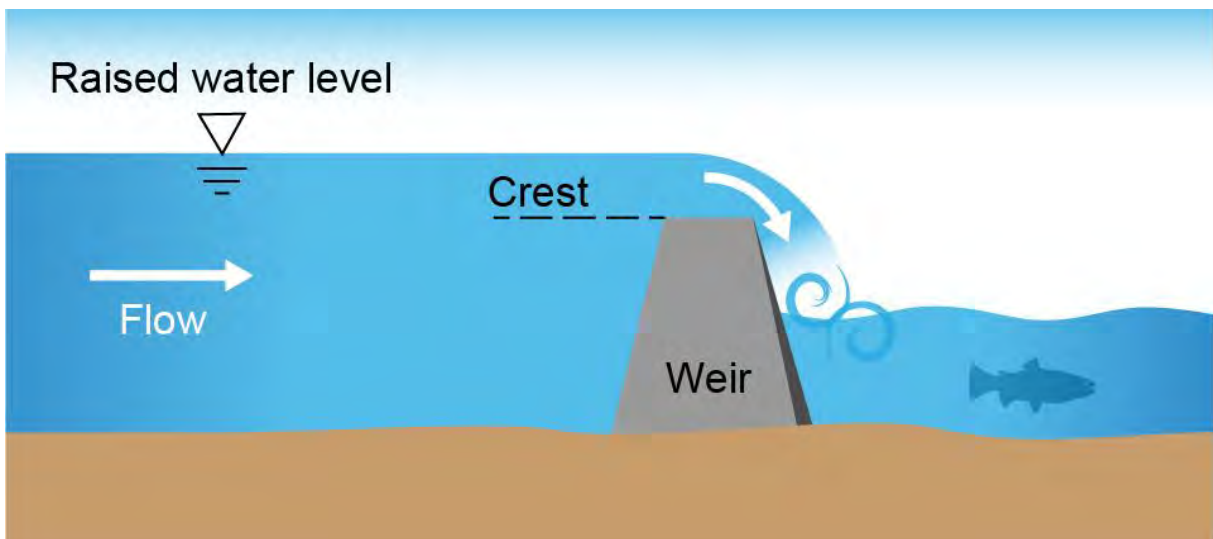
Figure F-8: Example of a weir ensuring a raised water level on the upstream side

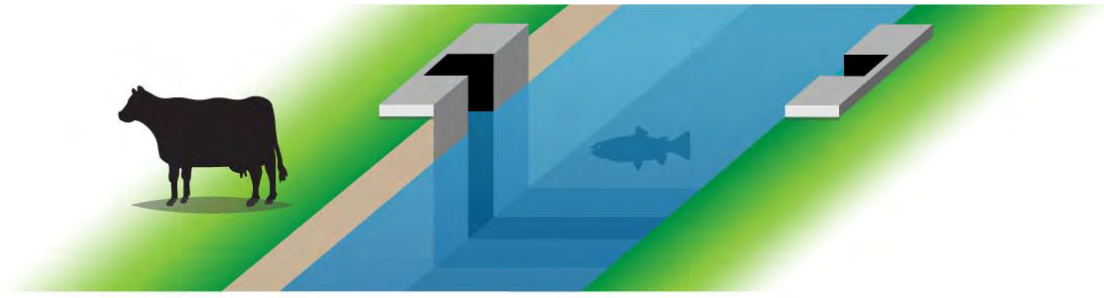
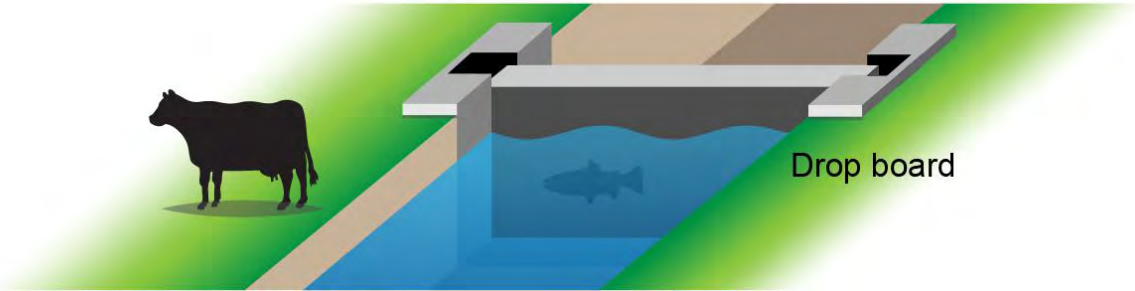
**Figure F-9: Example of a drop board structure which can be used to control water levels and prevent inundation**

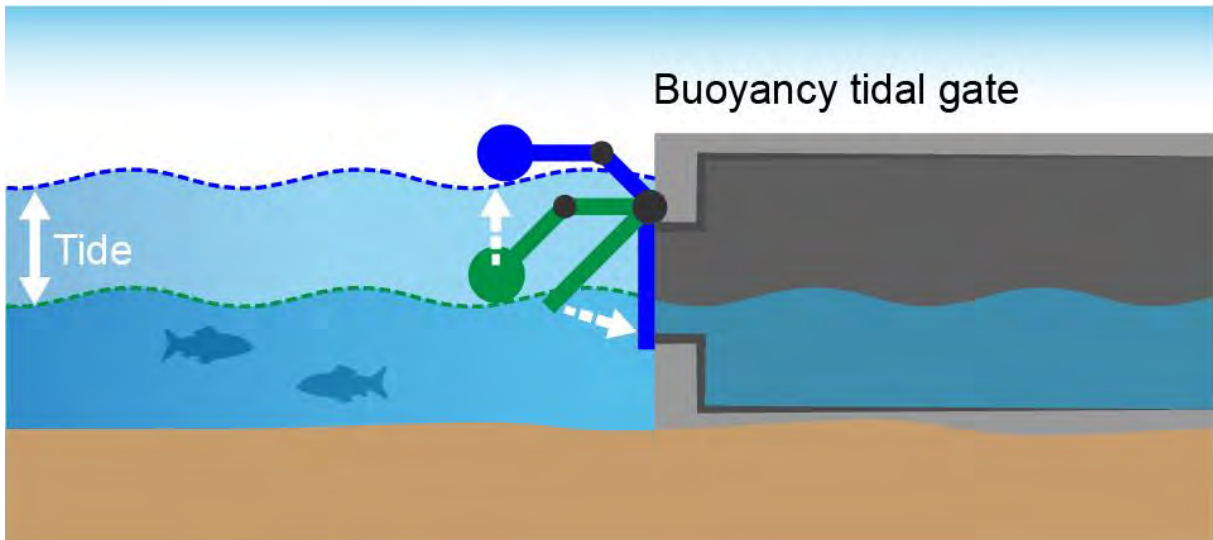
**Figure F-10: Example of a buoyancy tidal gate that lets a controlled level of tidal water upstream of the structure (green) before closing due to a buoyancy mechanism and preventing further water ingress (blue)**

F-1650-FB-0001	1/03/2020 14:01	Floodgate	3		2	2.5	503801	6725543		-0.54	Good	Primary	Clarence Valley Council	Water had foul odour. Boat access was good.
F-1660-FB-0001	1/03/2020 13:16	Floodgate	4		1.8	2.6	504666	6726776		-1.03	Good	Primary	Clarence Valley Council	Observed blackwater event.
F-1680-FB-0001	29/02/2020 14:22	Floodgate	3		2.1	2.1	511488	6729094		1.13	Good	Primary	Clarence Valley Council	Gates act as sluices.
F-1690-FP-0001	6/02/2020 12:58	Floodgate	2	1.8			511505	6728417		-0.33	Good	Secondary	Clarence Valley Council	Appears to have square flaps on circular culverts. The upstream side of the culvert is in private property.
F-1700-FB-0001	6/02/2020 12:46	Floodgate	6		2	2.4	511727	6727199		-1.31	Good	Primary	Clarence Valley Council	Left gate winches open. The upstream side of the culvert is in private property. Dimensions are approximate.
F-1710-FP-0001	6/02/2020 12:37	Floodgate	1	1.2			511395	6726746		-0.89	Poor	Primary	Clarence Valley Council	Gate leaking and rusty. Buoyancy tidal gate present. Dimensions approximate.

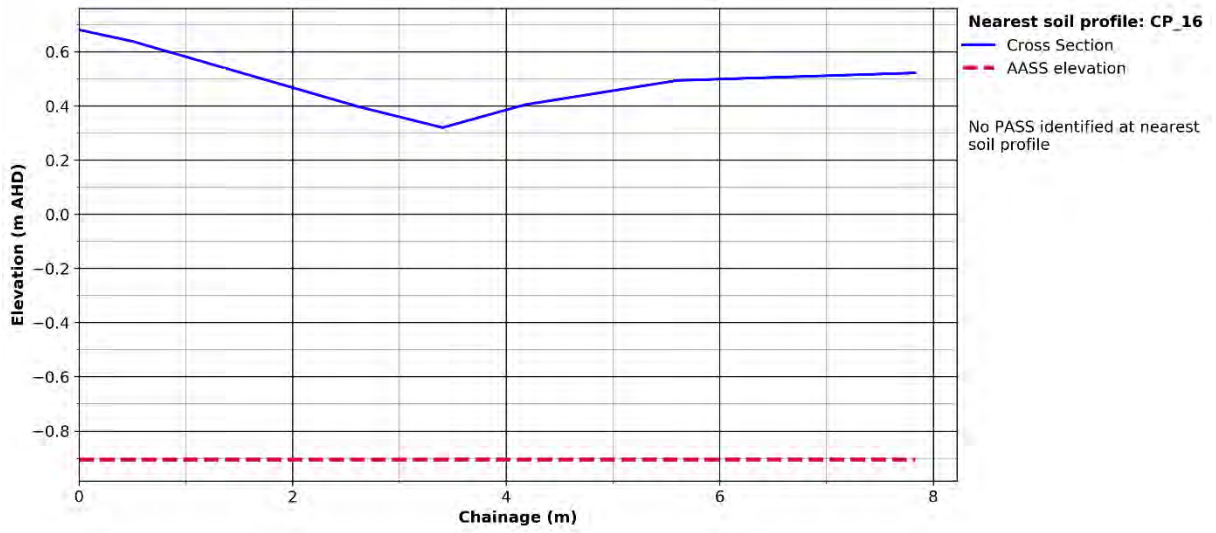
**Figure G-34: Clarence cross-section 205**

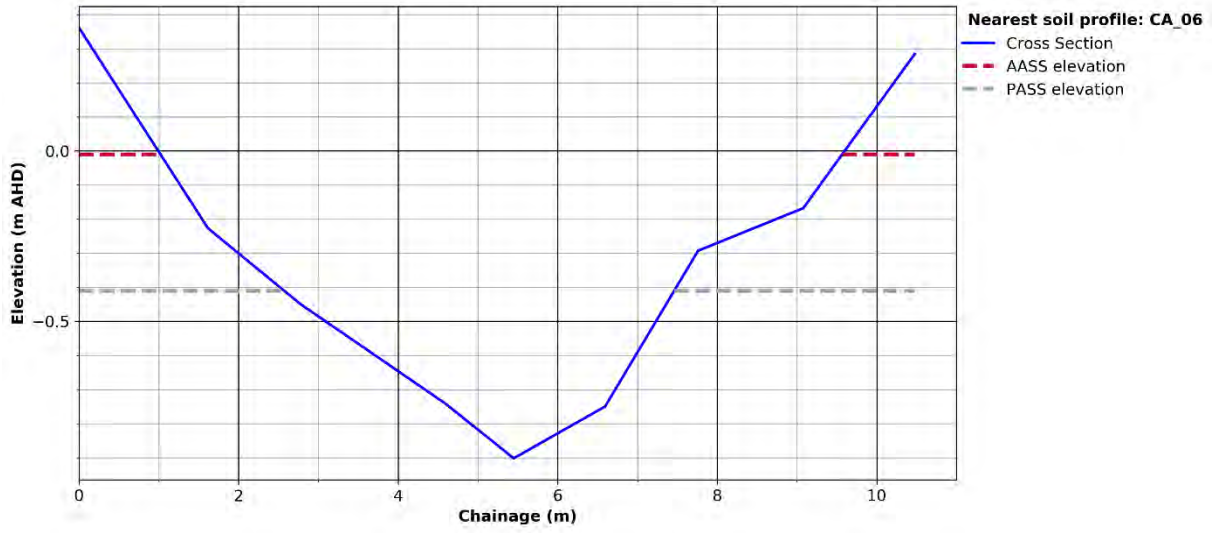
**Figure G-35: Clarence cross-section 206**

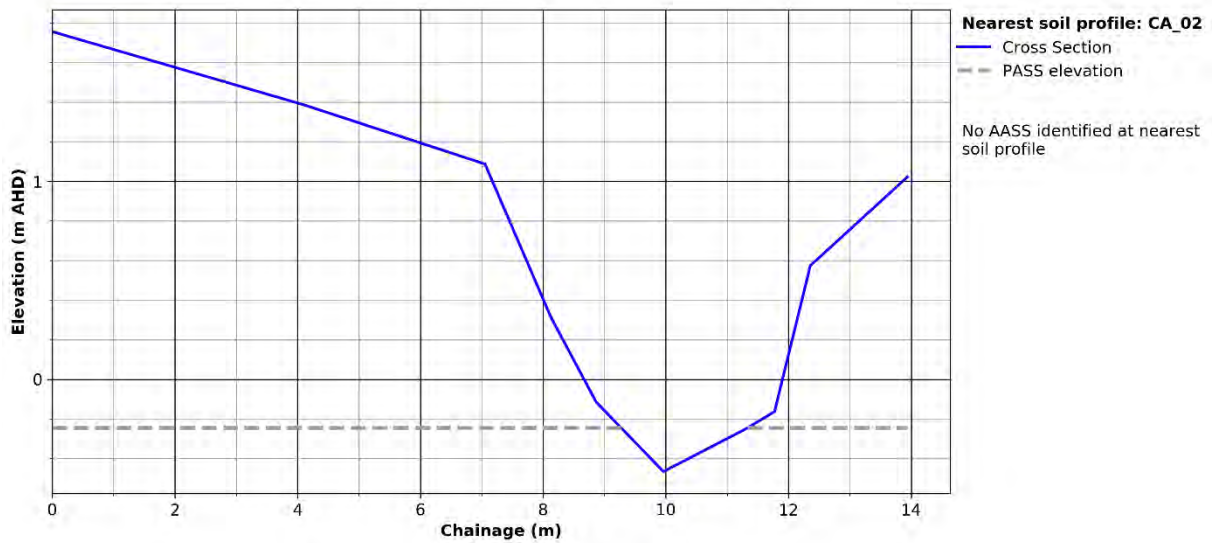
**Figure G-36: Clarence cross-section 207**

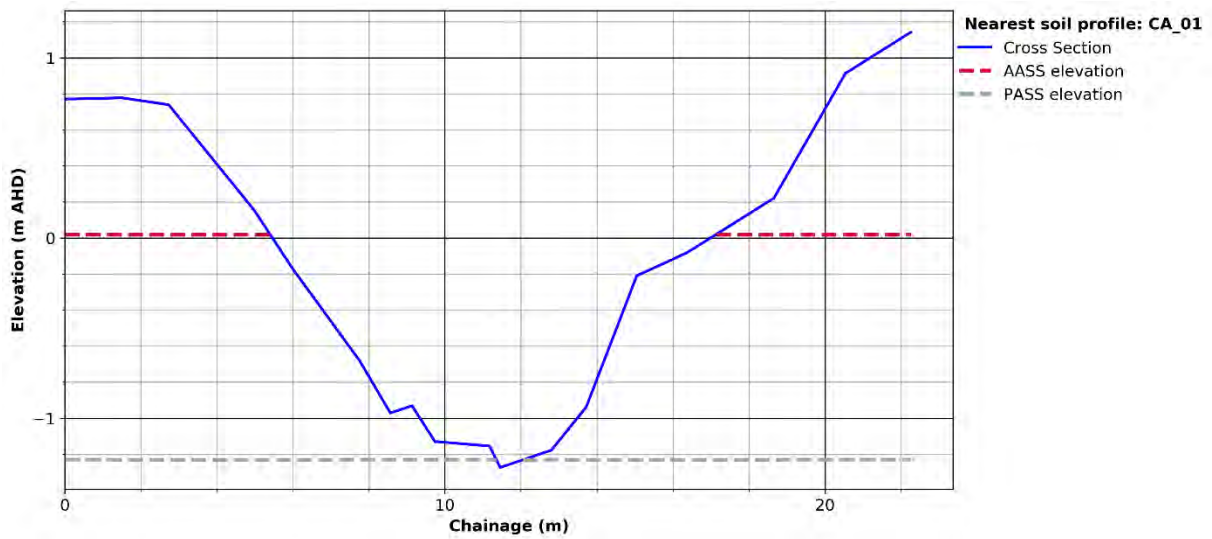
**Figure G-37: Clarence cross-section 208**

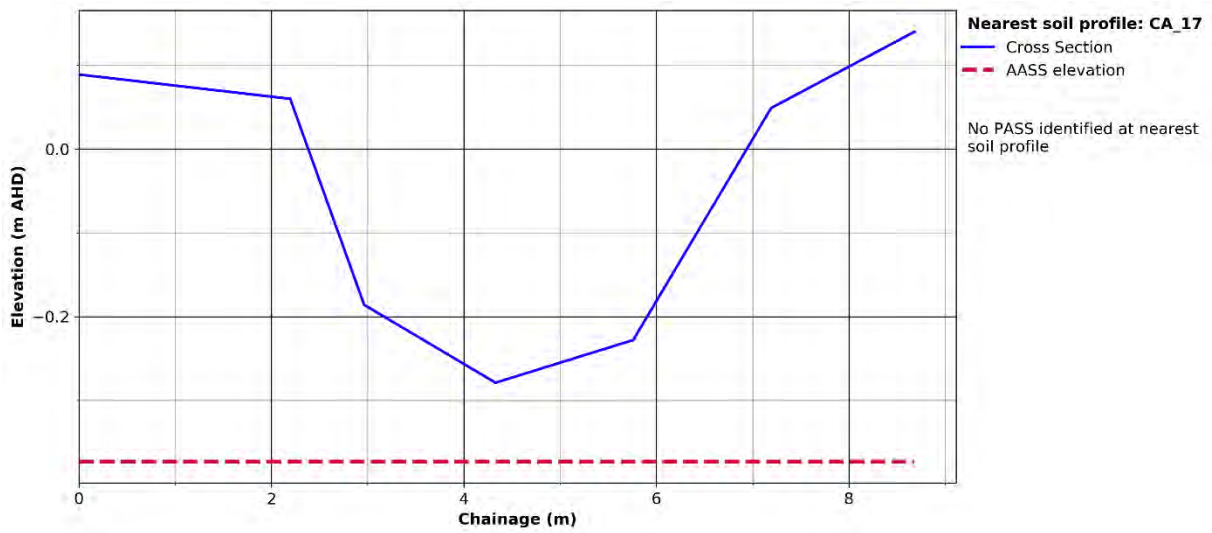
Figure G-38: Clarence cross-section 209

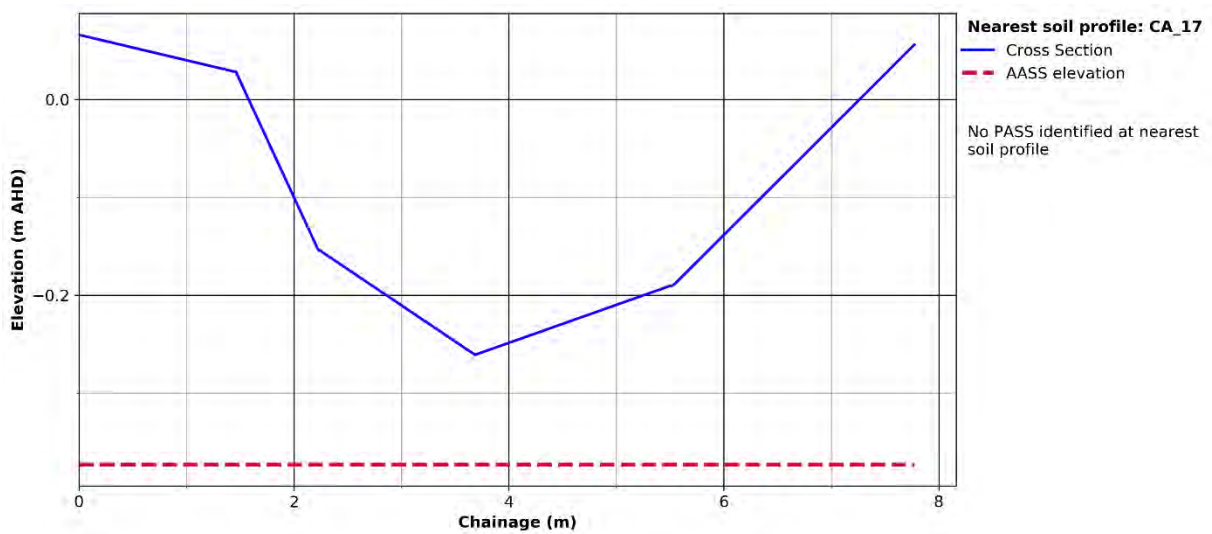
Figure G-39: Clarence cross-section 210

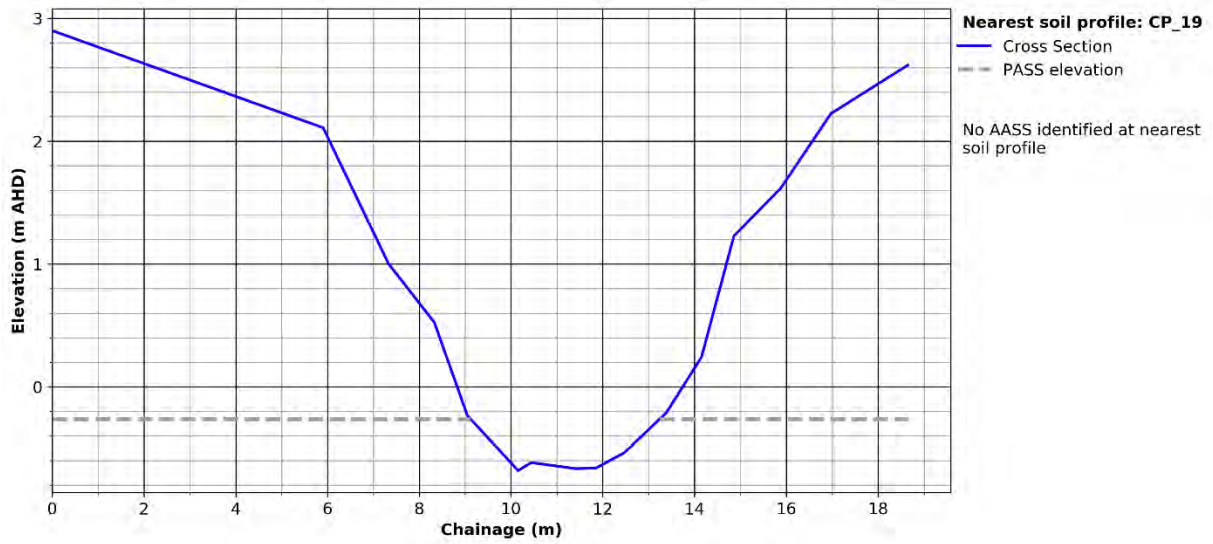
Figure G-40: Clarence cross-section 211

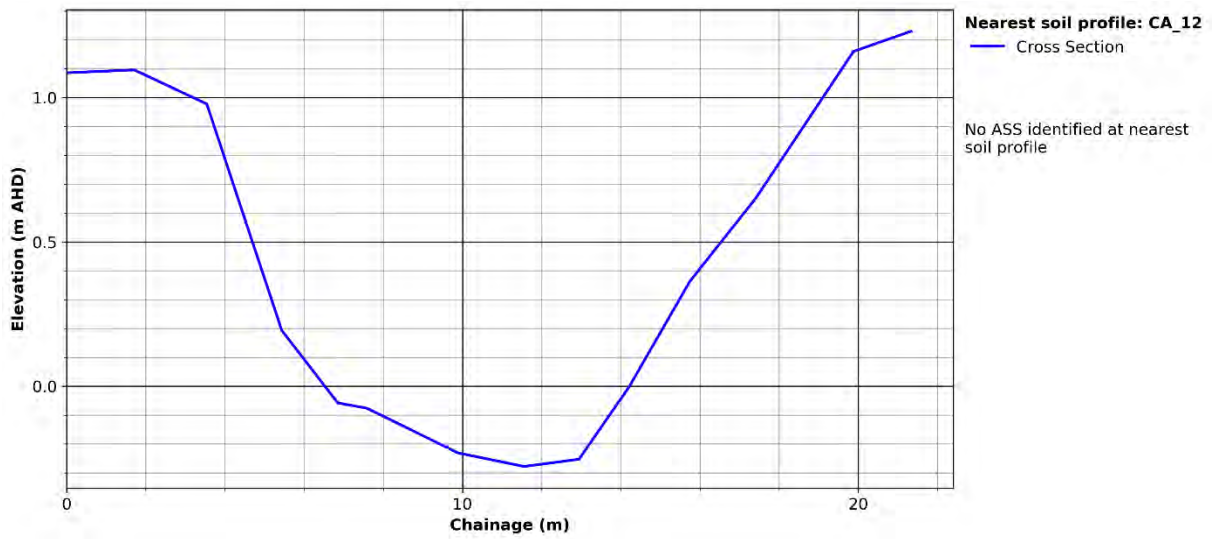
Figure G-41: Clarence cross-section 212

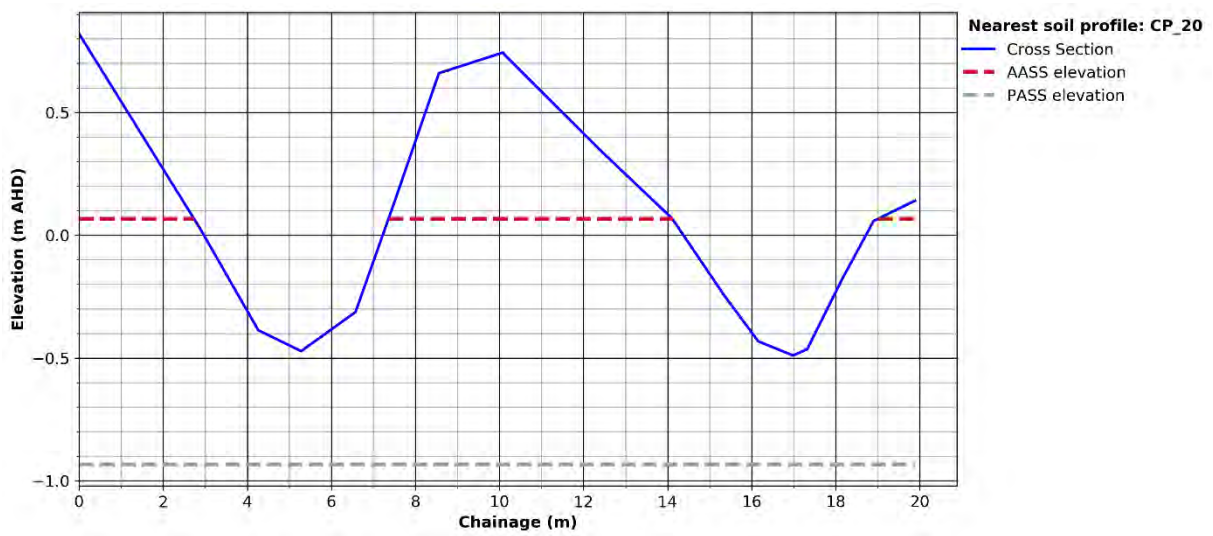
Figure G-42: Clarence cross-section 213

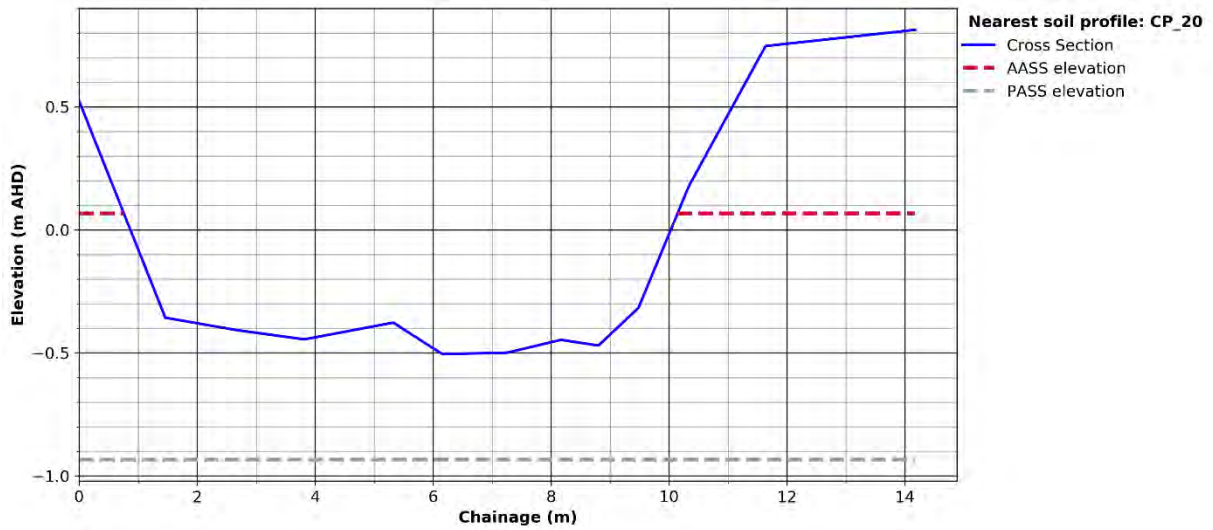
Figure G-43: Clarence cross-section 214

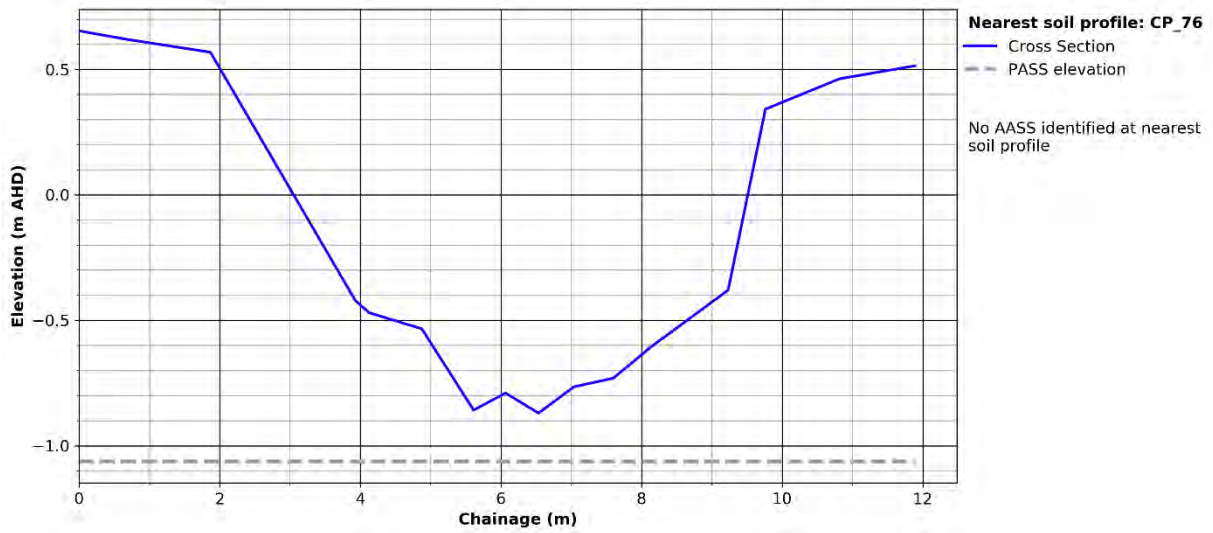
**Figure G-44: Clarence cross-section 216**

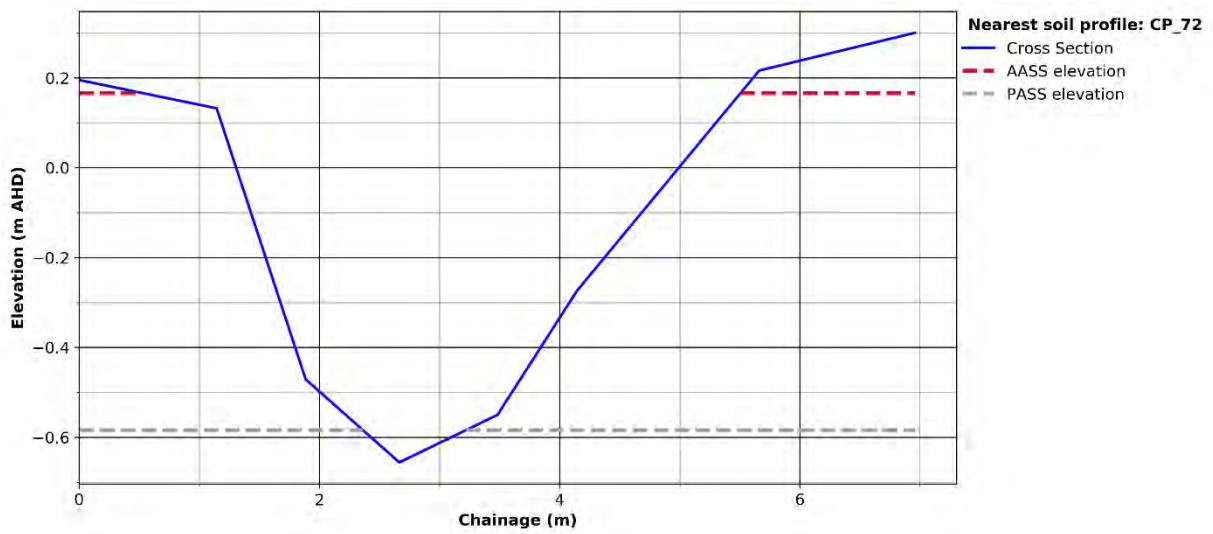
**Figure G-45: Clarence cross-section 217**

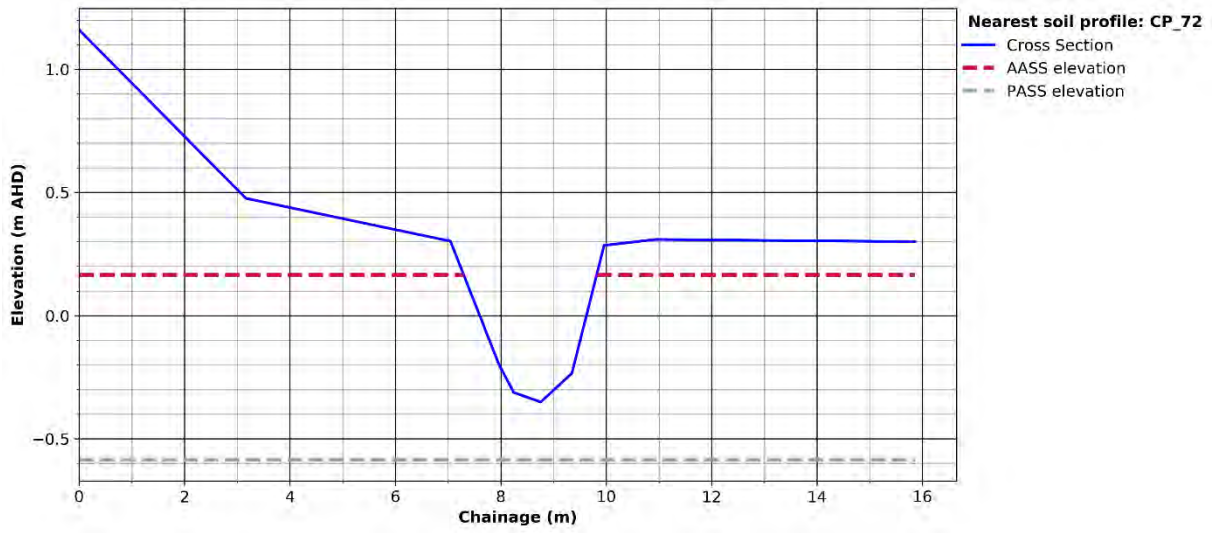
**Figure G-46: Clarence cross-section 218**

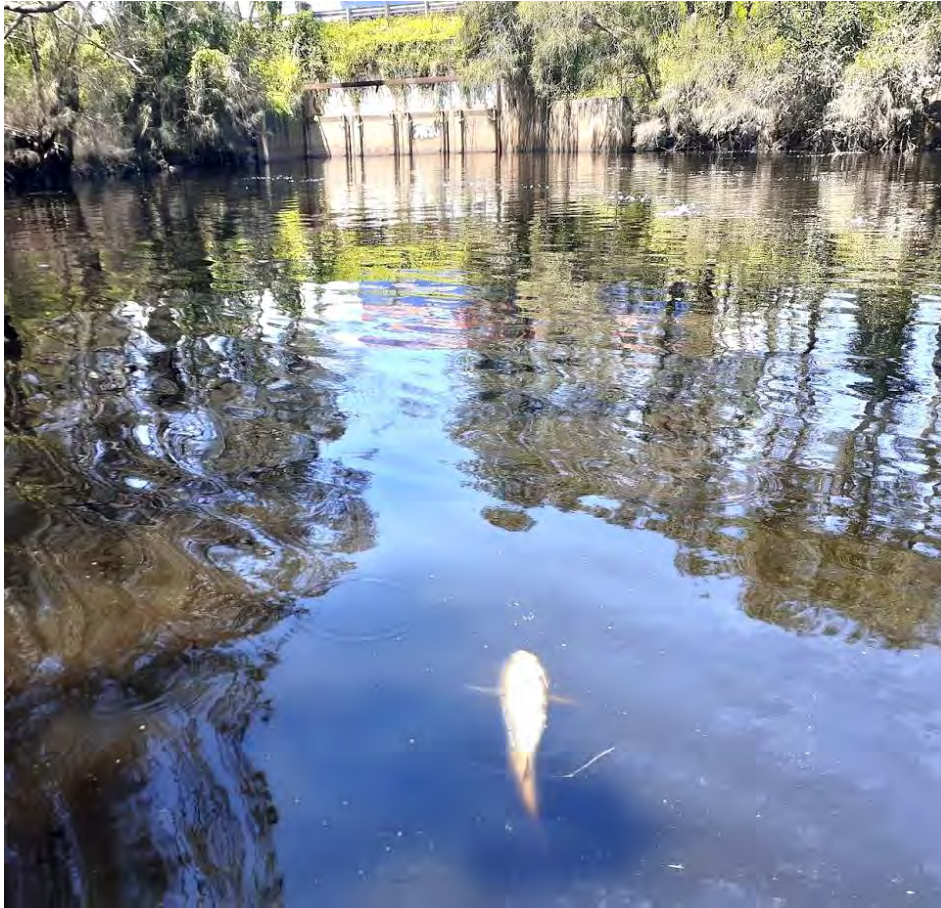
**Figure H-1: Fish kill observed on 1 March 2020 within Cowper No. 1 Drain due to blackwater caused from prolonged inundation of water causing the decomposition of vegetation**

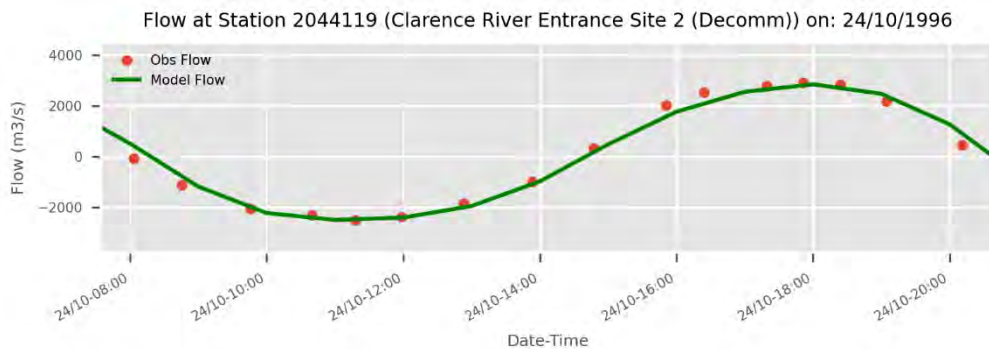
**Figure I-5: Clarence hydrodynamic model flow calibrations at Station 2044119**

The main internal model parameters for hydrodynamic calibrations in the RMA-2 model are eddy viscosity and friction (applied as Manning's n). The model was calibrated by adjusting the Manning's n value to match the observed flow, tidal ranges and phasings throughout the estuary. A Manning's n value of 0.20 was adopted for the main Clarence River channel, 0.025 in Oyster Channel, 0.045 in Palmers Channel and 0.20 for areas around culverts and bridges.

The flow calibration results are shown in Figure I-5 to Figure I-9. The water level calibration results for a 2-day window during this period are shown in Figure I-10 to Figure I-12. The model was calibrated (for dry weather periods) to less than 0.2 m for the entire estuary.

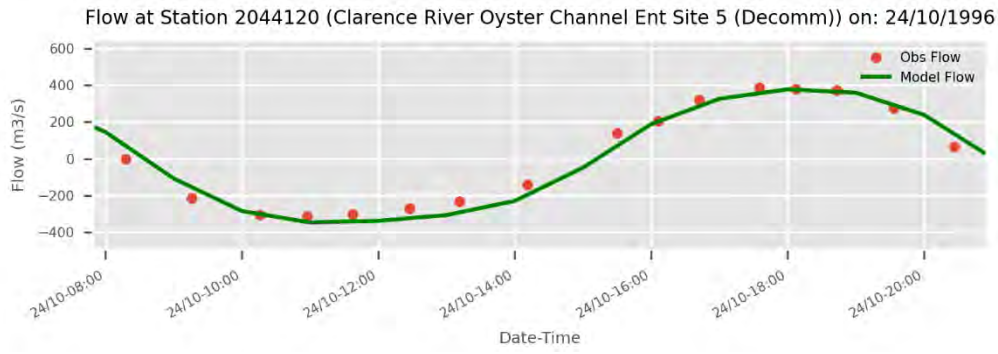
**Figure I-6: Clarence hydrodynamic model flow calibrations at Station 2044120**

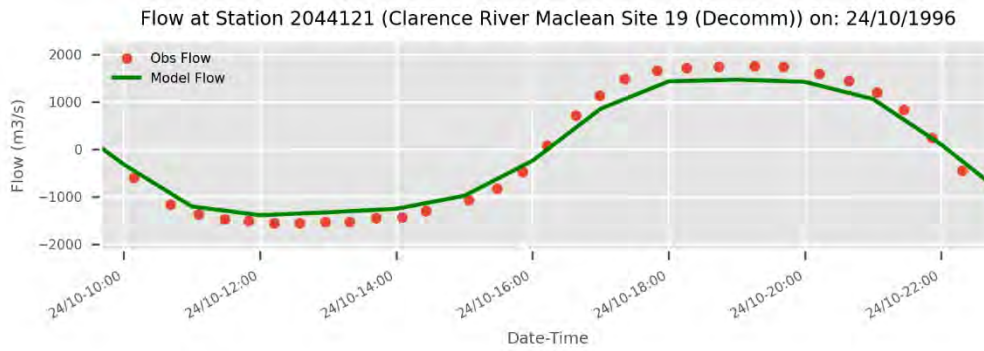
**Figure I-7: Clarence hydrodynamic model flow calibrations at Station 2044121**

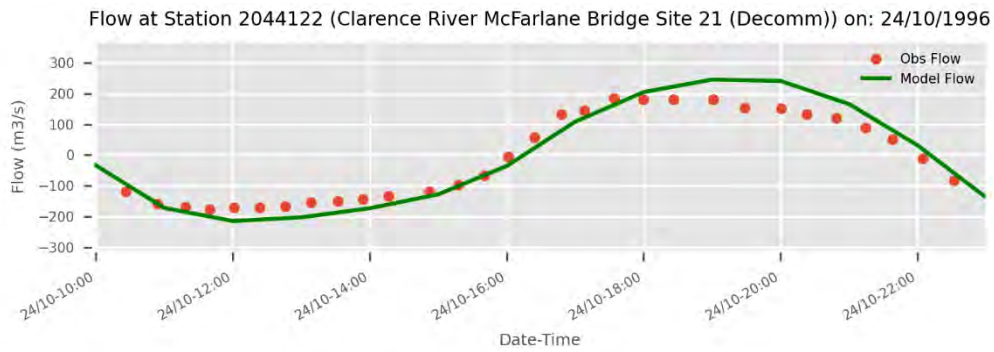
**Figure I-8: Clarence hydrodynamic model flow calibrations at Station 2044122**

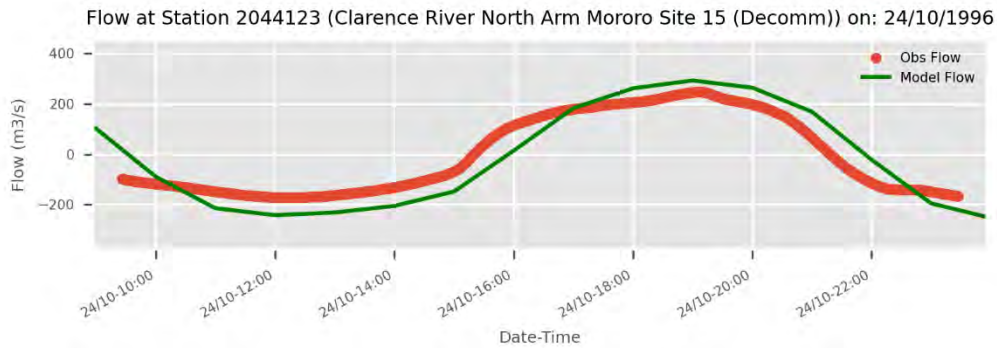
**Figure I-9: Clarence hydrodynamic model flow calibrations at Station 2044123**

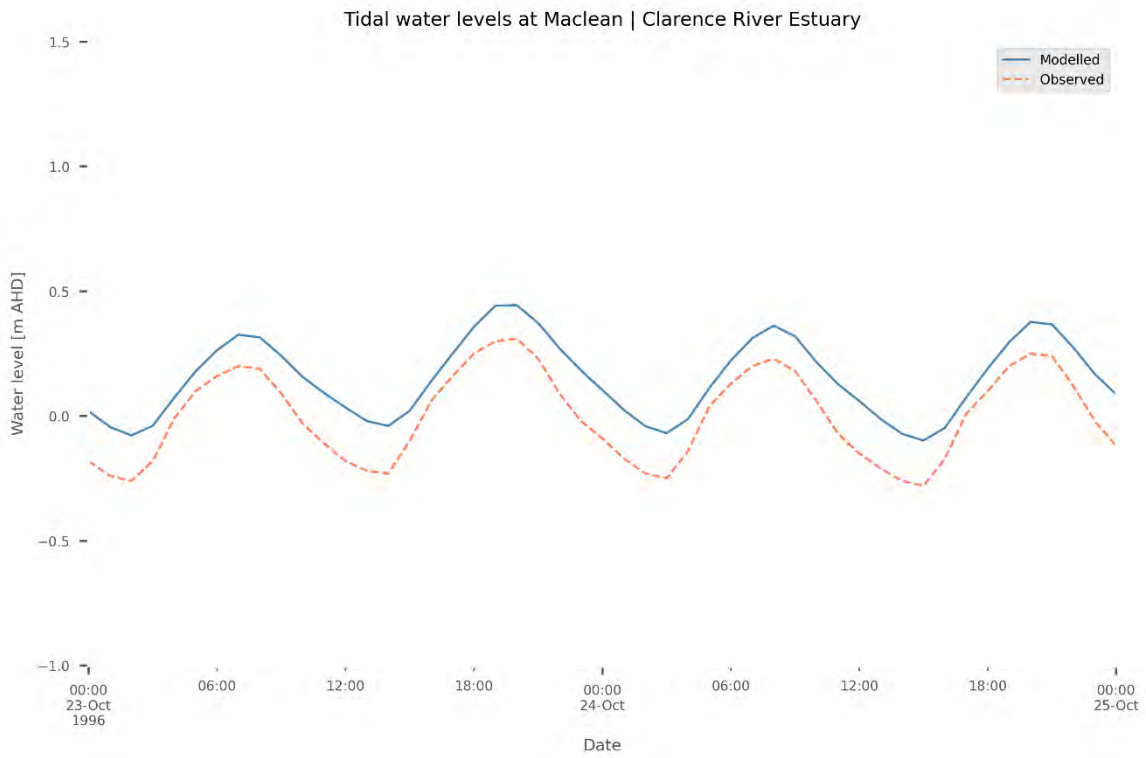
**Figure I-10: Clarence hydrodynamic model calibration results at Maclean (204410)**

<sup>1</sup> Note that that only some of the MHL water level stations shown in Figure I-4 had recorded data during the calibration period in 1996. The calibration results at these sites are shown in Figure I-10 to Figure I-12. The remaining sites shown in Figure I-4 are used during hydrodynamic model verification.

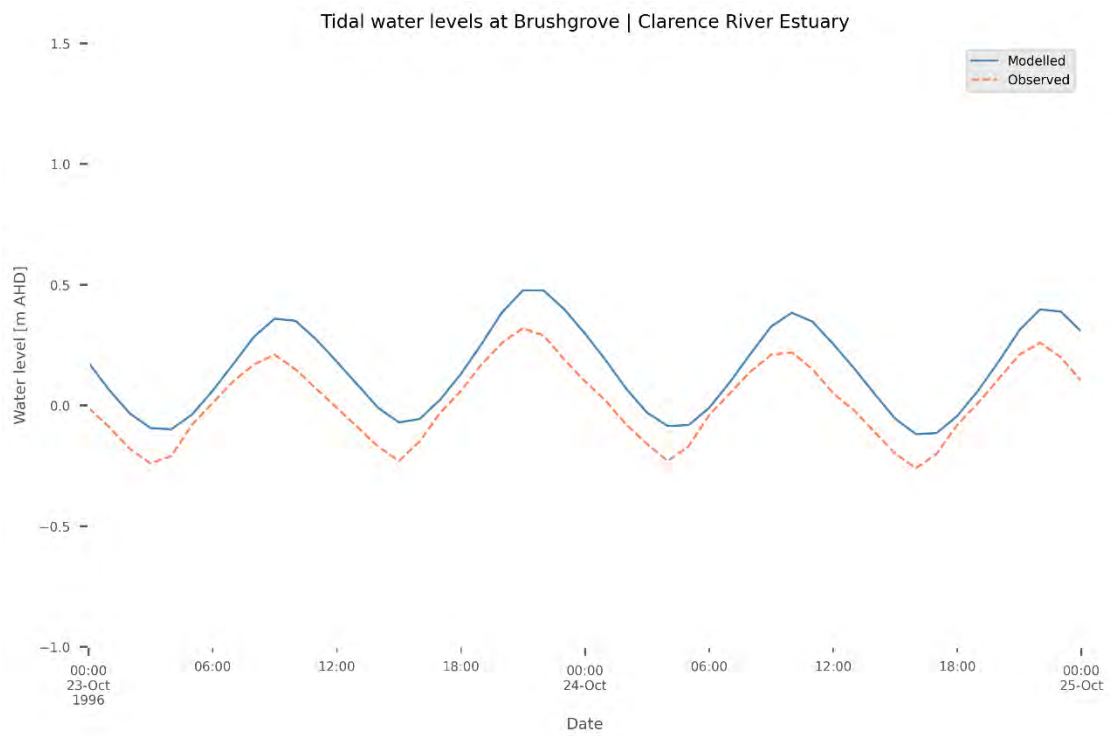
**Figure I-11: Clarence hydrodynamic model calibration results at Brushgrove (204406)**

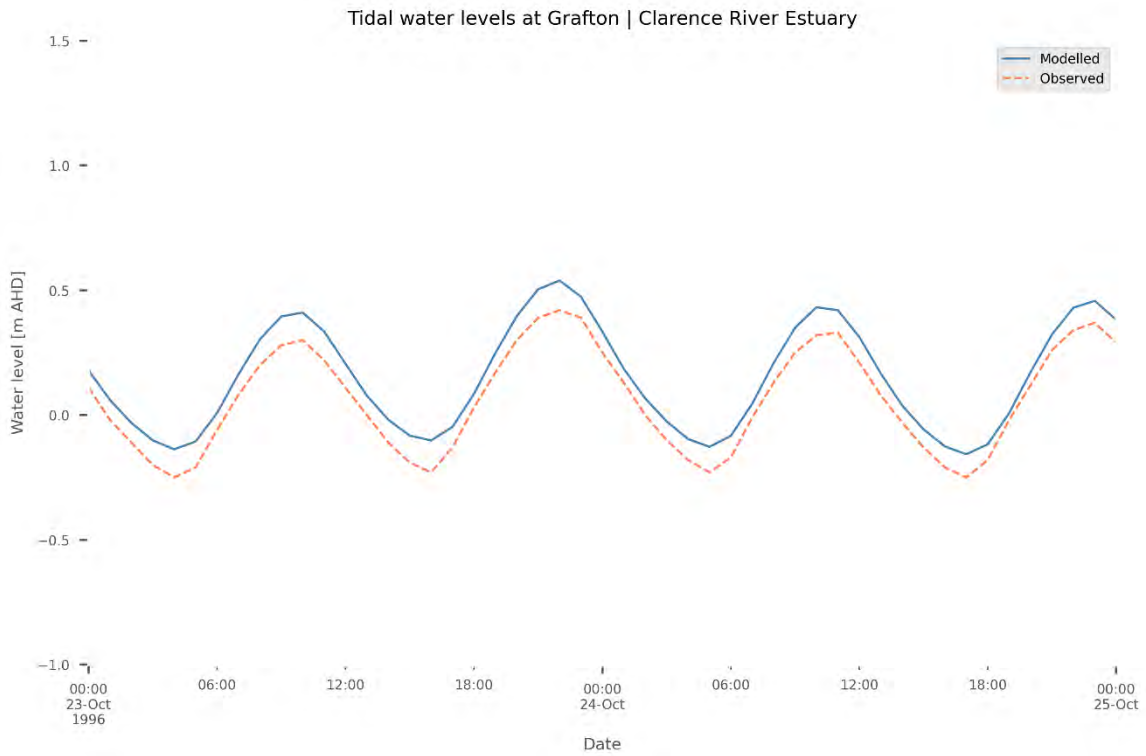
**Figure I-12: Clarence hydrodynamic model calibration results at Grafton (204400)**

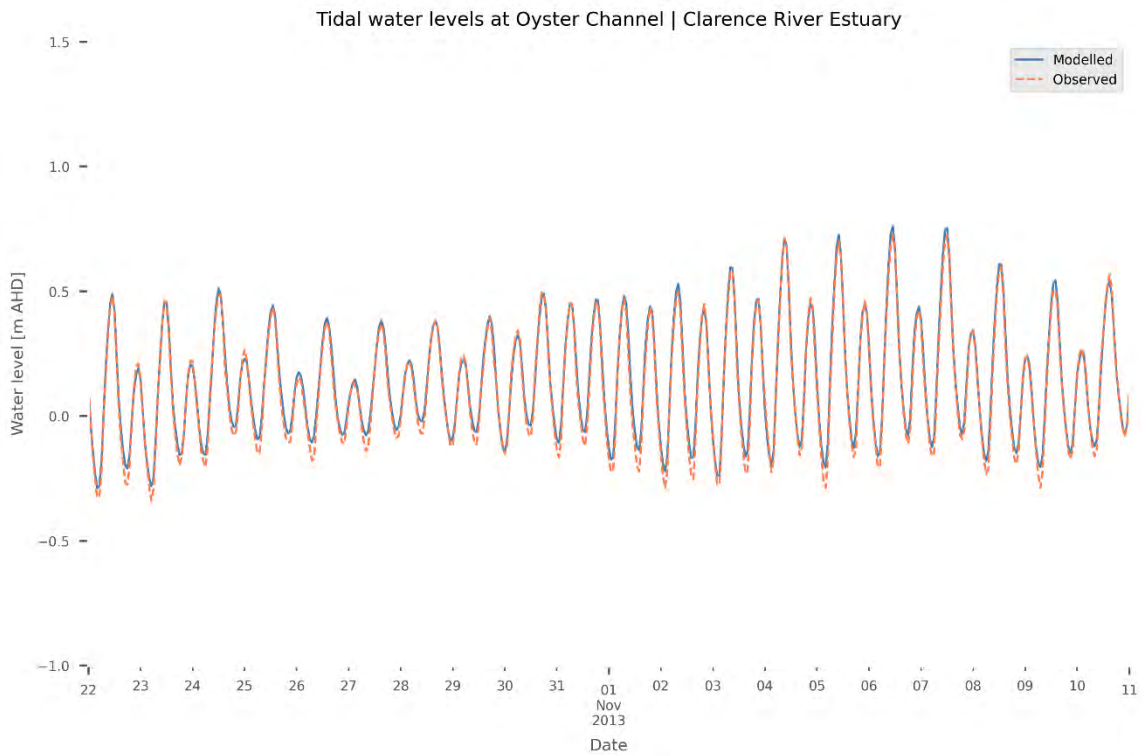
**Figure I-13: Clarence hydrodynamic model verification results (2013) at Oyster Channel (204451)**

The calibrated model was then used to simulate a representative ‘wet’ year (i.e. more rain than average across the catchment) and a representative ‘dry’ year (i.e. less rain than average across the catchment) based on analysis of BOM rainfall records in Northern NSW. For this study, 2013 and 2019 were selected as the wet and dry years respectively. The model results from these simulations were then used to verify the tidal water calibrations throughout the estuary. Tidal water level verification plots for a 20-day window for the Clarence Estuary for 2013 and 2019 are provided in Figure I-13 to Figure I-32.

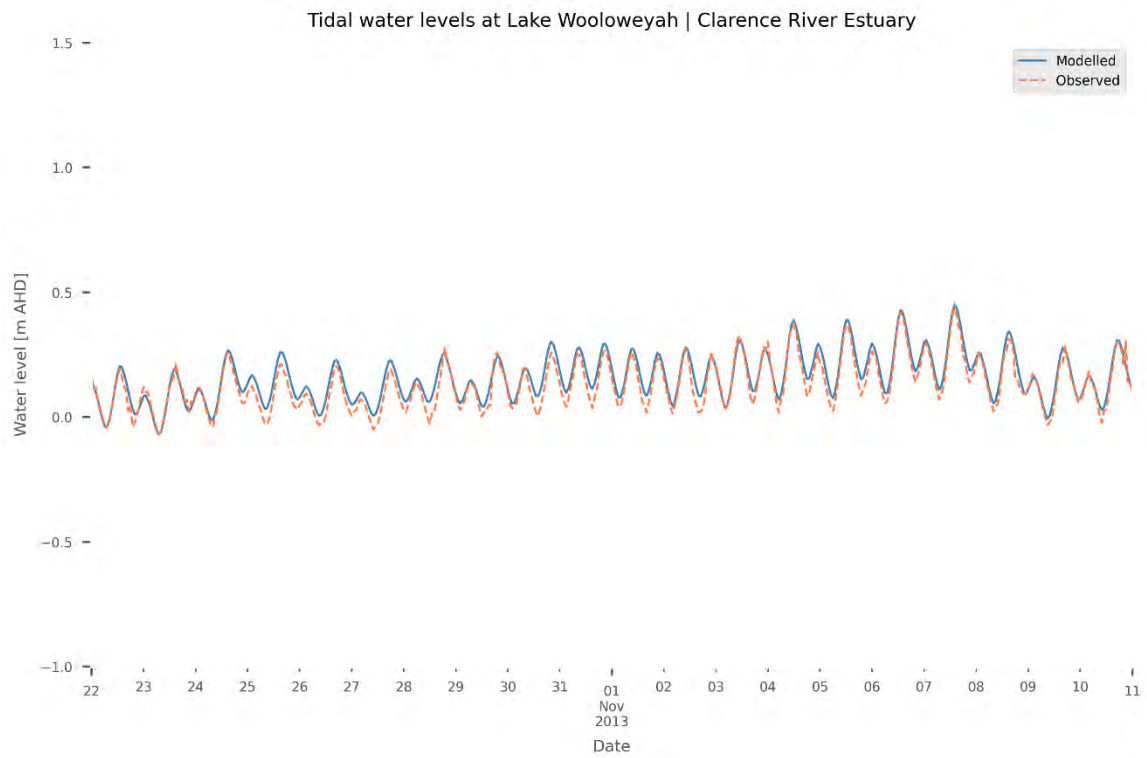
**Figure I-14: Clarence hydrodynamic model verification results (2013) at Lake Wooloweyah (204485)**
