# Clarence River Floodplain Prioritisation Study: Appendix A – L

WRL TR 2020/06, May 2023

# Appendix A Floodplain waterways

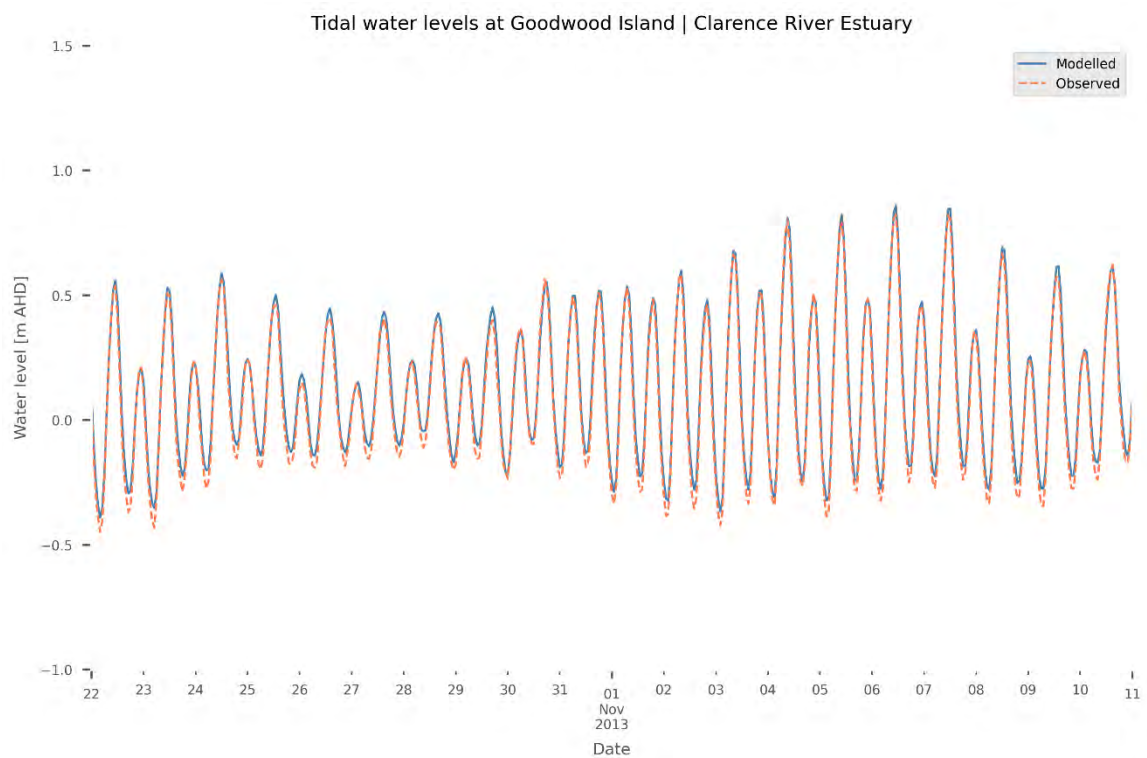
**Figure I-15: Clarence hydrodynamic model verification results (2013) at Goodwood Island (204490)**

The calibrated model was then used to simulate a representative ‘wet’ year (i.e. more rain than average across the catchment) and a representative ‘dry’ year (i.e. less rain than average across the catchment) based on analysis of BOM rainfall records in Northern NSW. For this study, 2013 and 2019 were selected as the wet and dry years respectively. The model results from these simulations were then used to verify the tidal water calibrations throughout the estuary. Tidal water level verification plots for a 20-day window for the Clarence Estuary for 2013 and 2019 are provided in Figure I-13 to Figure I-32.

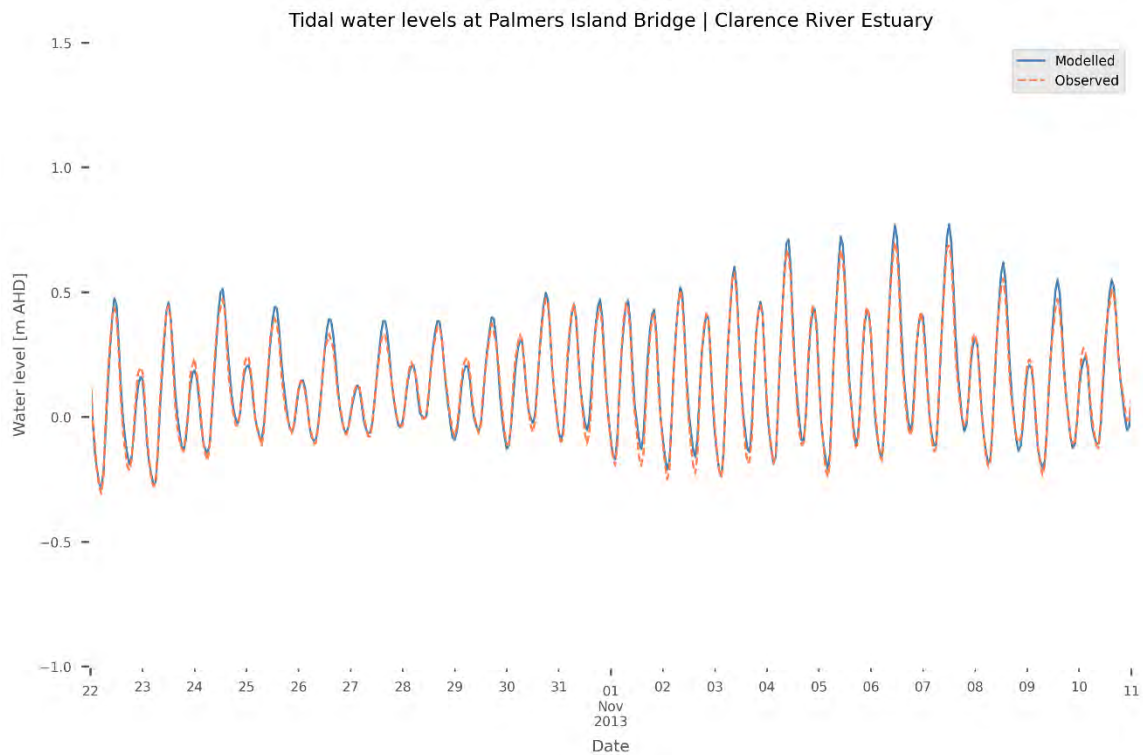
**Figure I-16: Clarence hydrodynamic model verification results (2013) at Palmers Island Bridge (204426)**

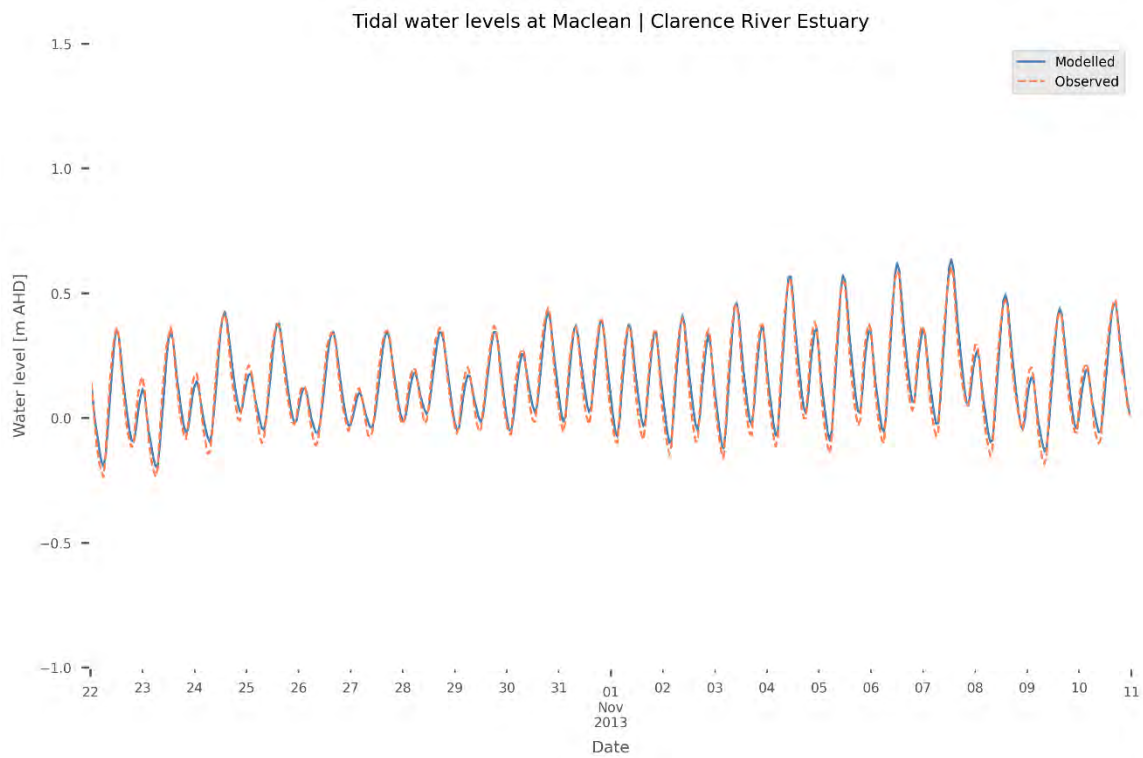
**Figure I-17: Clarence hydrodynamic model verification results (2013) at Maclean (204410)**

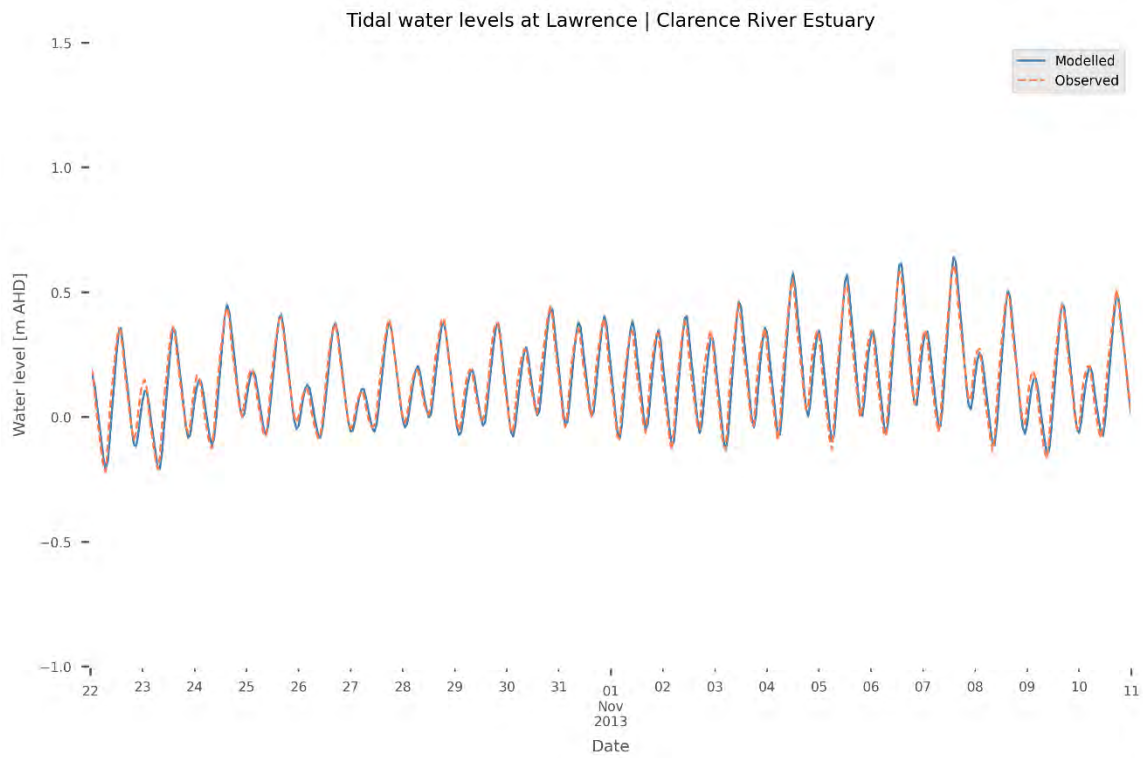
**Figure I-18: Clarence hydrodynamic model verification results (2013) at Lawrence (204453)**

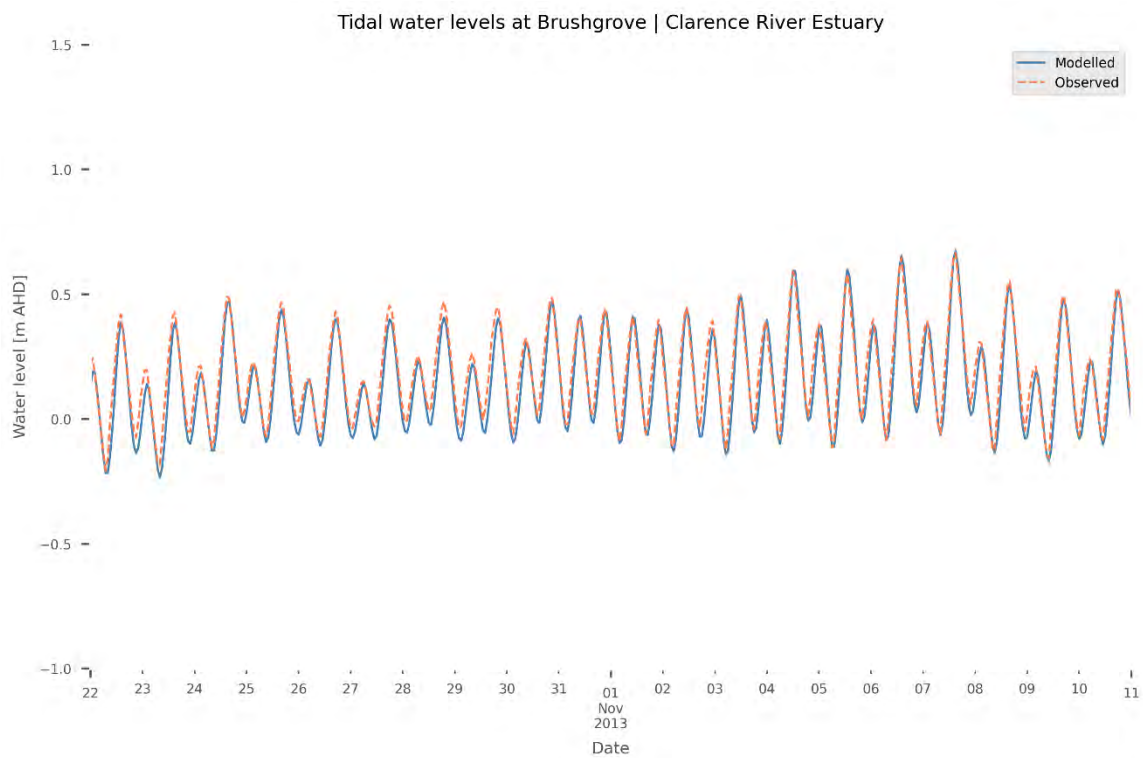
**Figure I-19: Clarence hydrodynamic model verification results (2013) at Brushgrove (204406)**

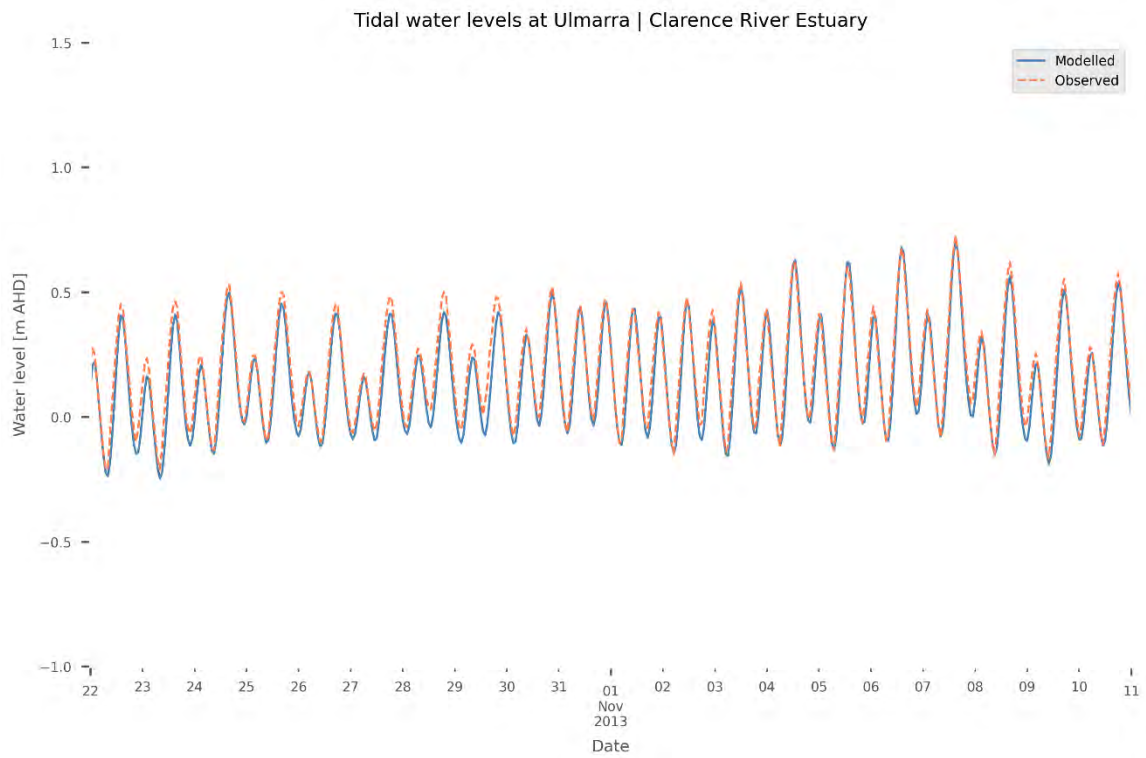
**Figure I-20: Clarence hydrodynamic model verification results (2013) at Ulmarra (204480)**

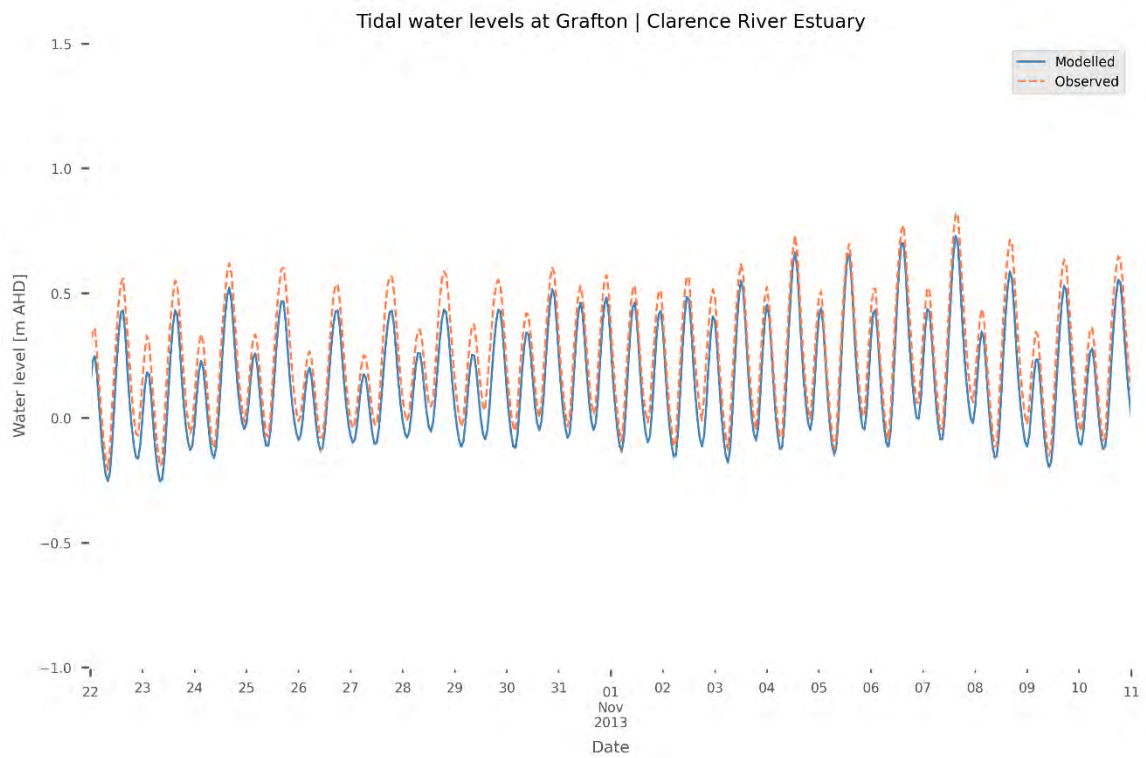
**Figure I-21: Clarence hydrodynamic model verification results (2013) at Grafton (204400)**

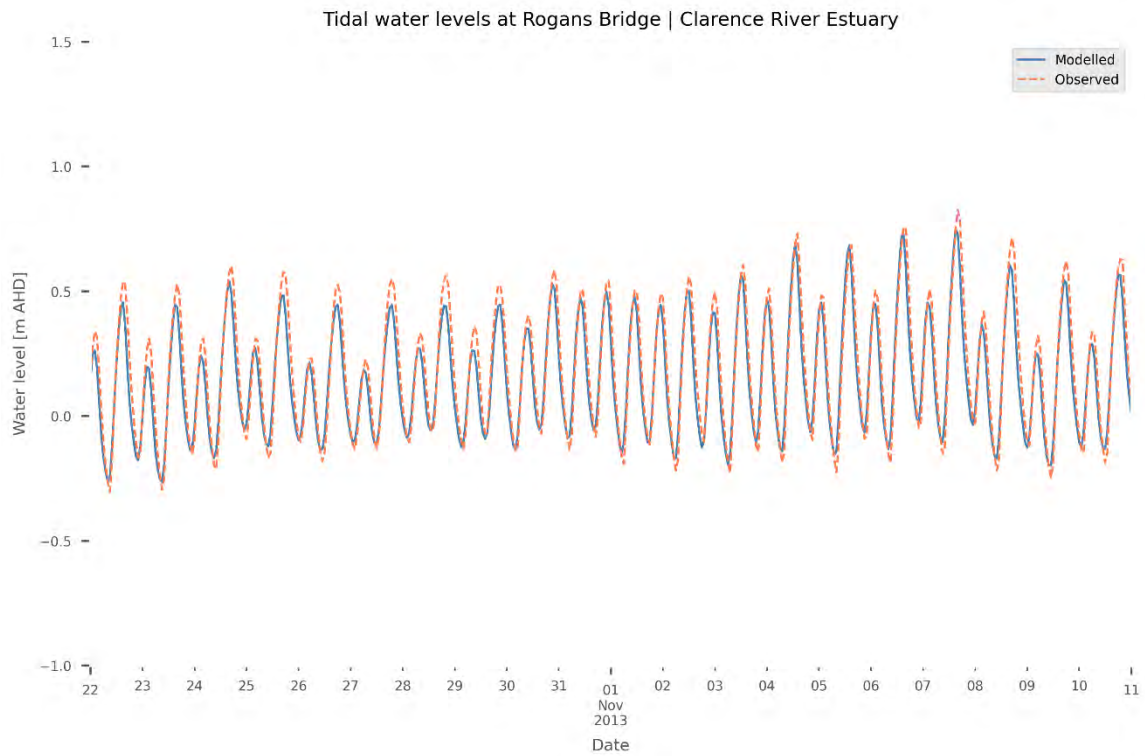
**Figure I-22: Clarence hydrodynamic model verification results (2013) at Rogan’s Bridge (204414)**

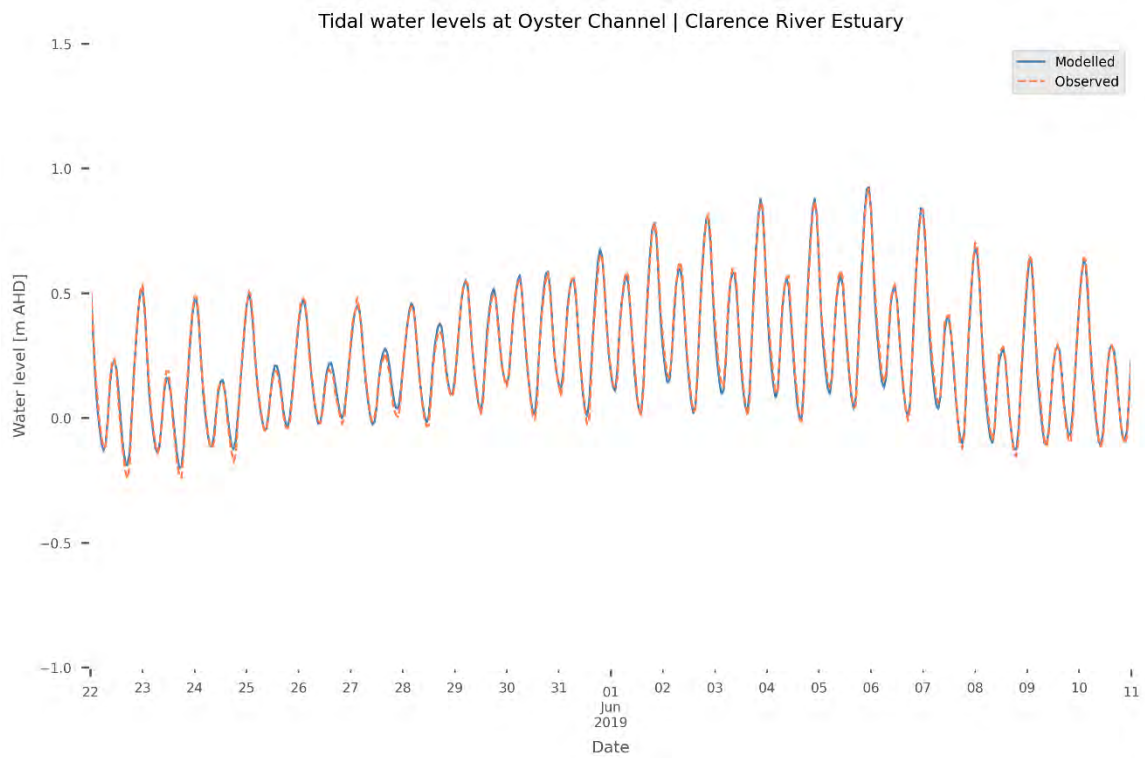
**Figure I-23: Clarence hydrodynamic model verification results (2019) at Oyster Channel (204451)**

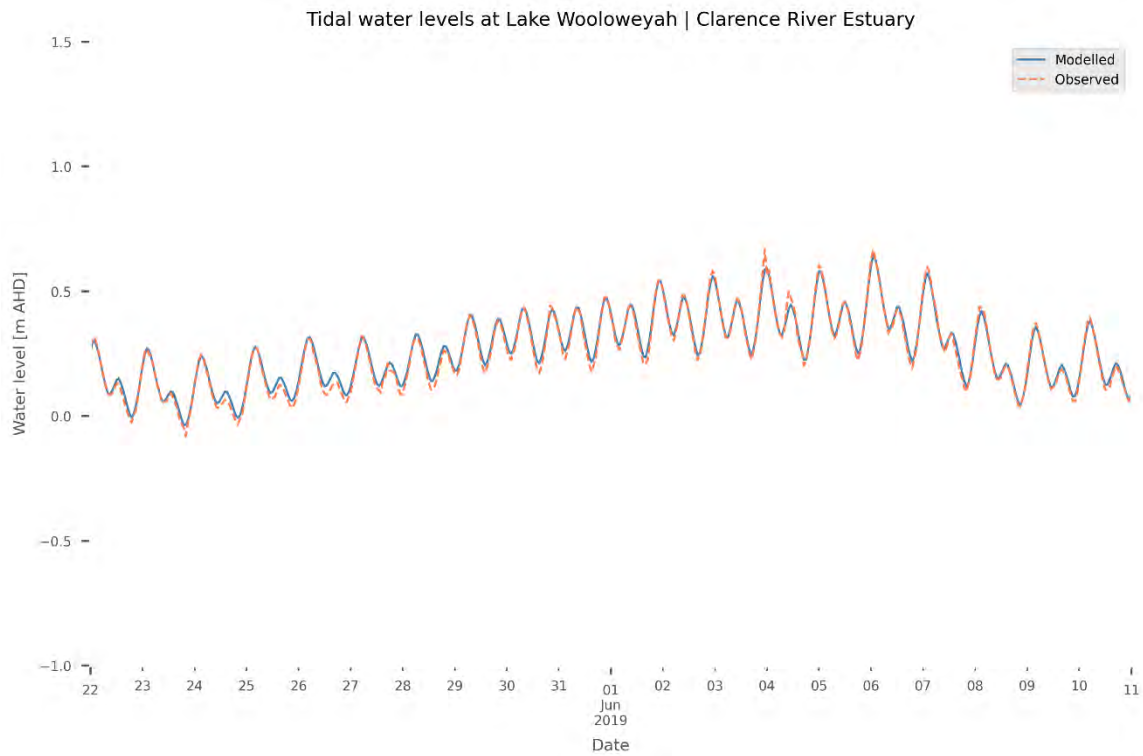
**Figure I-24: Clarence hydrodynamic model verification results (2019) at Lake Wooloweyah (204485)**

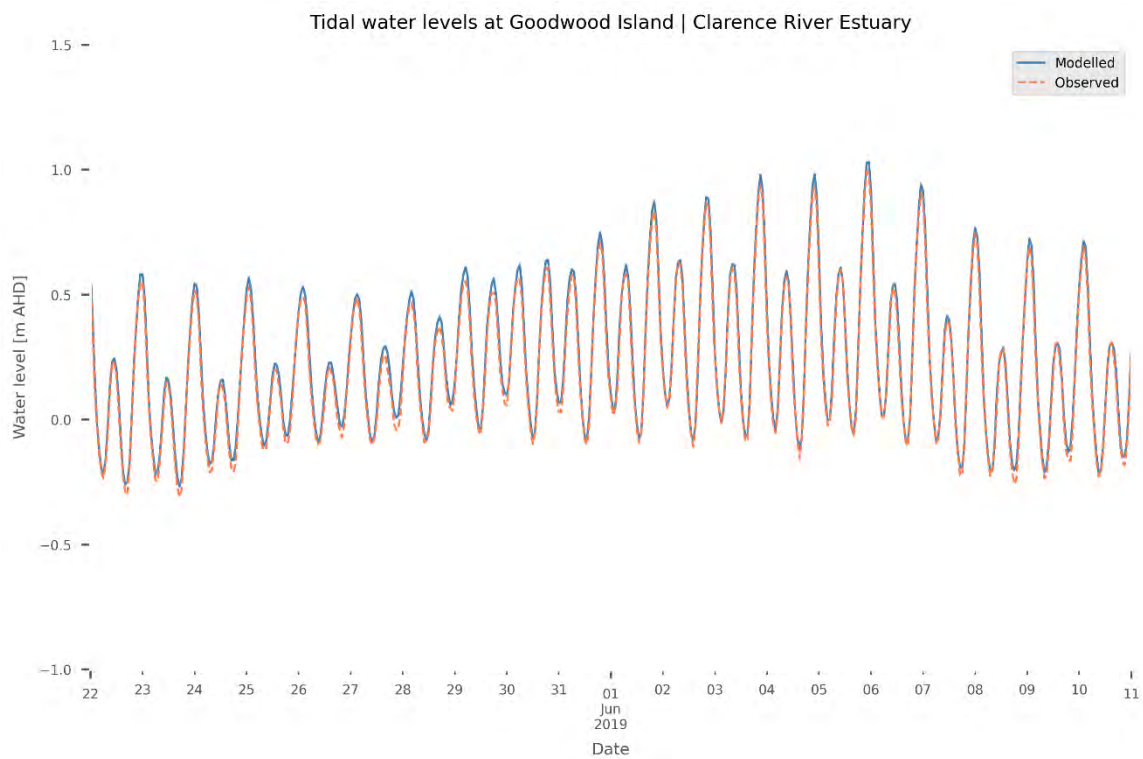
**Figure I-25: Clarence hydrodynamic model verification results (2019) at Goodwood Island (204490+)**

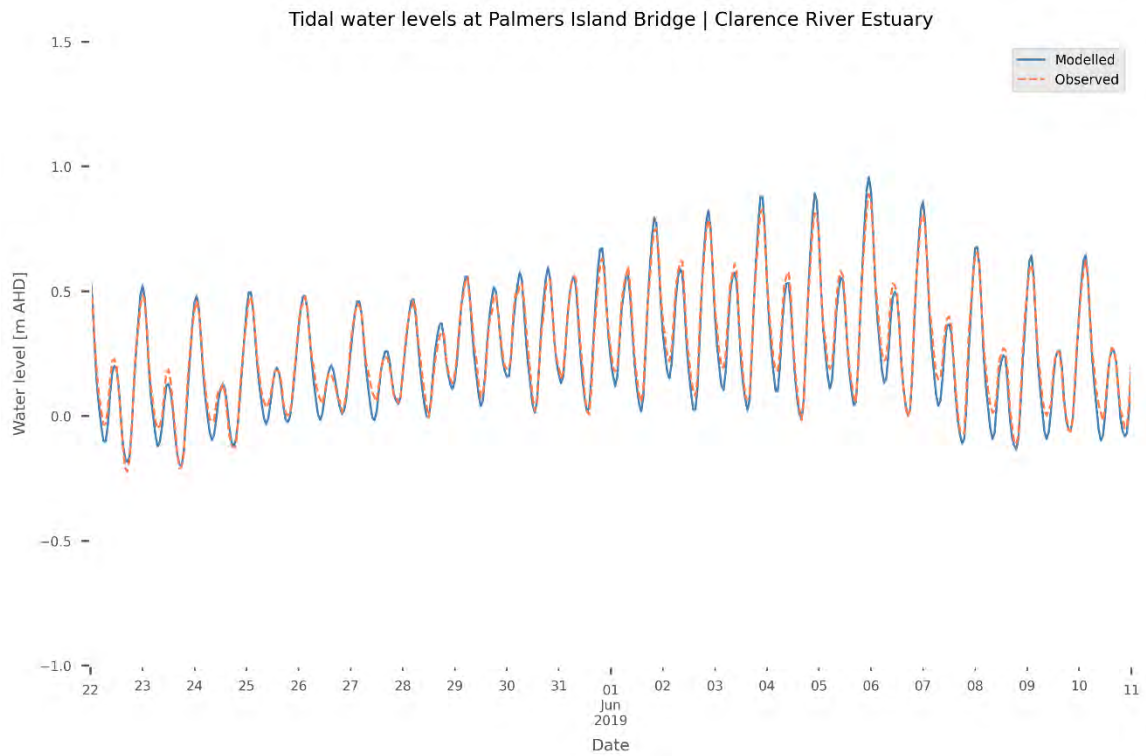
**Figure I-26: Clarence hydrodynamic model verification results (2019) at Palmers Island Bridge (204426)**

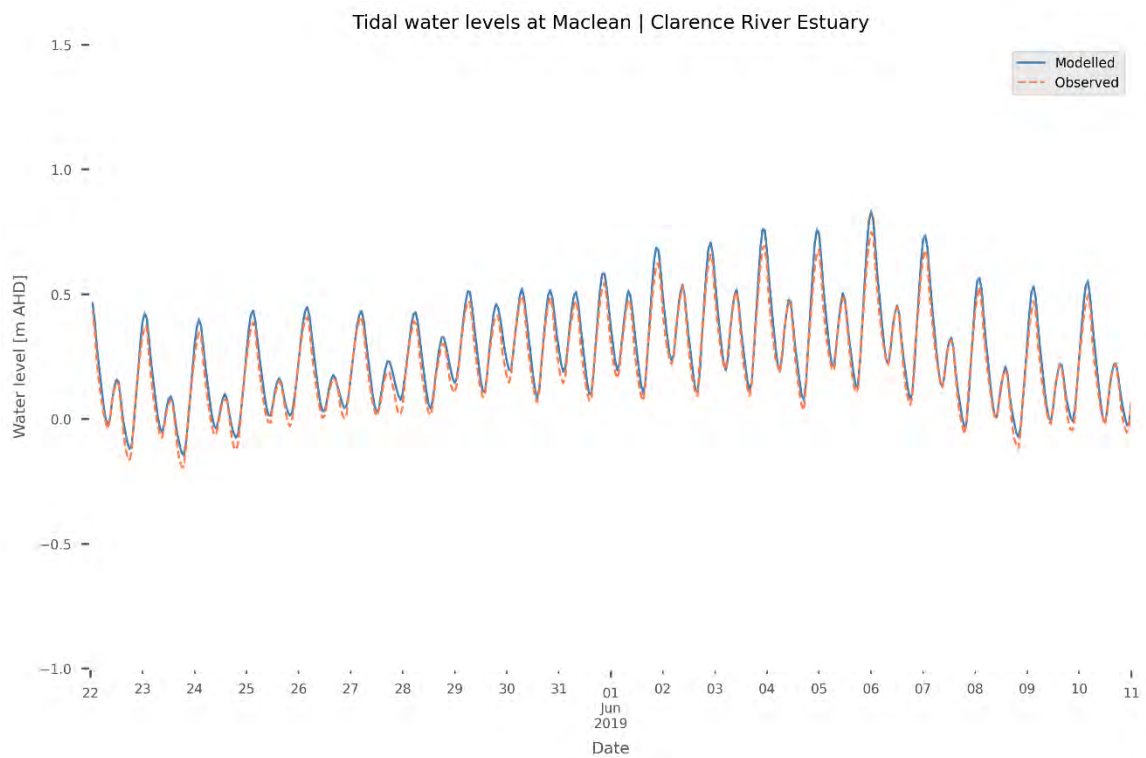
**Figure I-27: Clarence hydrodynamic model verification results (2019) at Maclean (204410)**

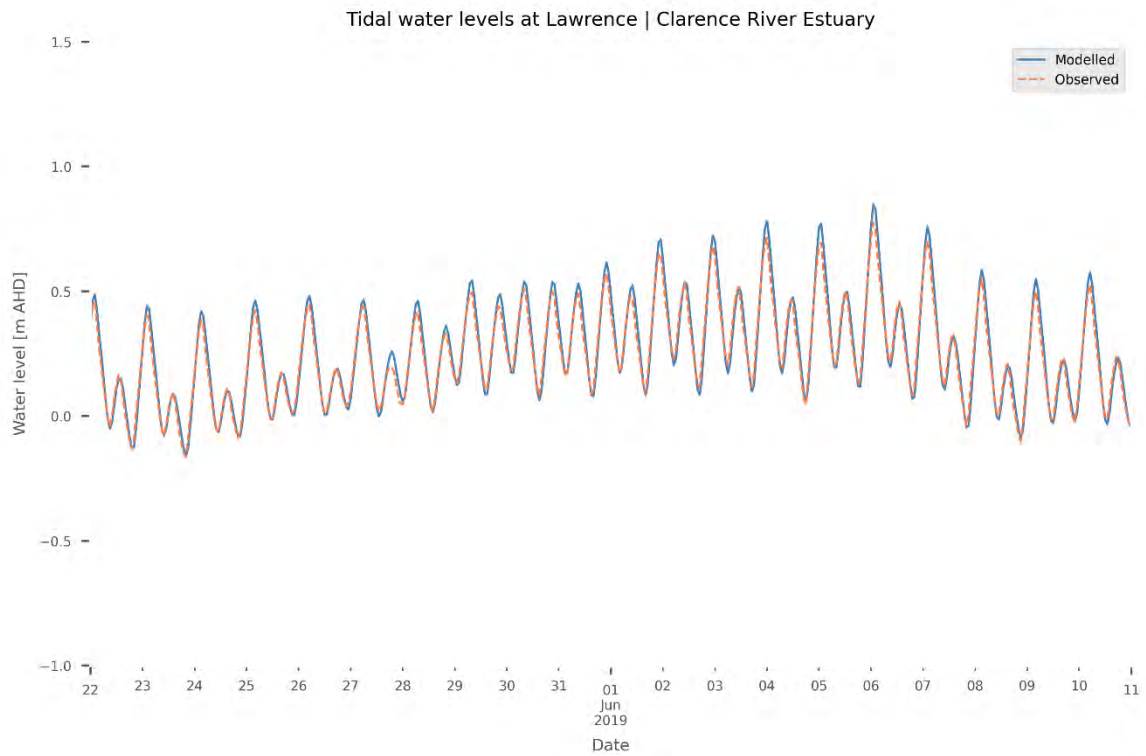
**Figure I-28: Clarence hydrodynamic model verification results (2019) at Lawrence (204453)**

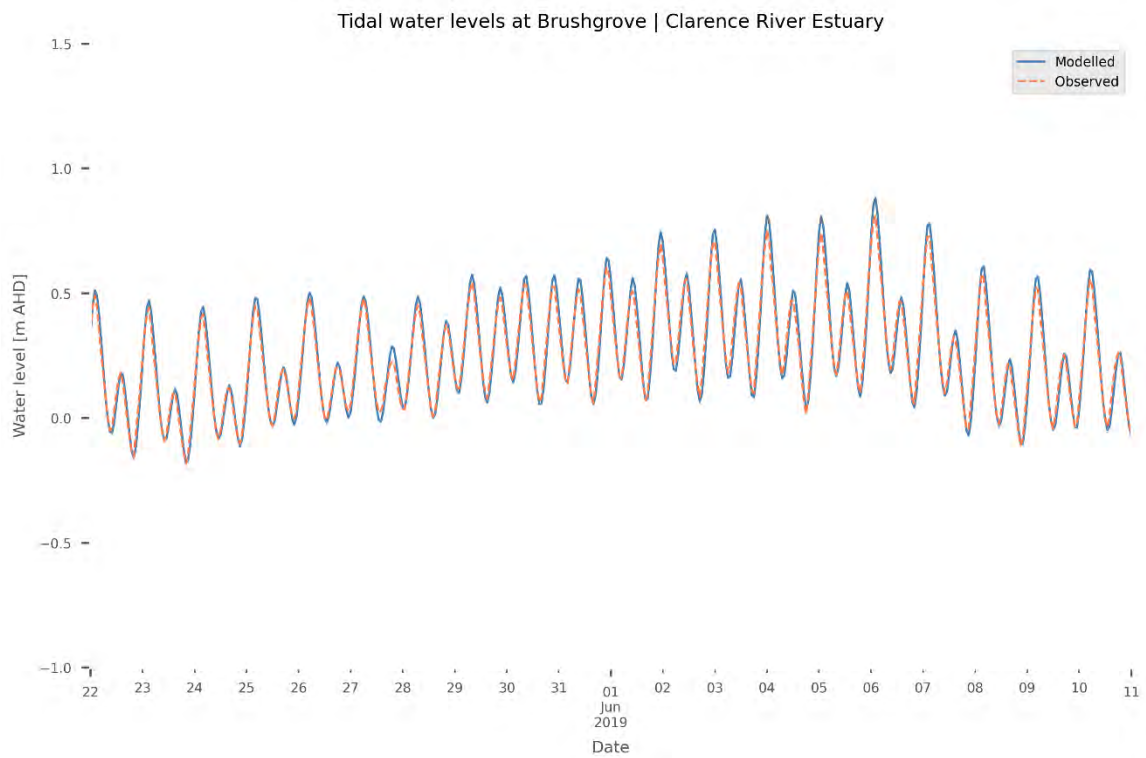
**Figure I-29: Clarence hydrodynamic model verification results (2019) at Brushgrove (204406)**

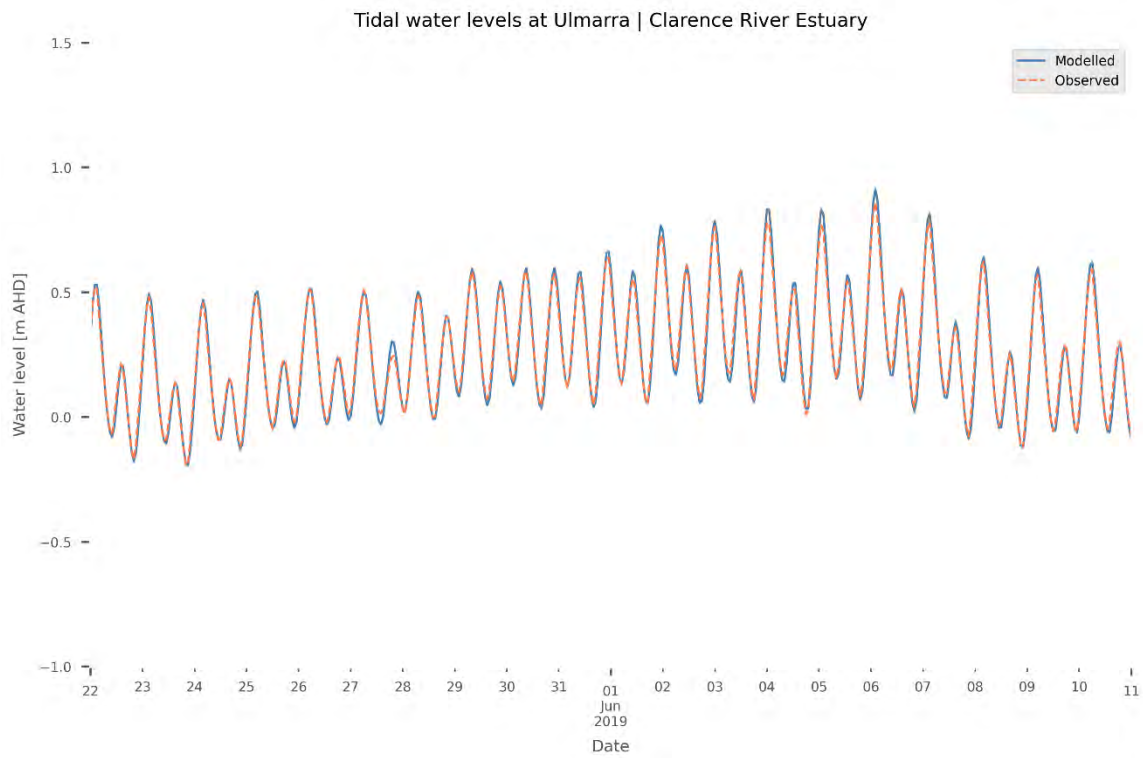
**Figure I-30: Clarence hydrodynamic model verification results (2019) at Ulmarra (204480)**

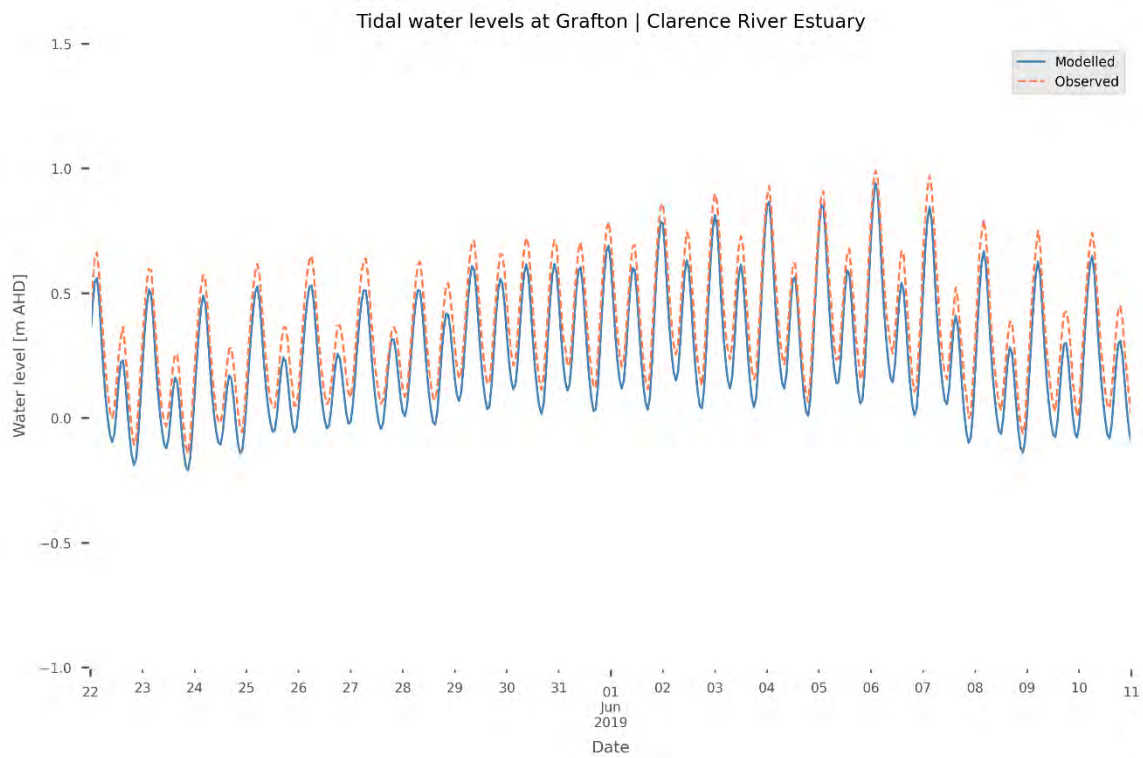
**Figure I-31: Clarence hydrodynamic model verification results (2019) at Grafton (204400)**

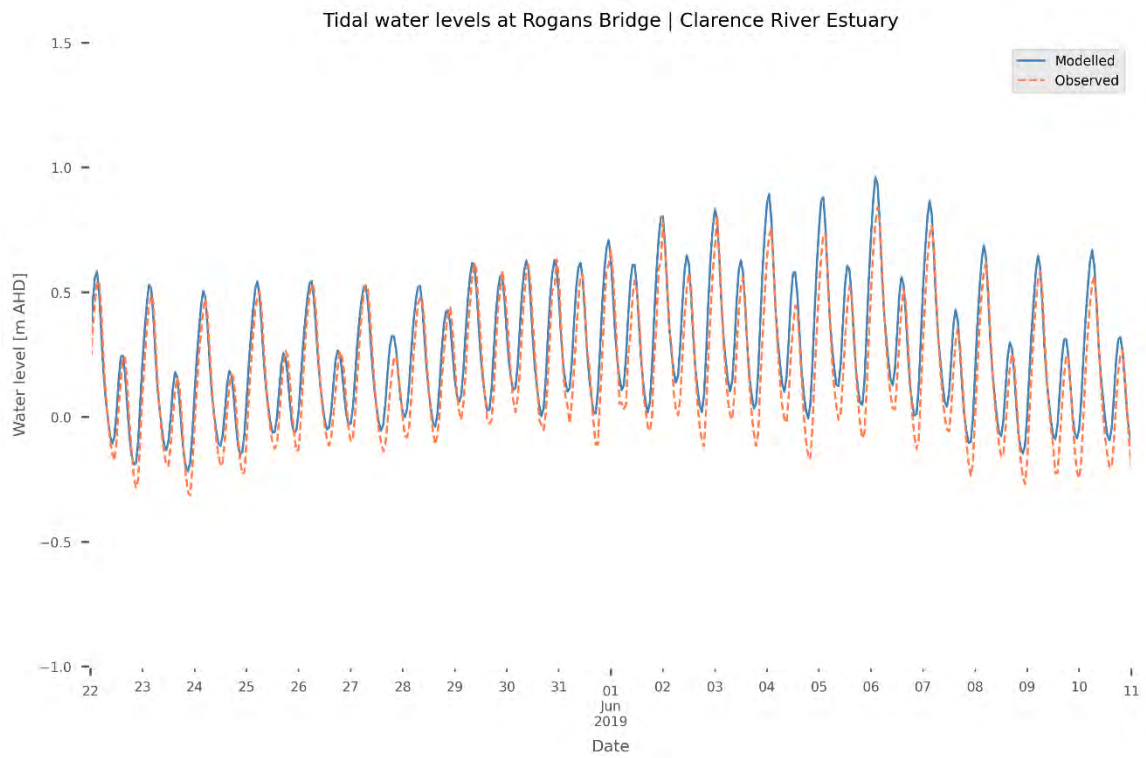
**Figure I-32: Clarence hydrodynamic model verification results (2019) at Rogans Bridge (204414)**

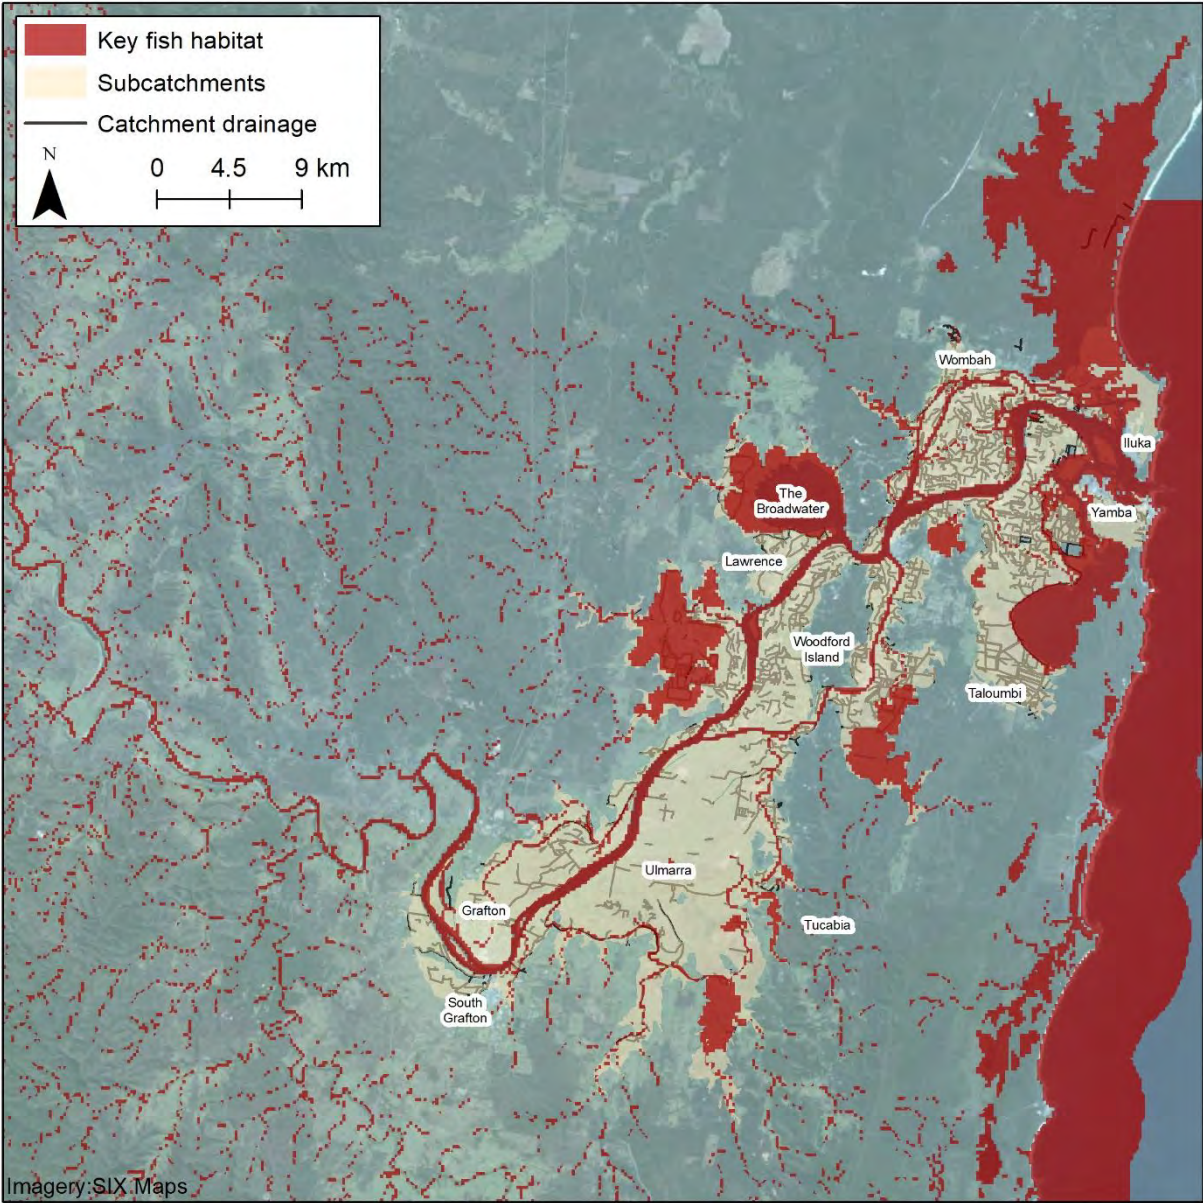
**Figure J-1: Key fisheries habitat (Source: NSW DPI Fisheries)**

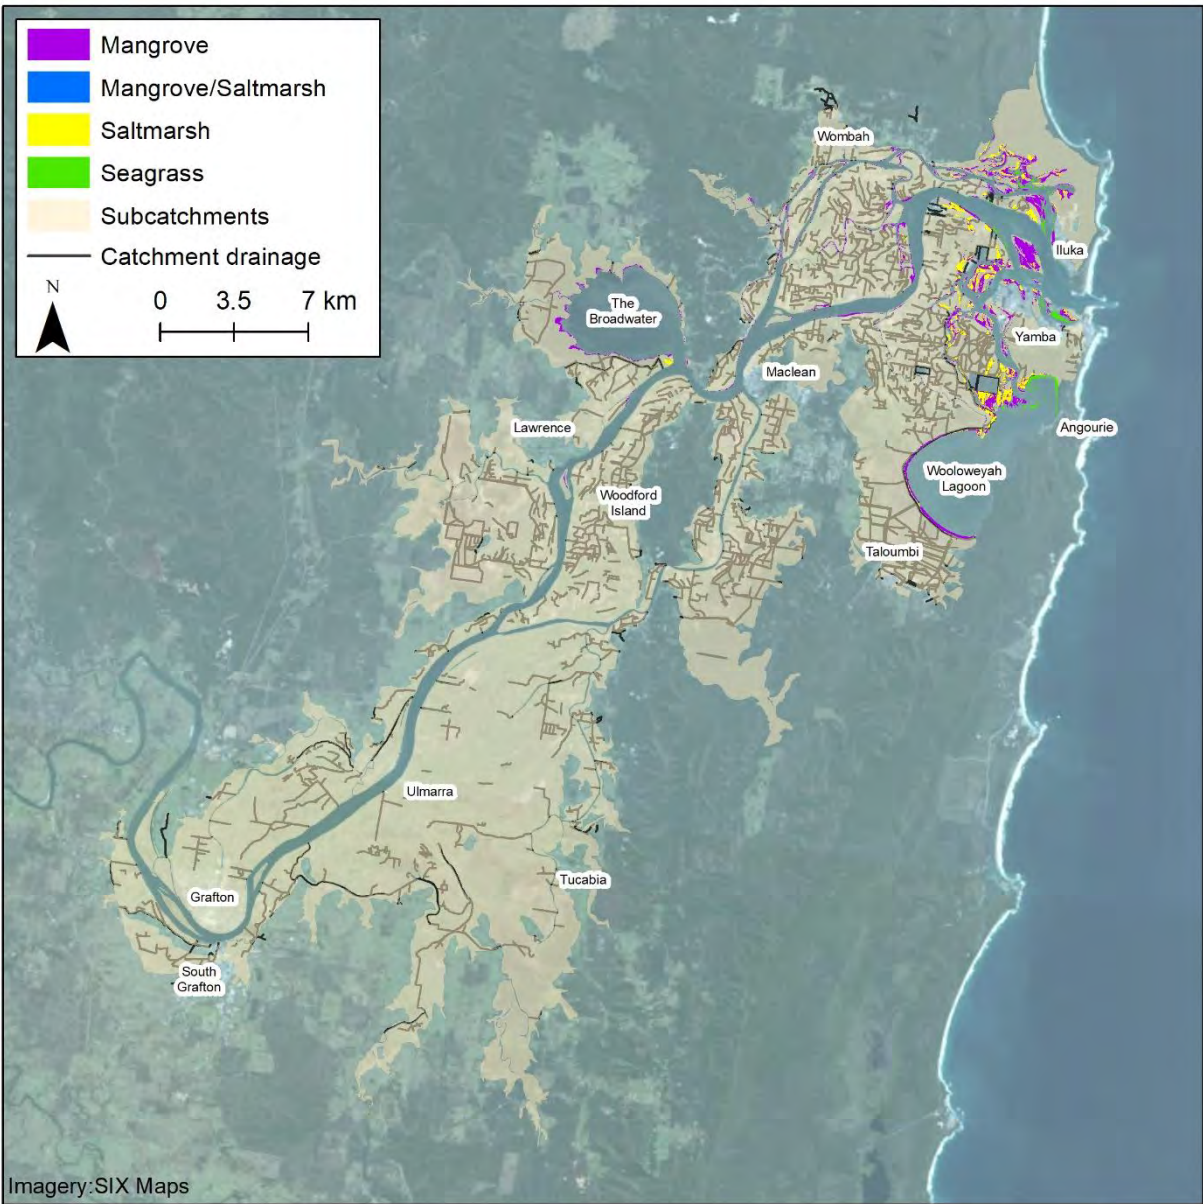
Figure J-3: Estuarine macrophytes (Source: NSW DPI Fisheries)

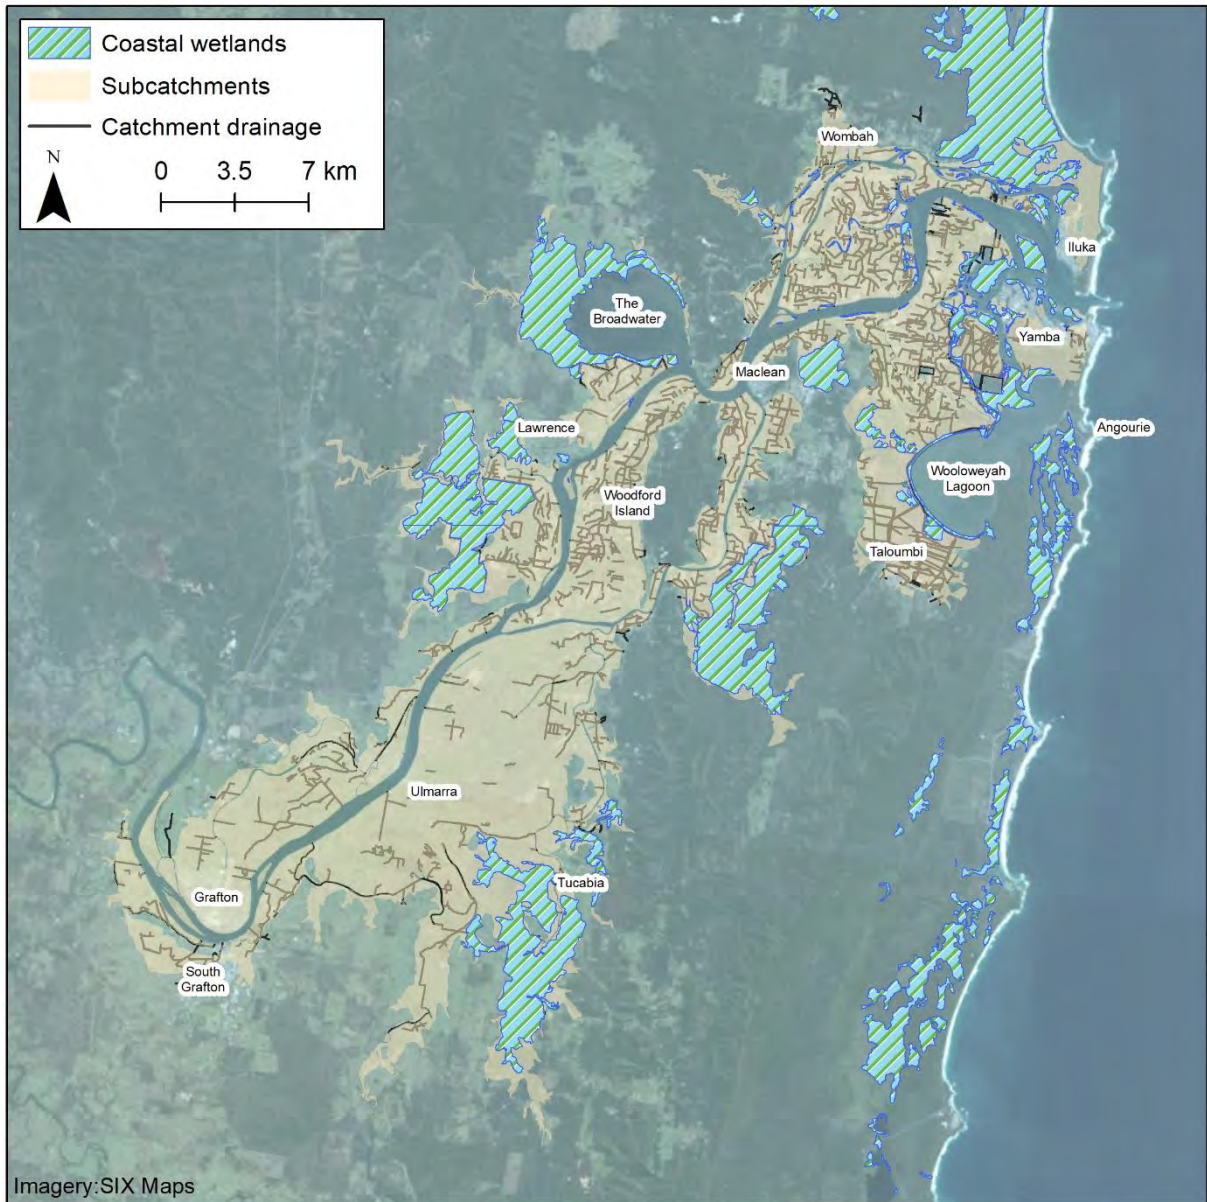
**Figure J-4: Coastal Management SEPP coastal wetlands (Source: SEED NSW data portal)<sup>1</sup>**

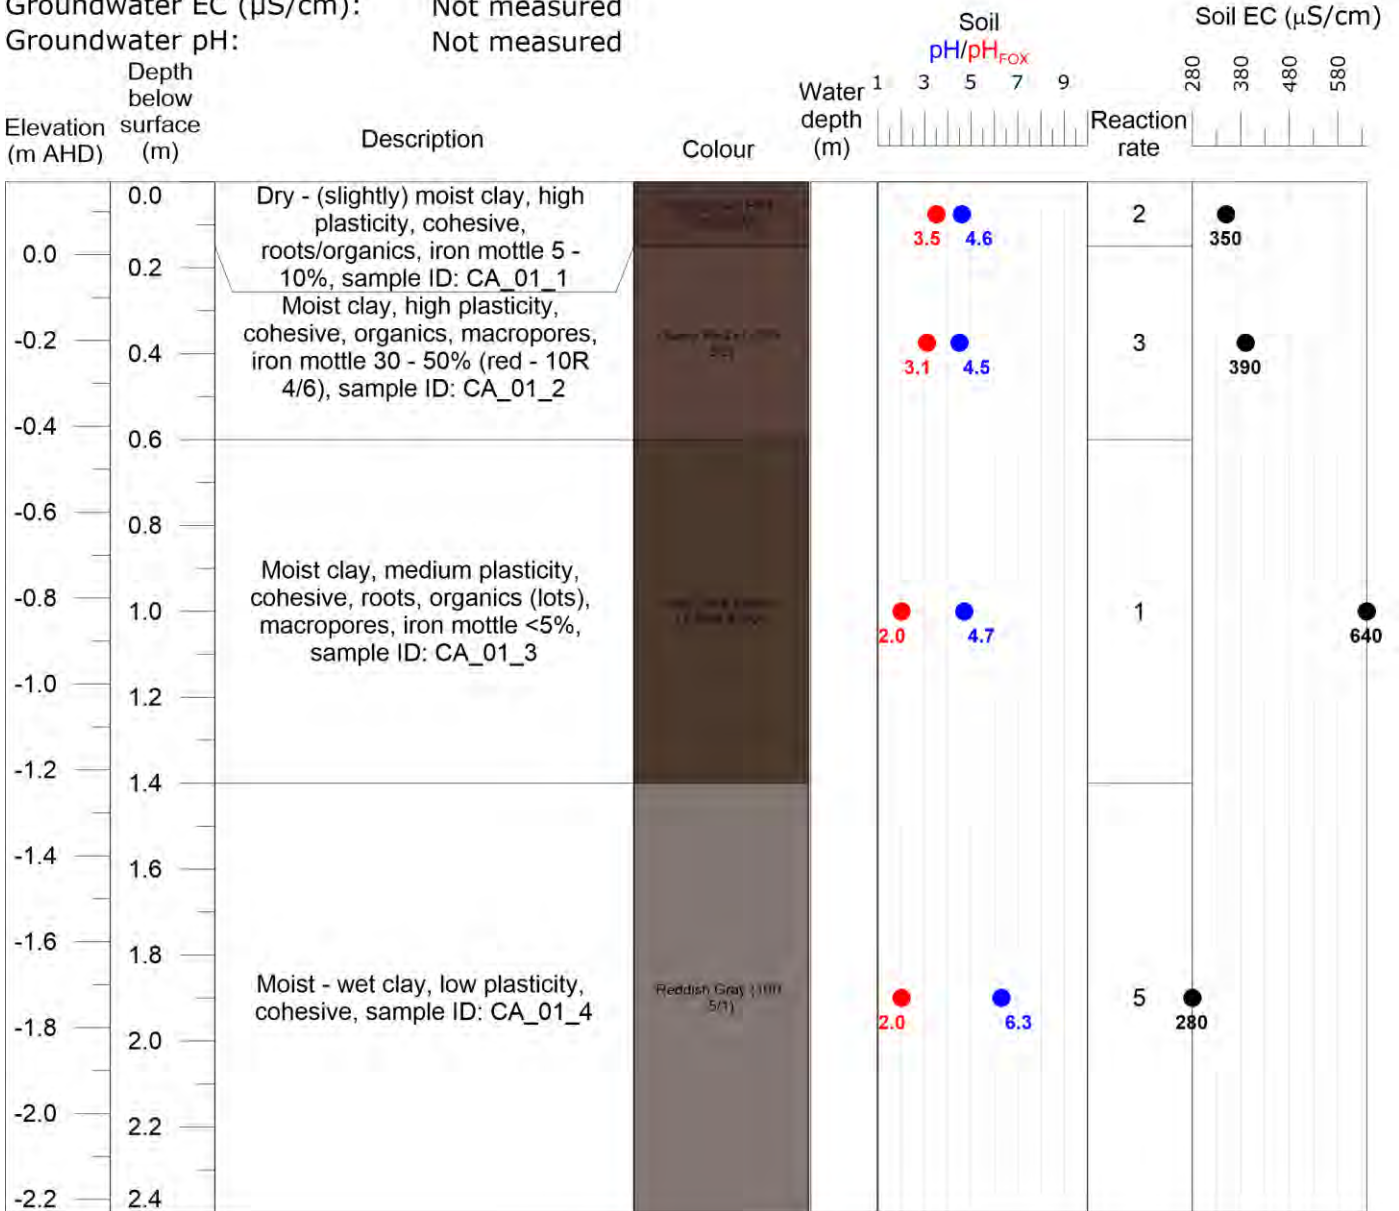
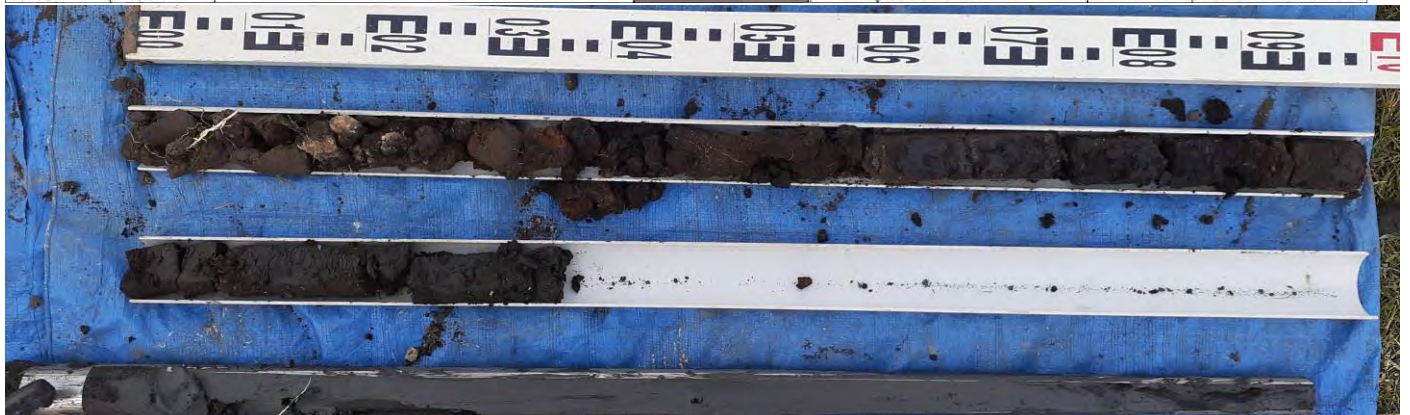
Surface water EC ( $\mu\text{S/cm}$ ): 900  
 Surface water pH: 7.2  
 Groundwater EC ( $\mu\text{S/cm}$ ): Not measured  
 Groundwater pH: Not measured
