# Clarence River Floodplain Prioritisation Study: Appendix A – L

WRL TR 2020/06, May 2023

# Appendix A Floodplain waterways

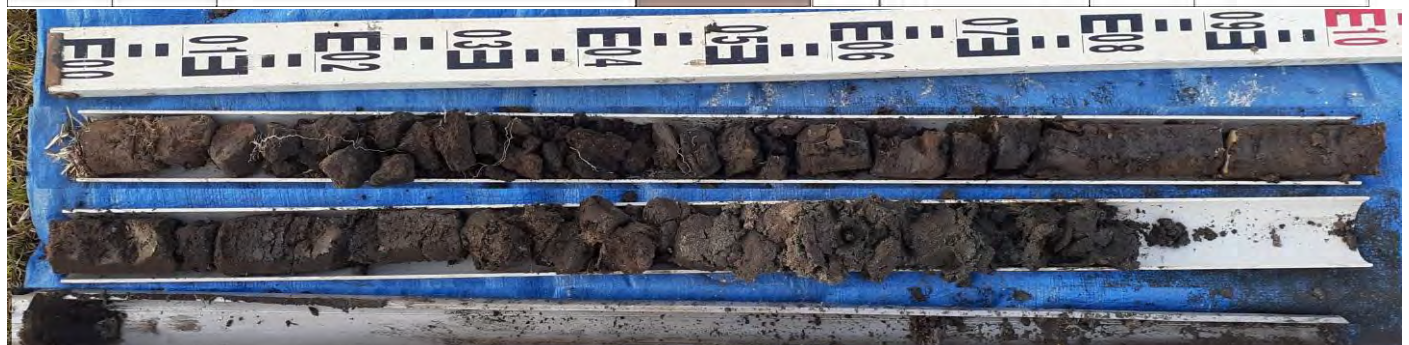
Surface water EC ( $\mu\text{S/cm}$ ): 2,120  
 Surface water pH: 7.1  
 Groundwater EC ( $\mu\text{S/cm}$ ): Not measured  
 Groundwater pH: Not measured

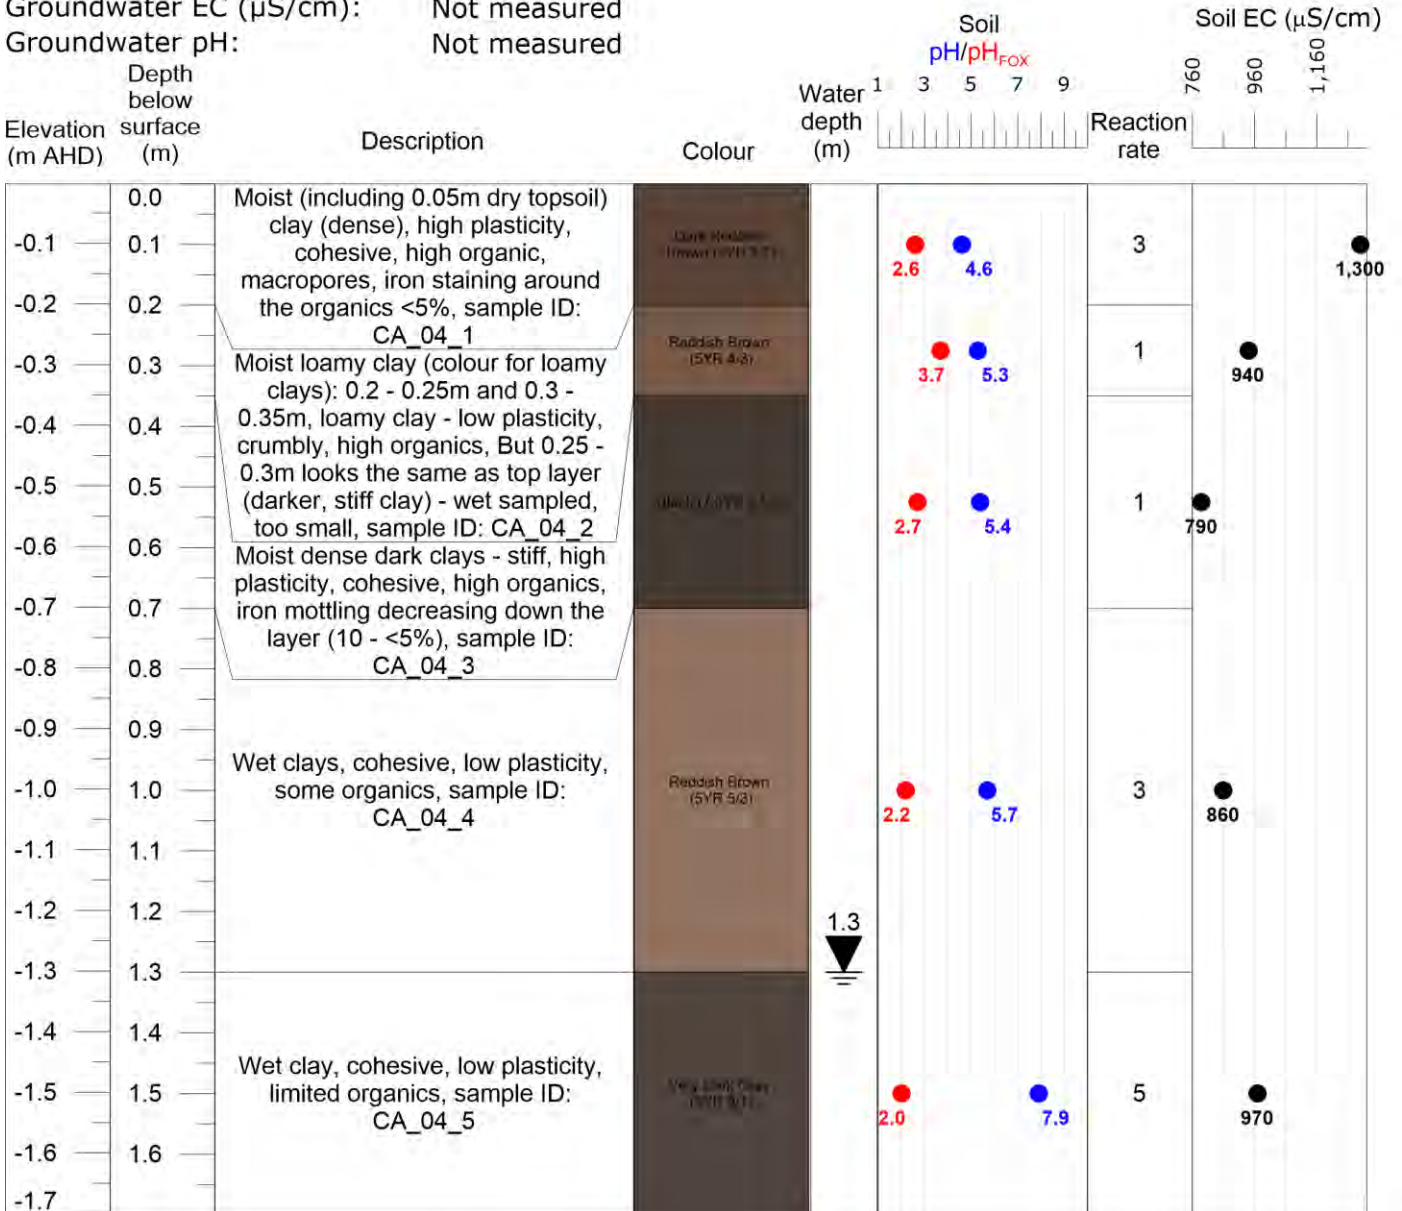
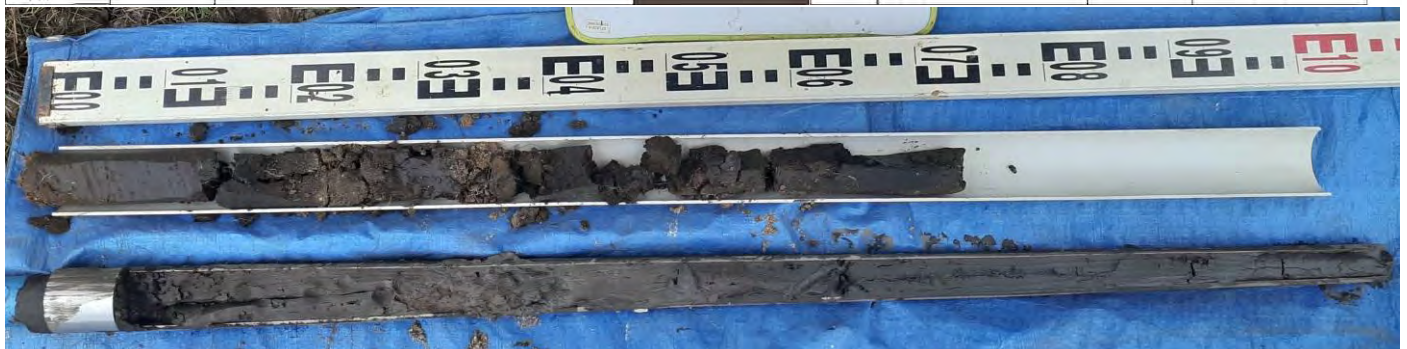
Surface water EC ( $\mu\text{S/cm}$ ): Not measured  
 Surface water pH: Not measured  
 Groundwater EC ( $\mu\text{S/cm}$ ): Not measured  
 Groundwater pH: Not measured

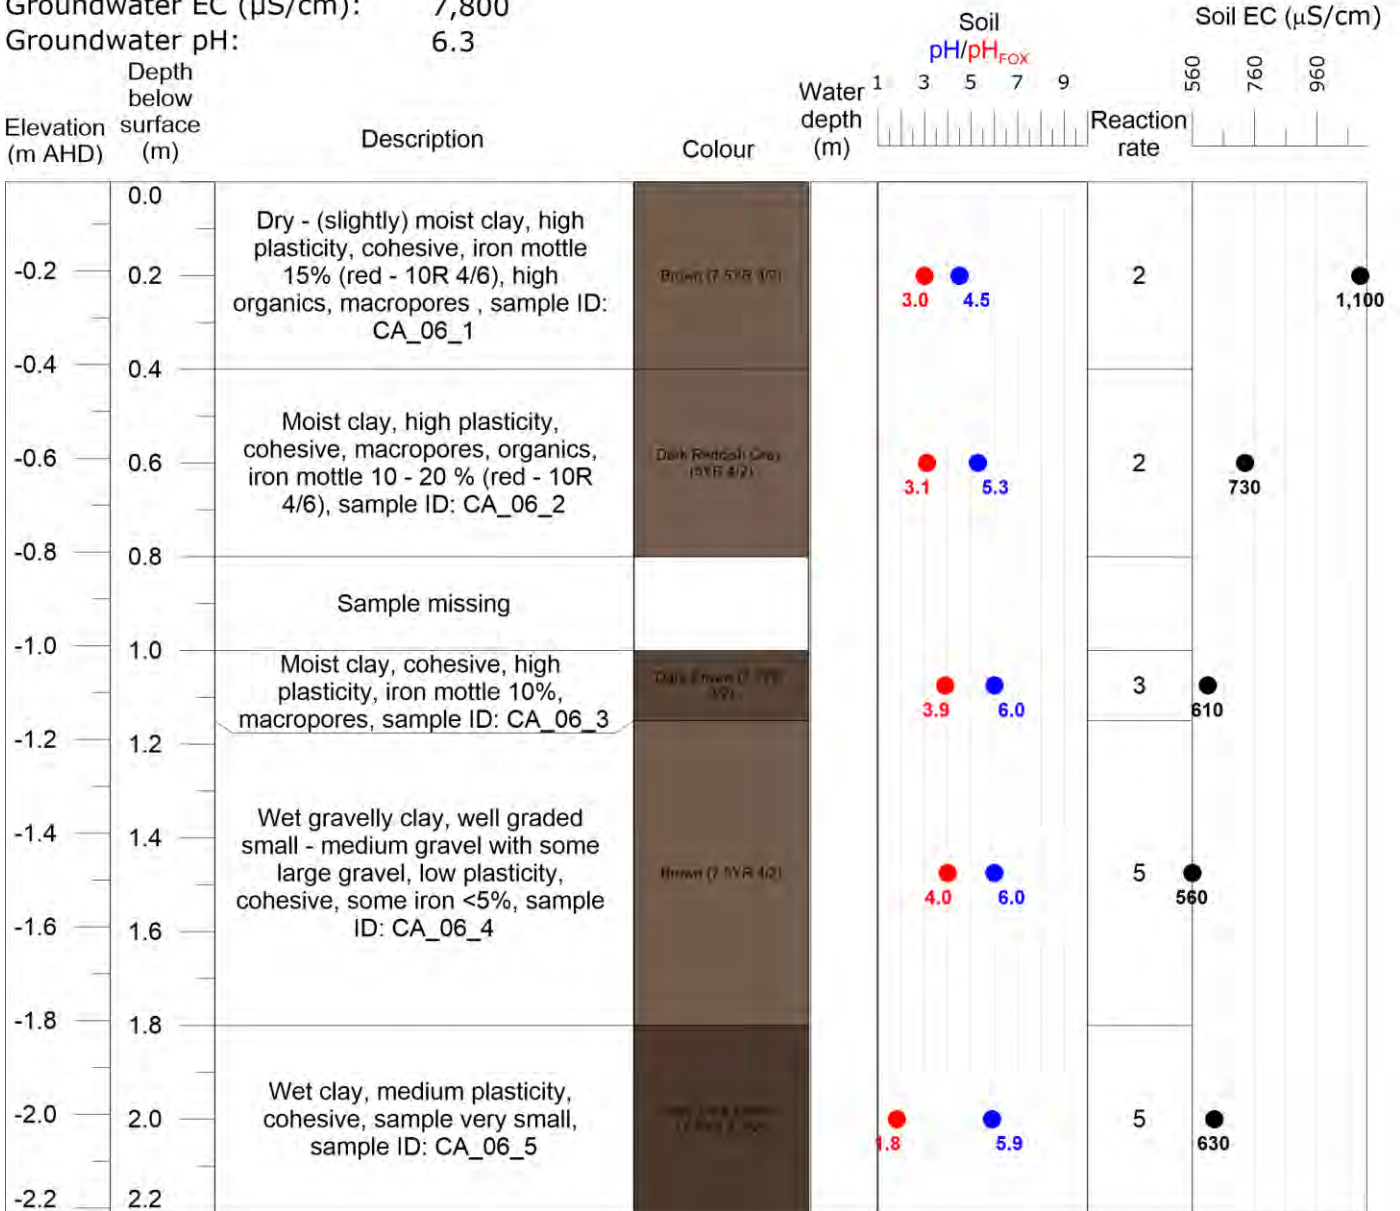
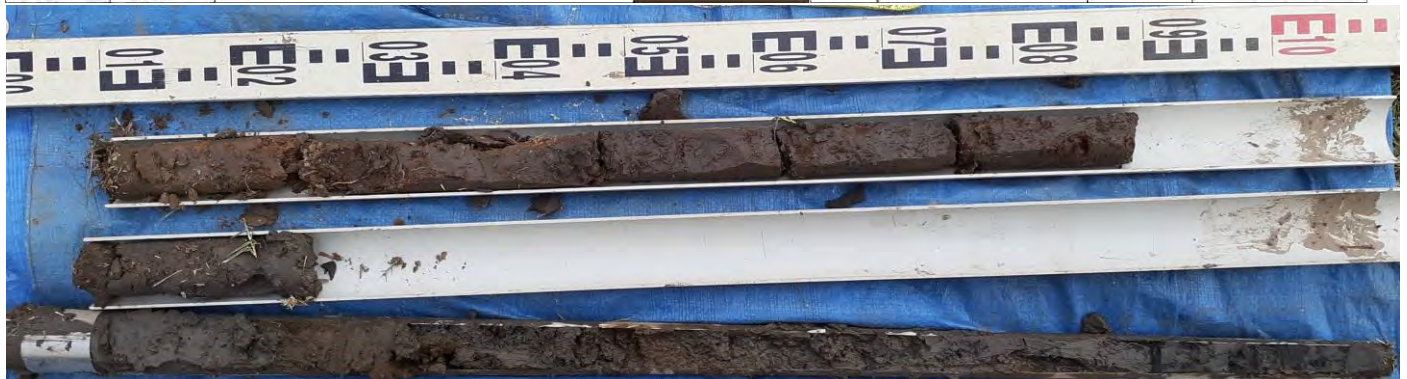
Surface water EC ( $\mu\text{S/cm}$ ): 27,830  
 Surface water pH: 7.3  
 Groundwater EC ( $\mu\text{S/cm}$ ): 7,800  
 Groundwater pH: 6.3

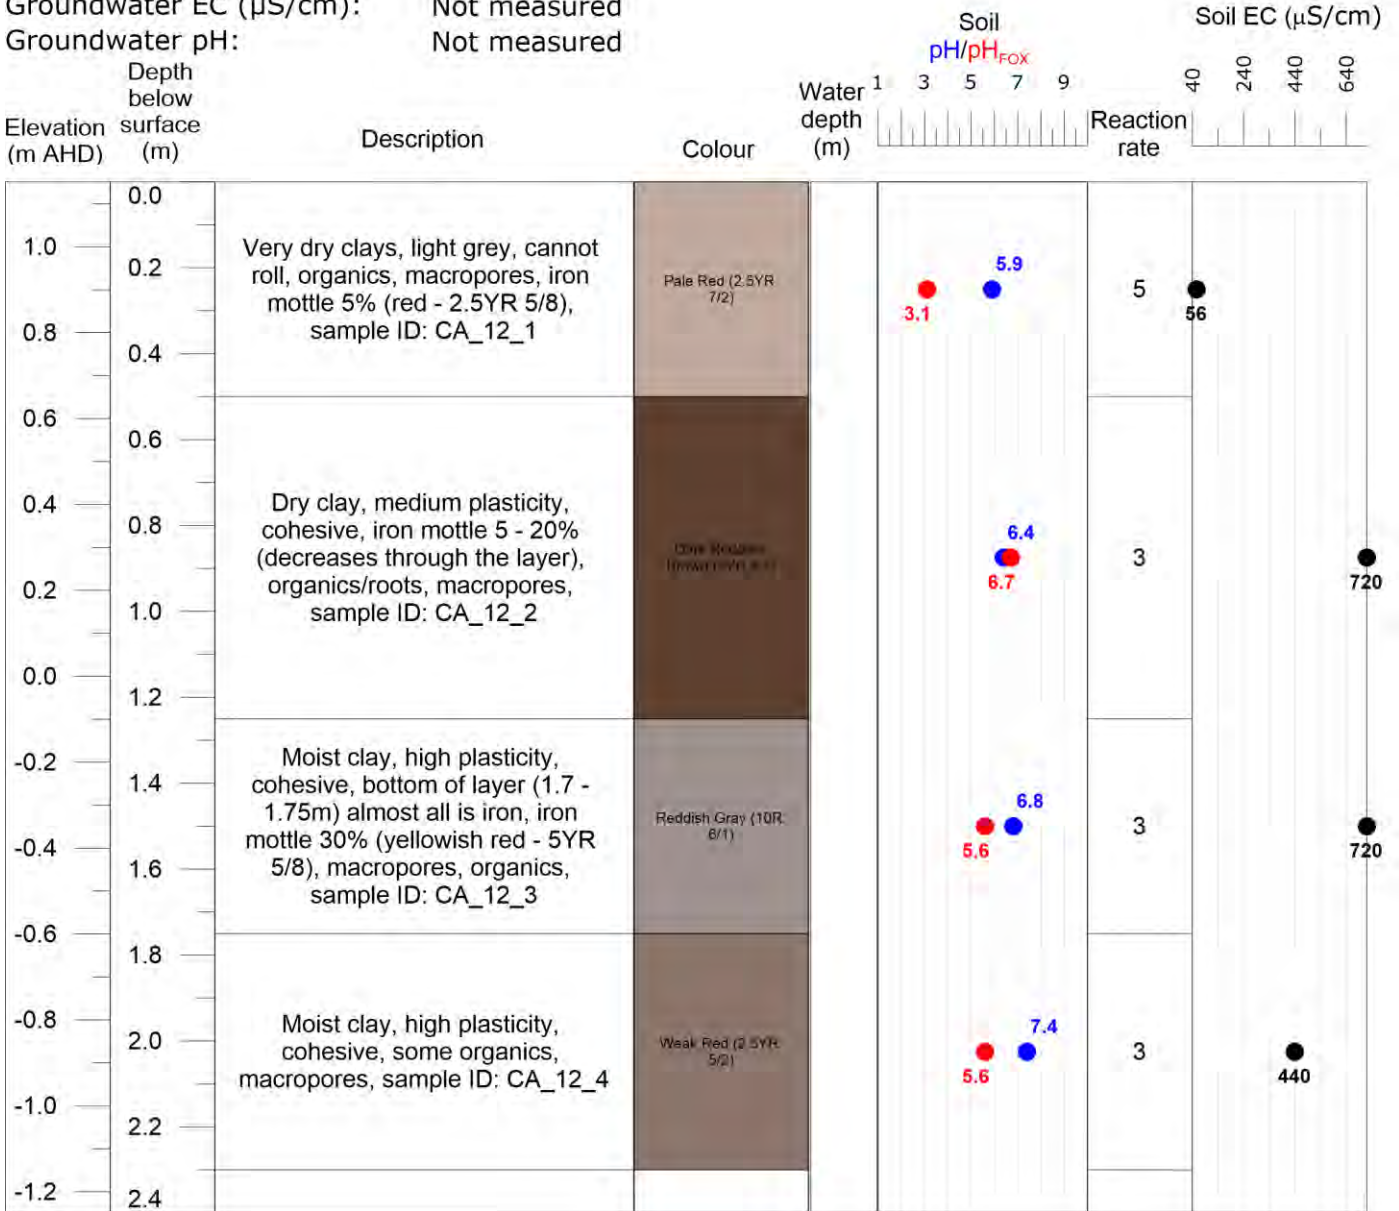
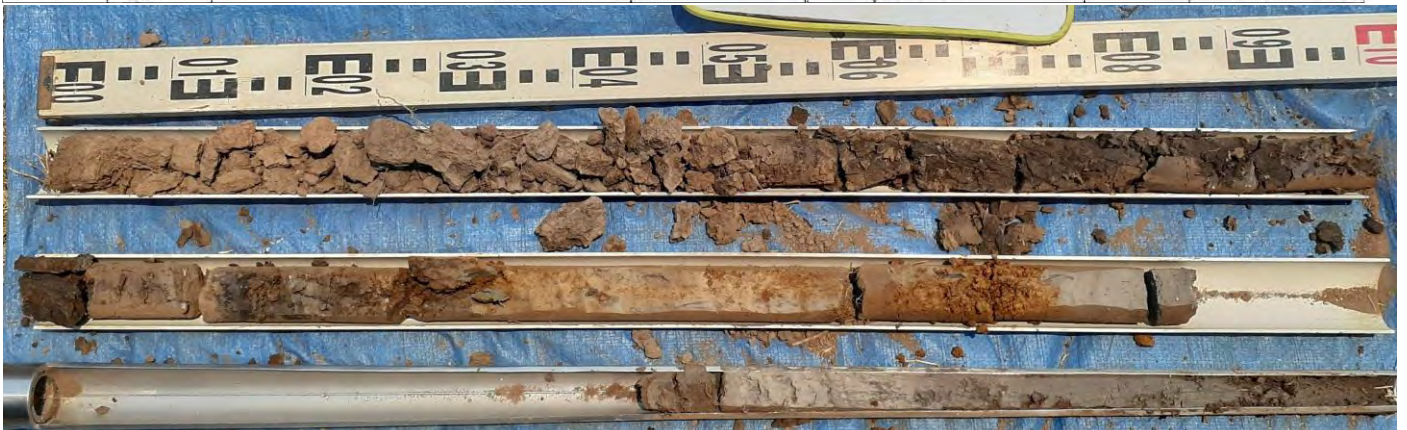
Surface water EC ( $\mu\text{S/cm}$ ): 26,250  
 Surface water pH: 7.7  
 Groundwater EC ( $\mu\text{S/cm}$ ): Not measured  
 Groundwater pH: Not measured

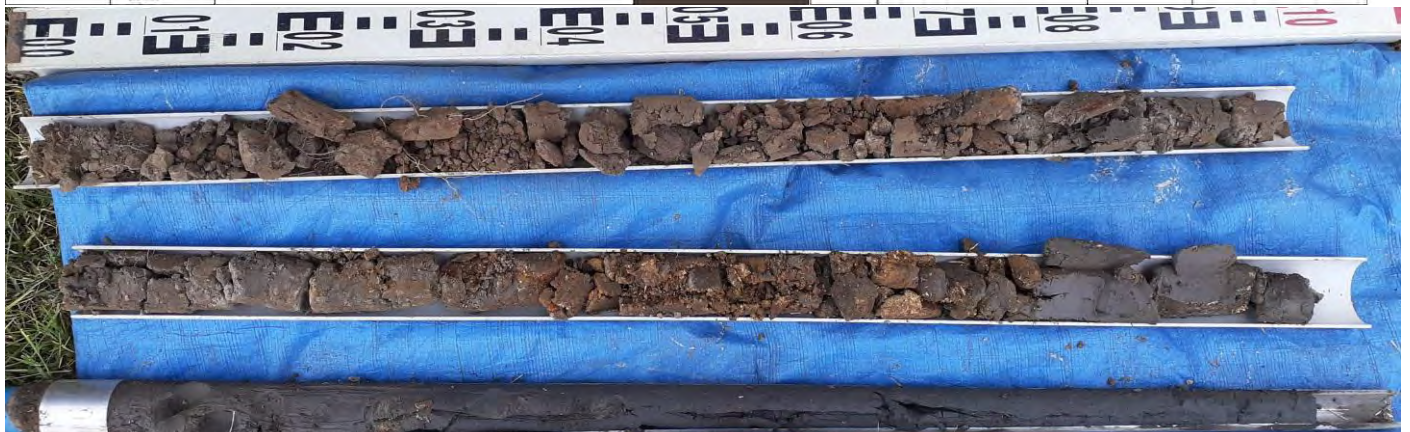
Surface water EC ( $\mu\text{S/cm}$ ): Not measured  
 Surface water pH: Not measured  
 Groundwater EC ( $\mu\text{S/cm}$ ): Not measured  
 Groundwater pH: Not measured

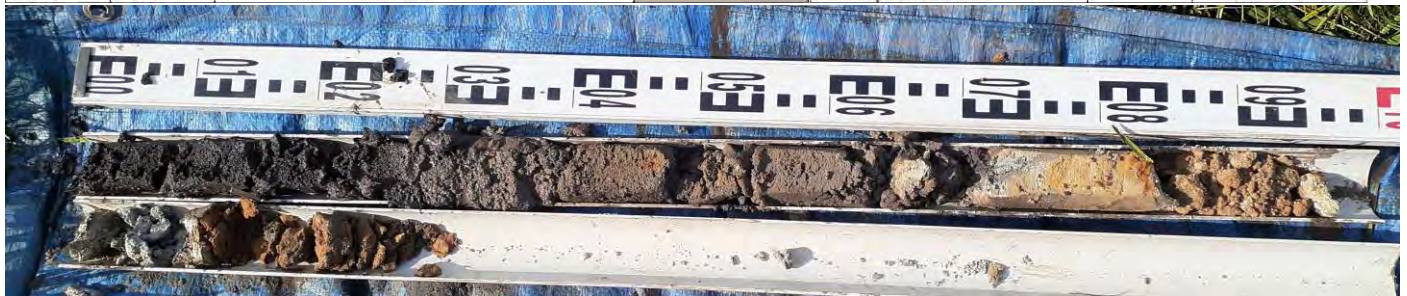
Surface water EC ( $\mu\text{S/cm}$ ): 116  
 Surface water pH: 5.6  
 Groundwater EC ( $\mu\text{S/cm}$ ): 163  
 Groundwater pH: 5.38

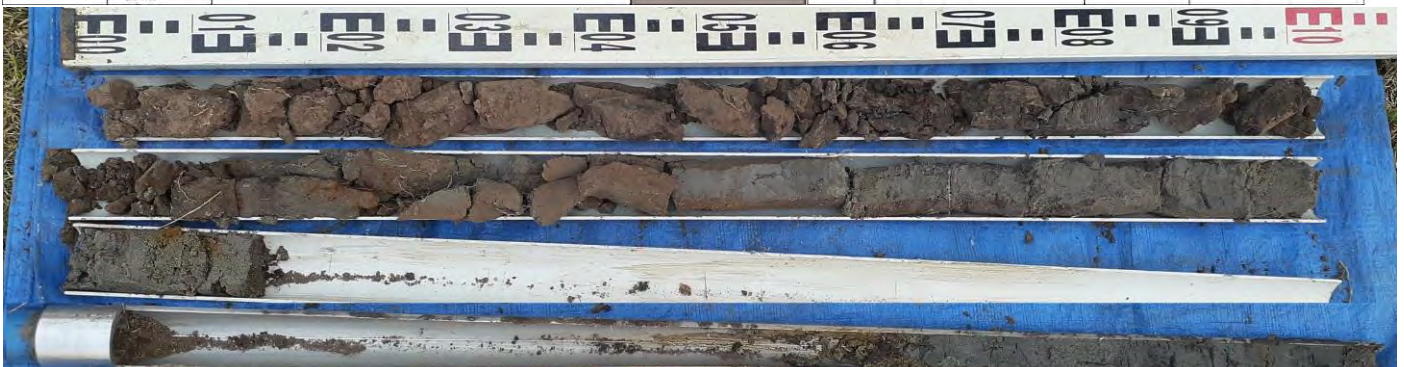
Surface water EC ( $\mu\text{S/cm}$ ): 31,300  
 Surface water pH: 7  
 Groundwater EC ( $\mu\text{S/cm}$ ): Not measured  
 Groundwater pH: Not measured

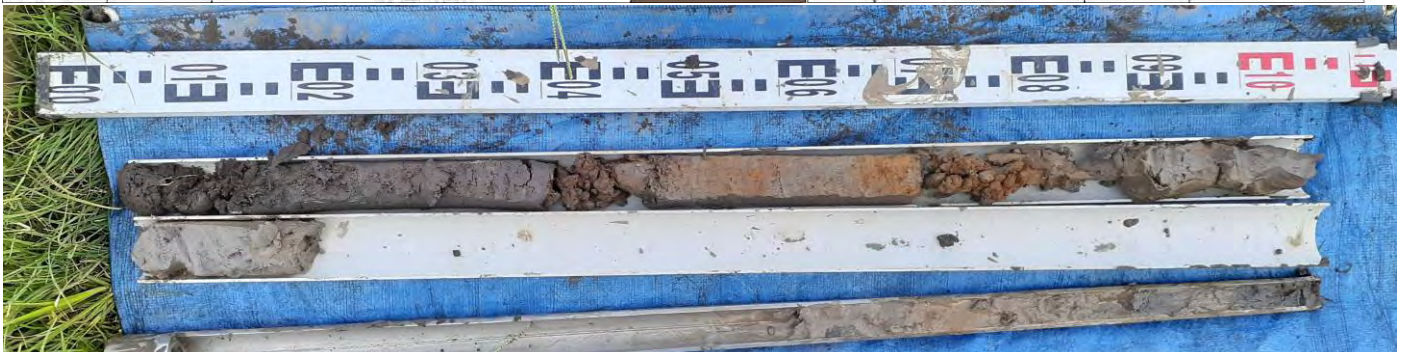
Surface water EC (µS/cm): 2,267  
 Surface water pH: 4.97  
 Groundwater EC (µS/cm): 3,318  
 Groundwater pH: 5.67

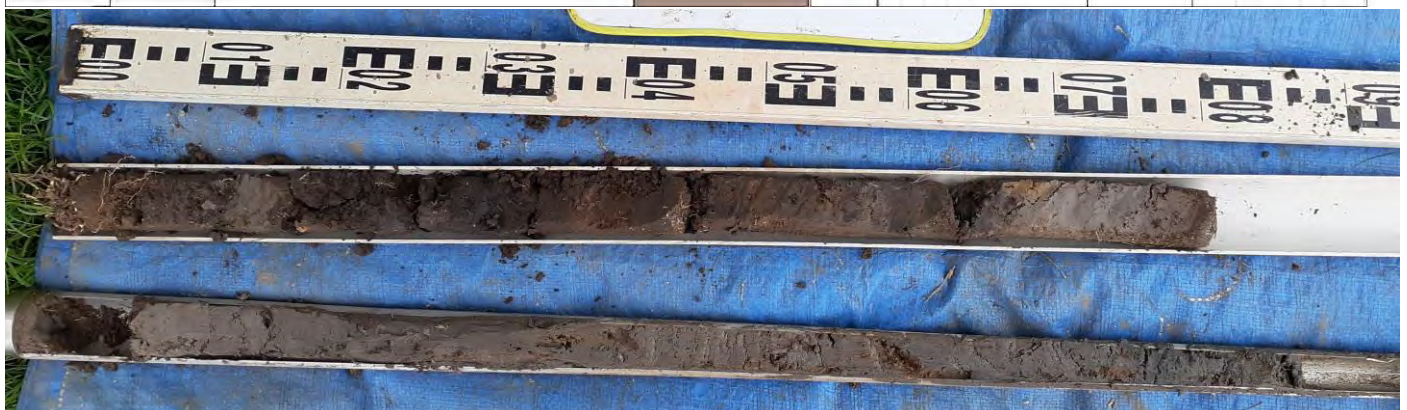
Surface water EC ( $\mu\text{S/cm}$ ): 2,712  
 Surface water pH: 6.37  
 Groundwater EC ( $\mu\text{S/cm}$ ): 14,332  
 Groundwater pH: 5.05

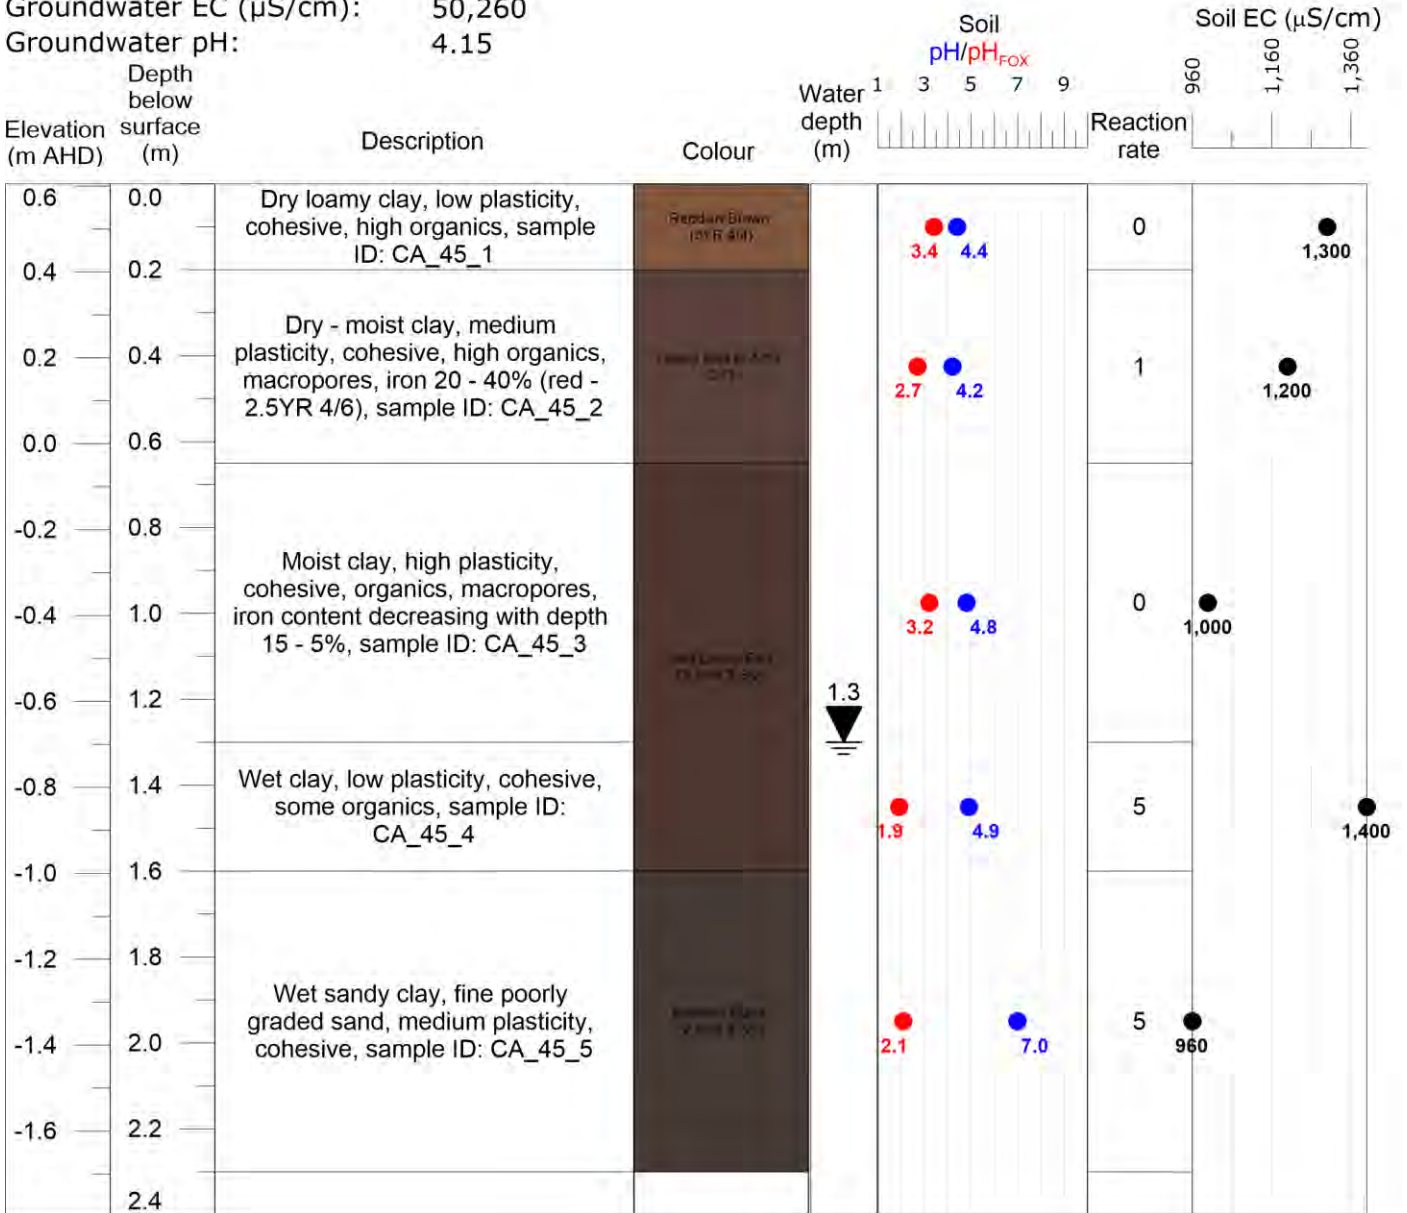
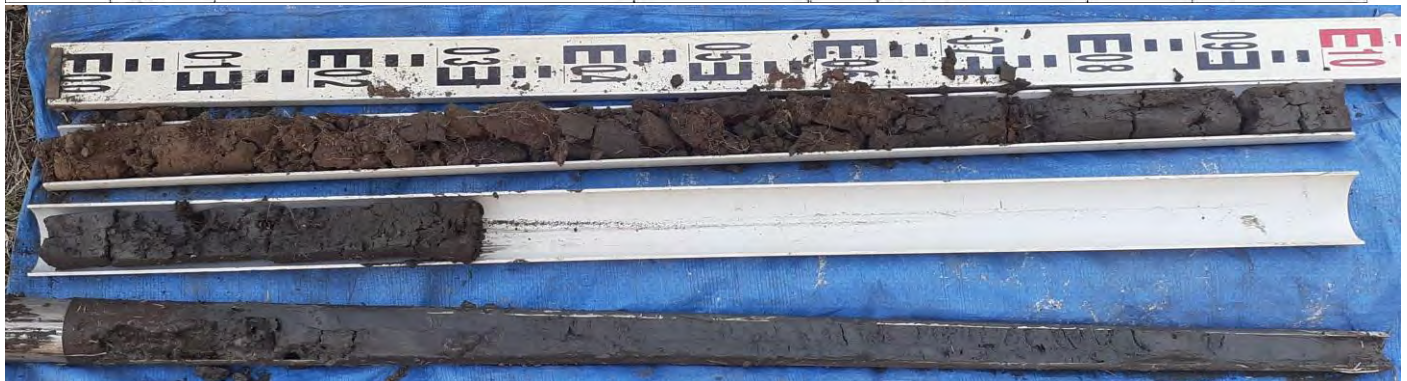
Surface water EC ( $\mu\text{S/cm}$ ): 23,500  
 Surface water pH: 6.8  
 Groundwater EC ( $\mu\text{S/cm}$ ): 50,260  
 Groundwater pH: 4.15

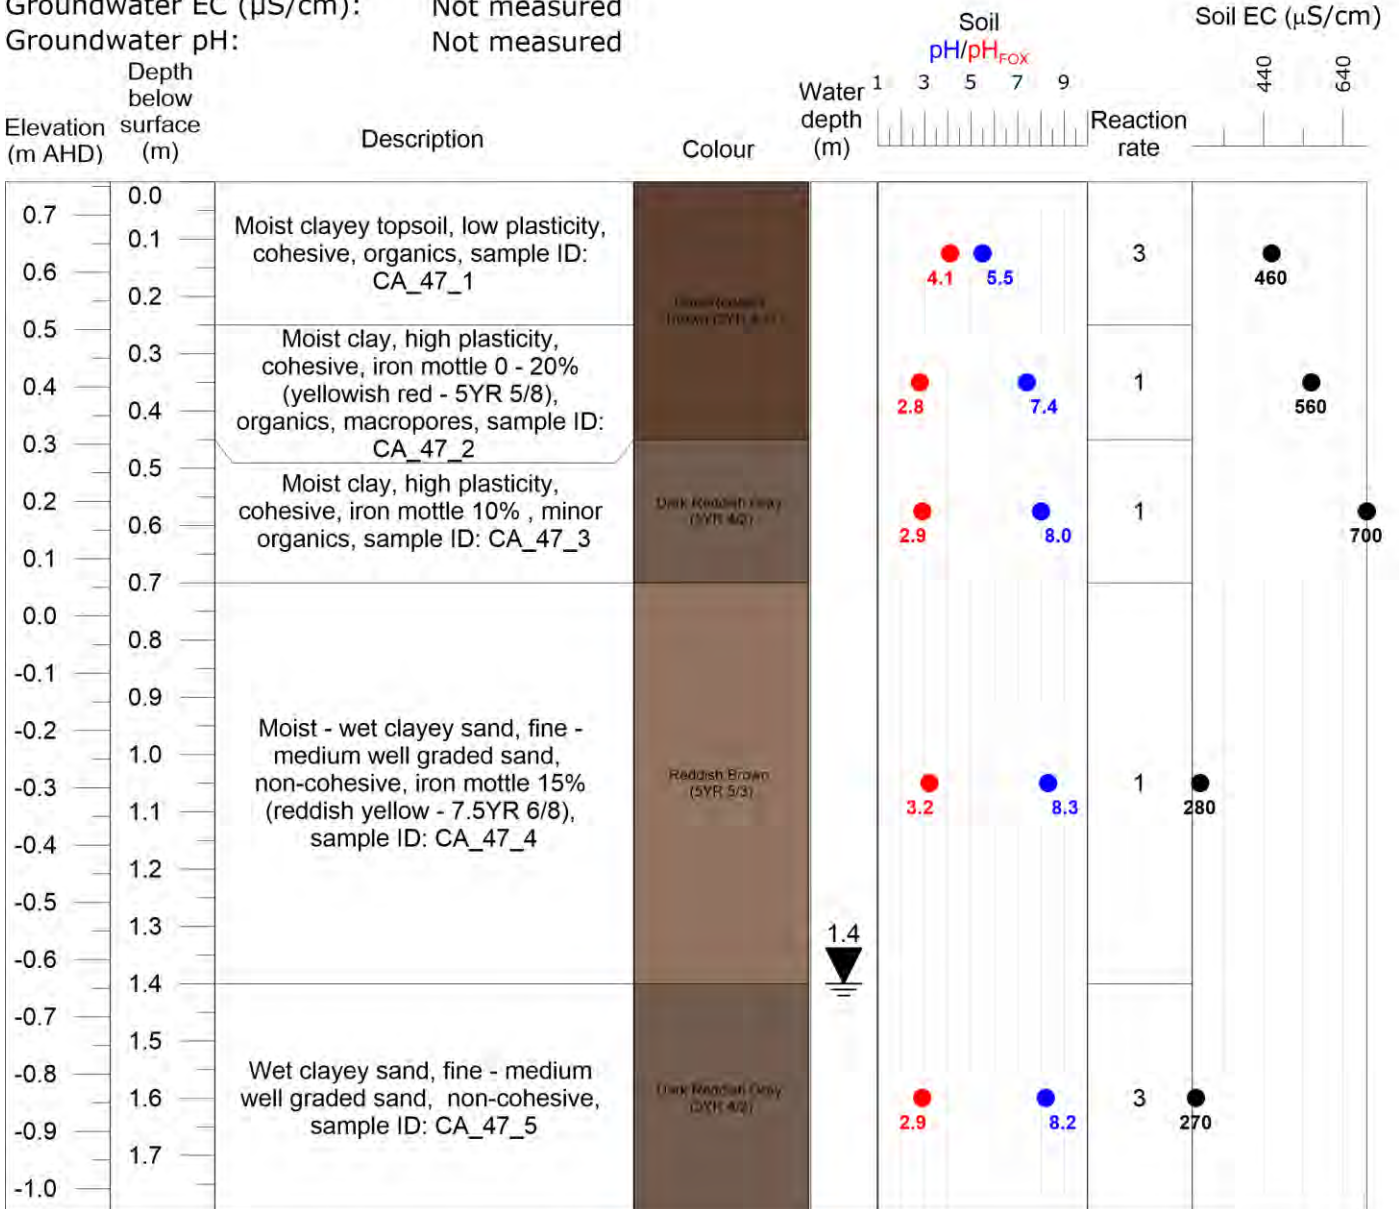
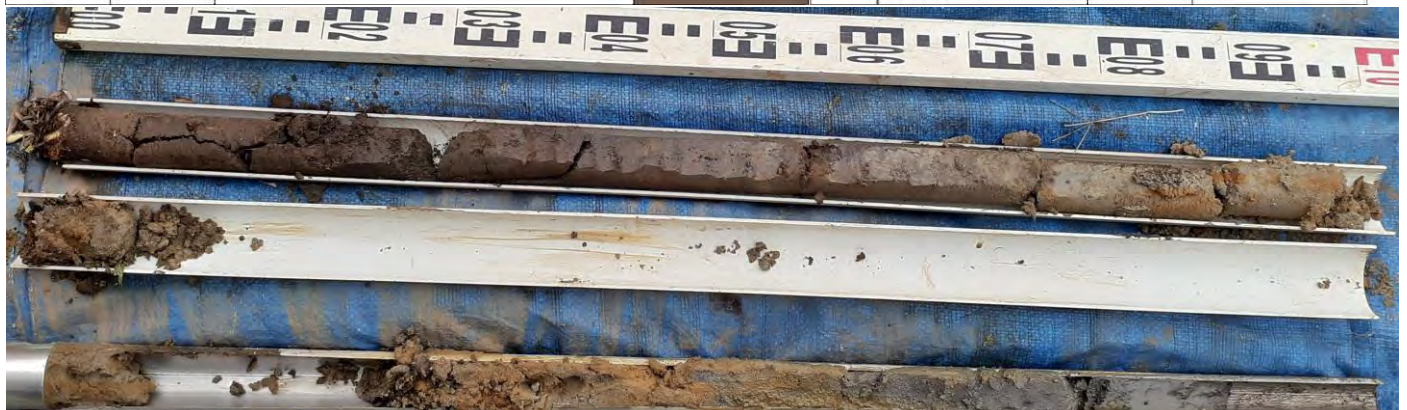
Surface water EC ( $\mu\text{S/cm}$ ): 643  
 Surface water pH: 6.7  
 Groundwater EC ( $\mu\text{S/cm}$ ): Not measured  
 Groundwater pH: Not measured

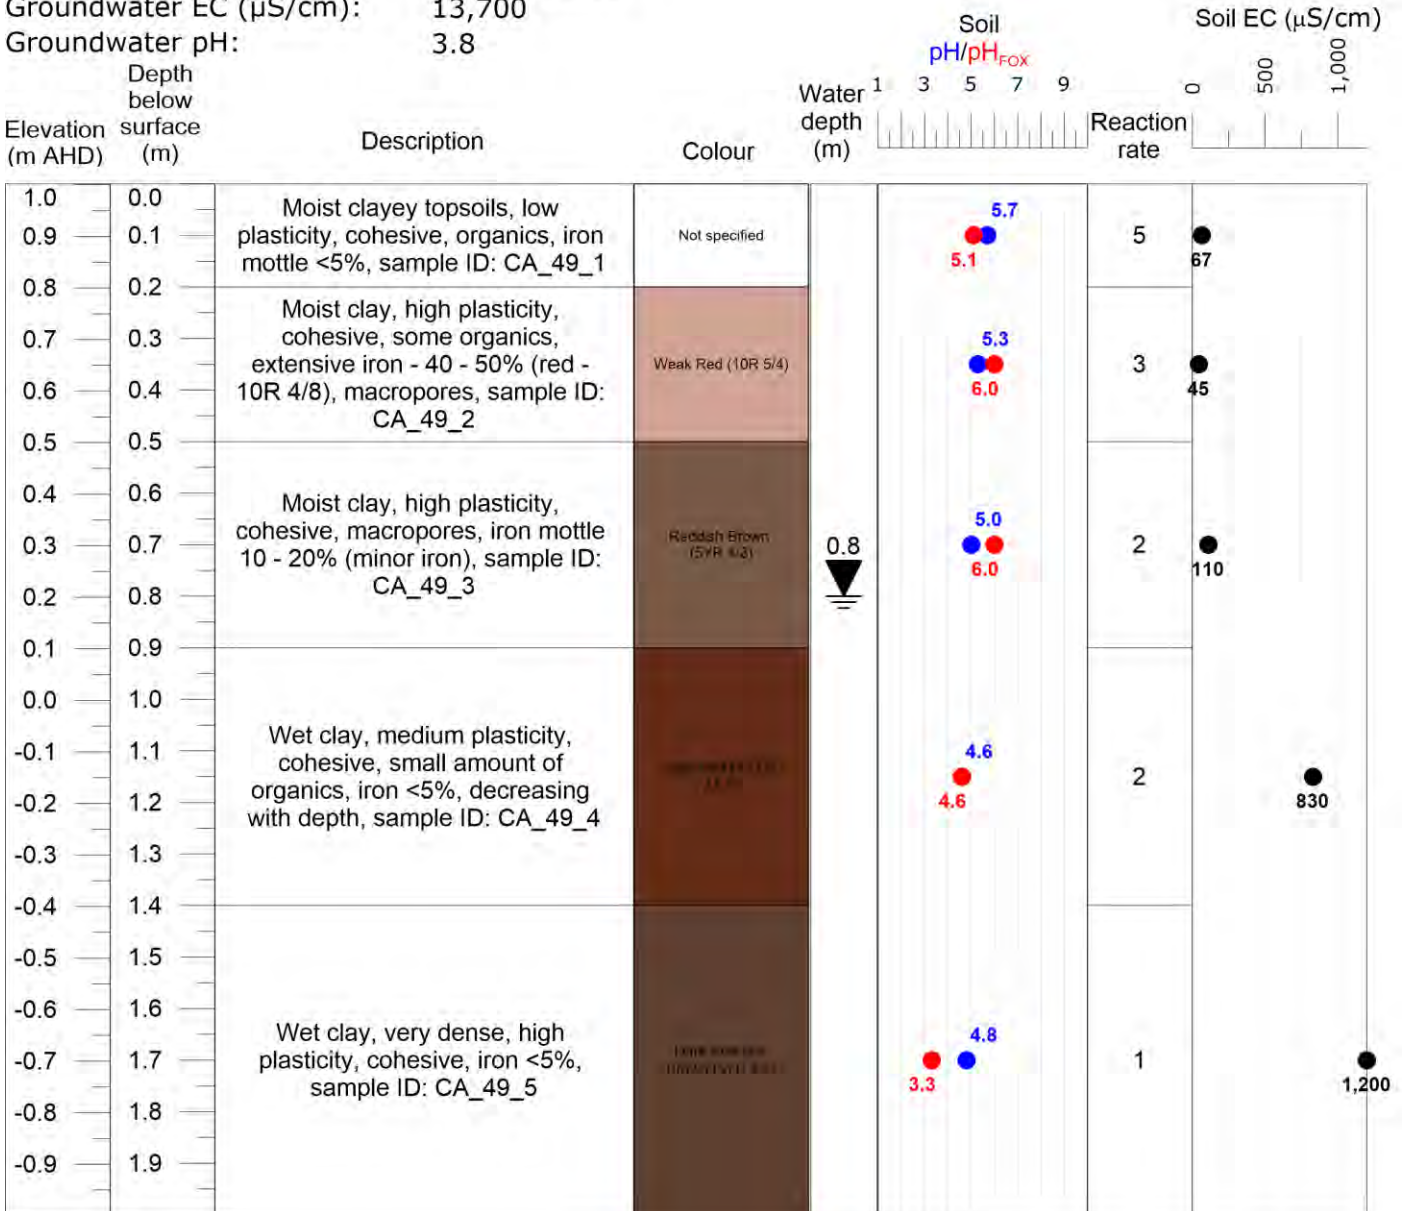
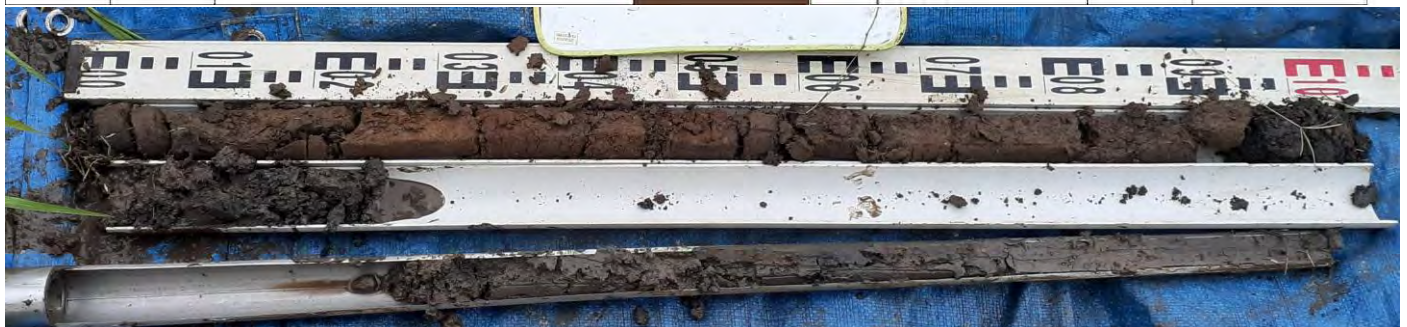
Surface water EC ( $\mu\text{S/cm}$ ): Not measured  
 Surface water pH: Not measured  
 Groundwater EC ( $\mu\text{S/cm}$ ): 13,700  
 Groundwater pH: 3.8

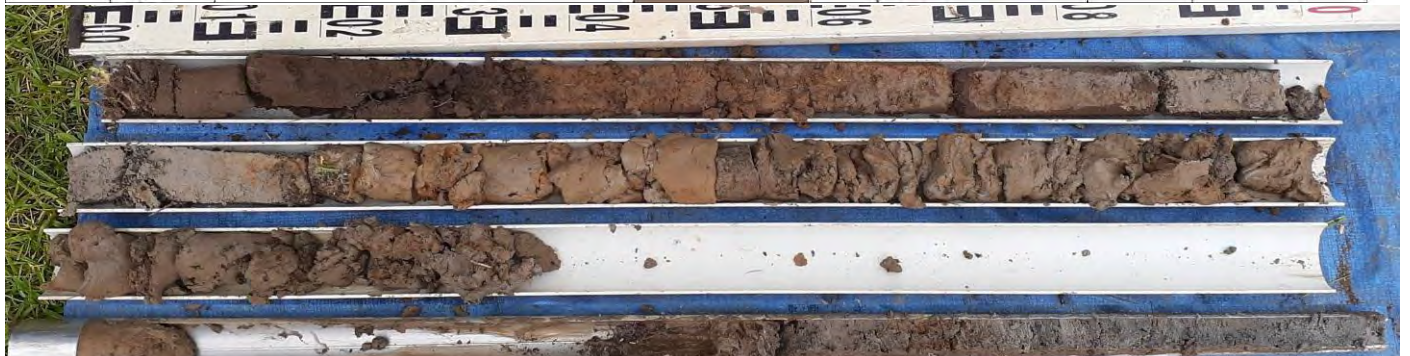
Project Number: 2018064 Profile ID: CA\_52\_S  
 River/estuary: Clarence Sample date: 05/02/20  
 Easting: 524586.7 Sampled by: AJH GL  
 Northing: 6740218.8  
 Ground elevation (m AHD): 1.06  
 Hydraulic conductivity (m/d): 0.19

Surface water EC ( $\mu\text{S/cm}$ ): 271  
 Surface water pH: 6.2  
 Groundwater EC ( $\mu\text{S/cm}$ ): 1,920  
 Groundwater pH: 5.4

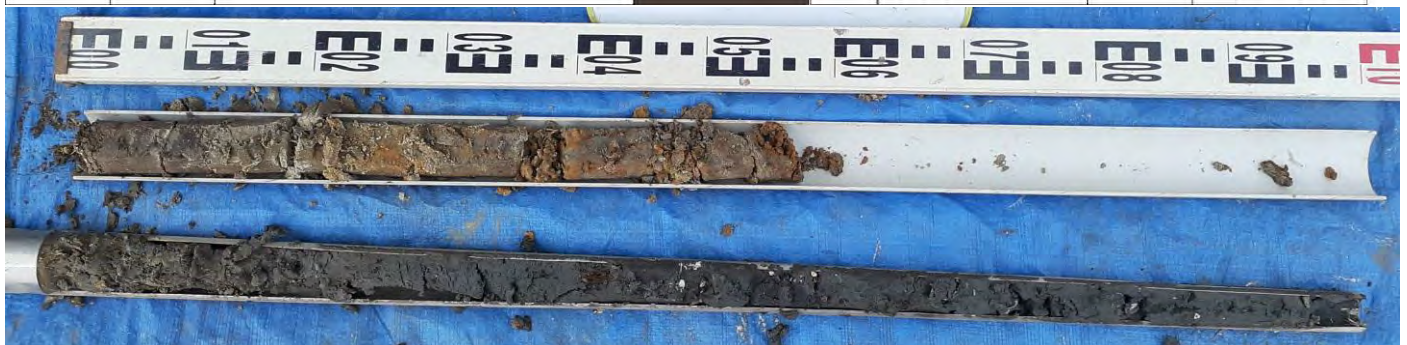
Project Number: 2018064 Profile ID: CA\_57  
 River/estuary: Clarence Sample date: 05/12/19  
 Easting: 528787.3 Sampled by: AJH GL  
 Northing: 6740781.5  
 Ground elevation (m AHD): -0.07  
 Hydraulic conductivity (m/d): 0.43

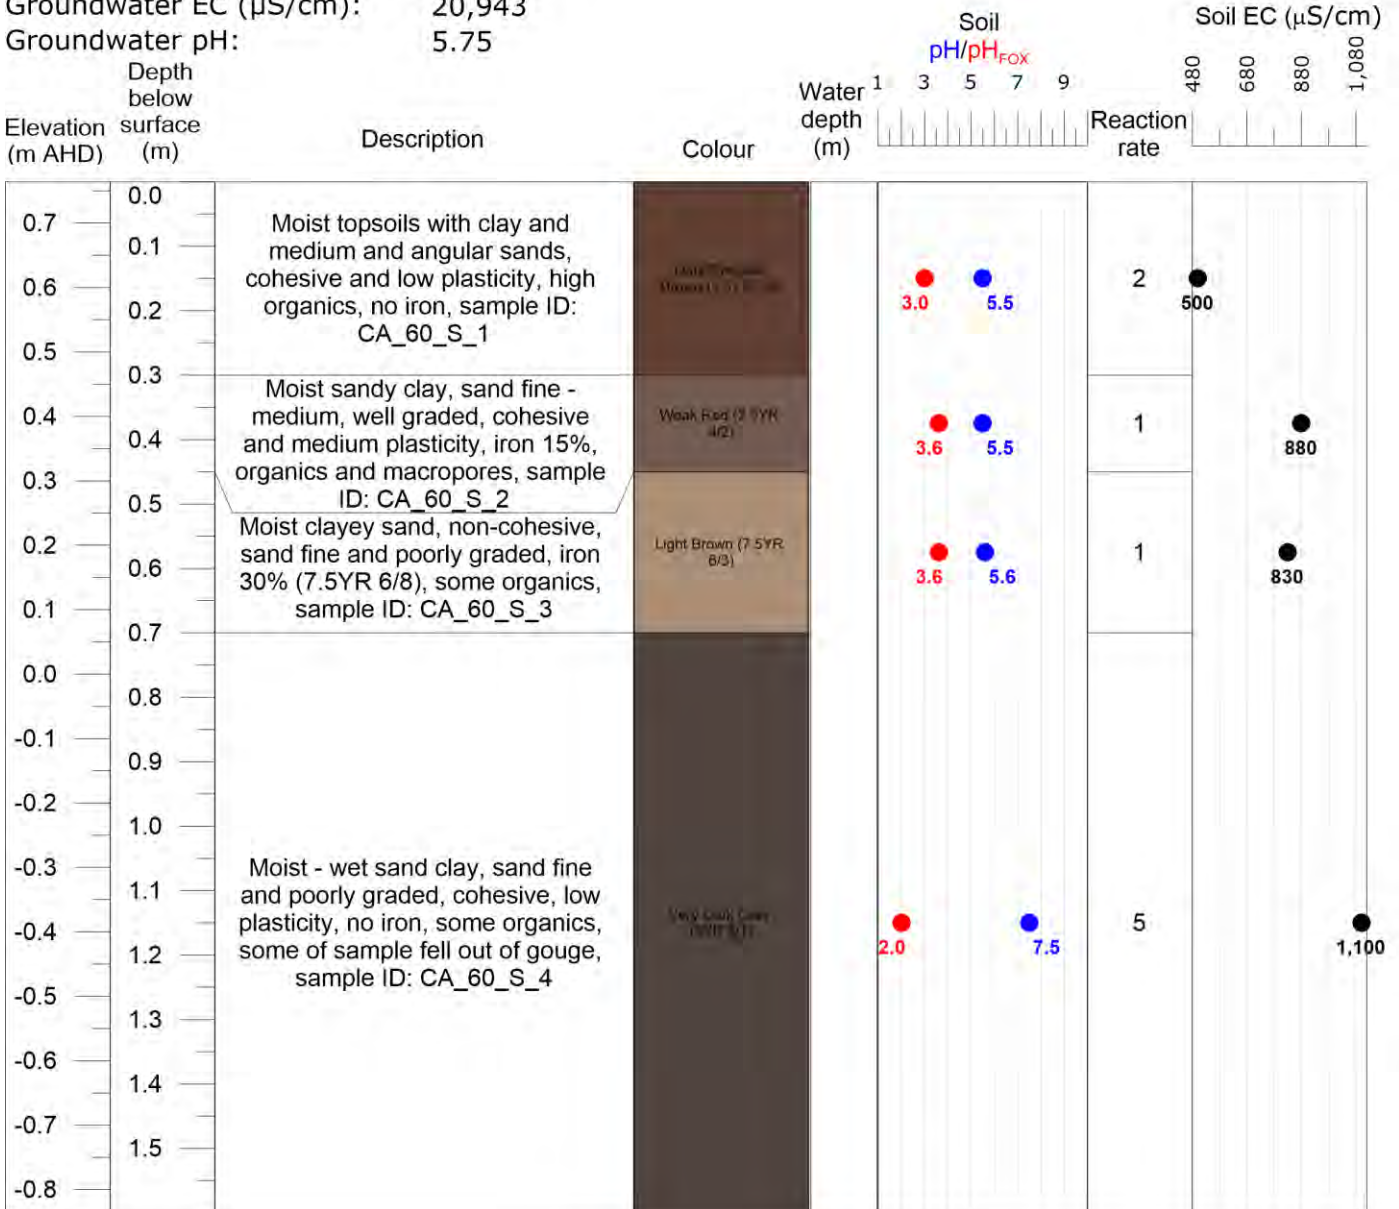
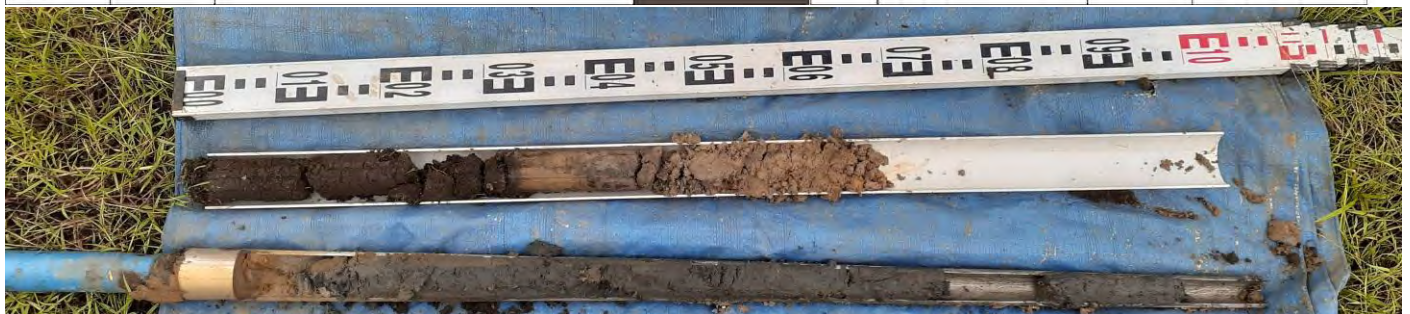
Project Number: 2018064 Profile ID: CA\_60\_S  
 River/estuary: Clarence Sample date: 03/03/20  
 Easting: 528507.3 Sampled by: AJH KW  
 Northing: 6743655.6  
 Ground elevation (m AHD): 0.76  
 Hydraulic conductivity (m/d): 0.072

Surface water EC ( $\mu\text{S/cm}$ ): 4,909  
 Surface water pH: 6.6  
 Groundwater EC ( $\mu\text{S/cm}$ ): 20,943  
 Groundwater pH: 5.75

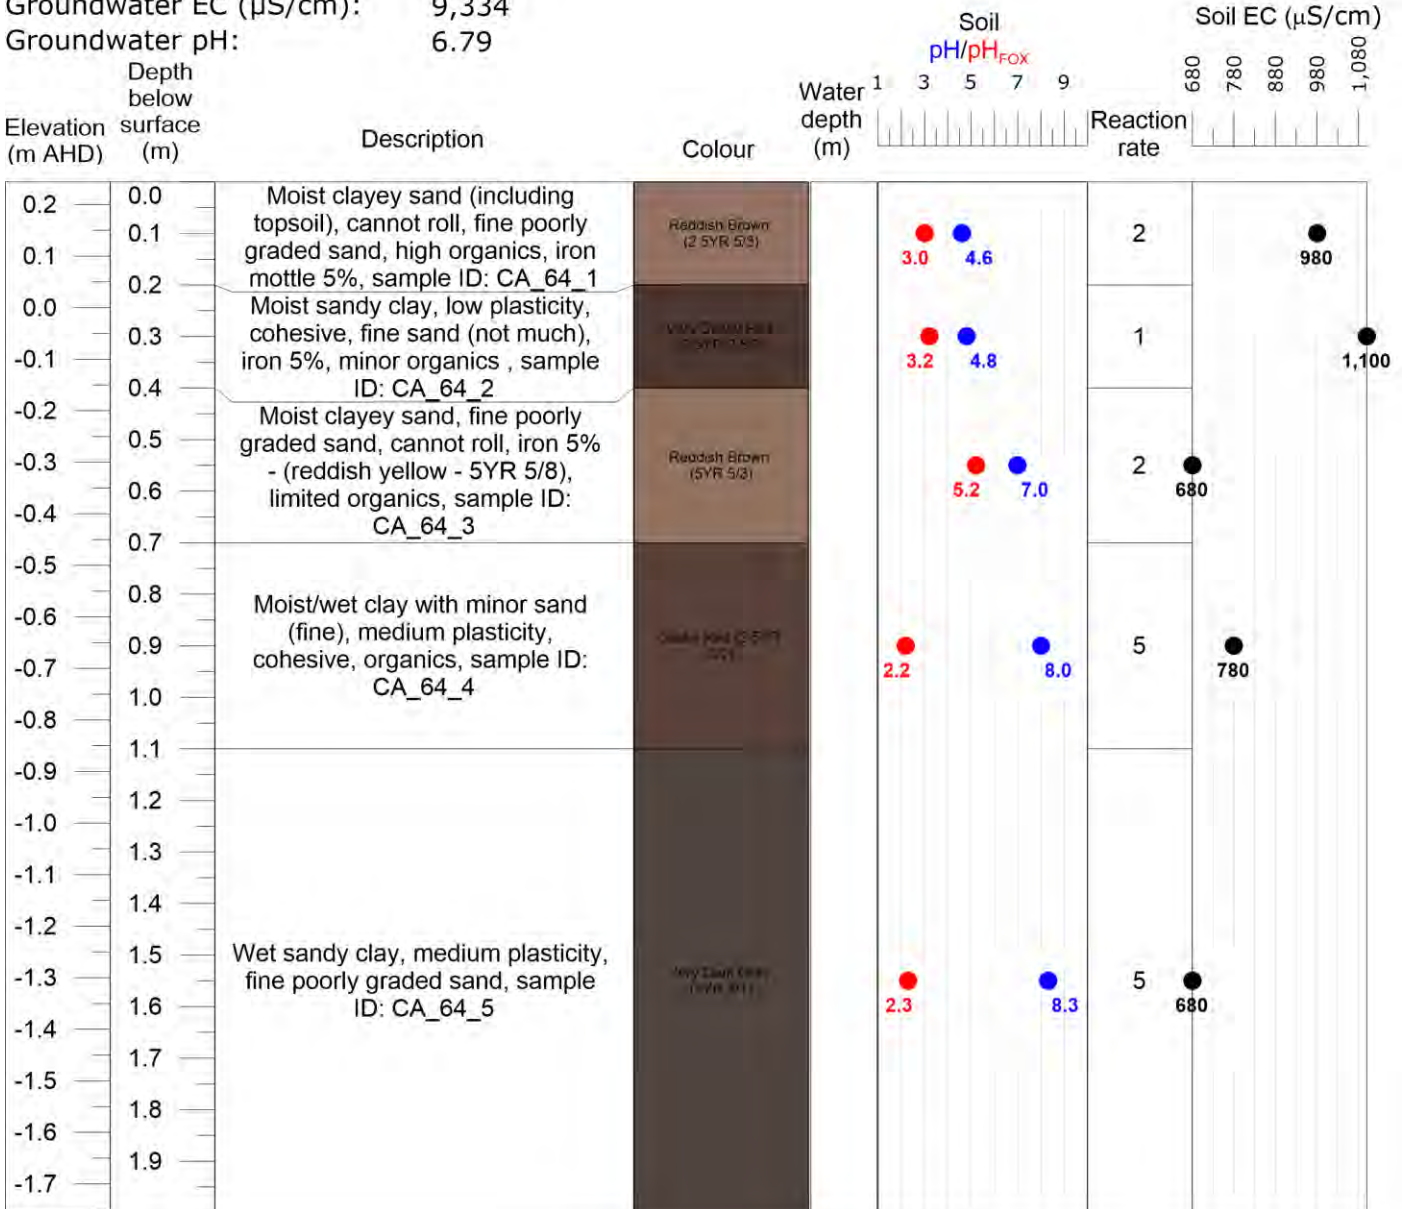
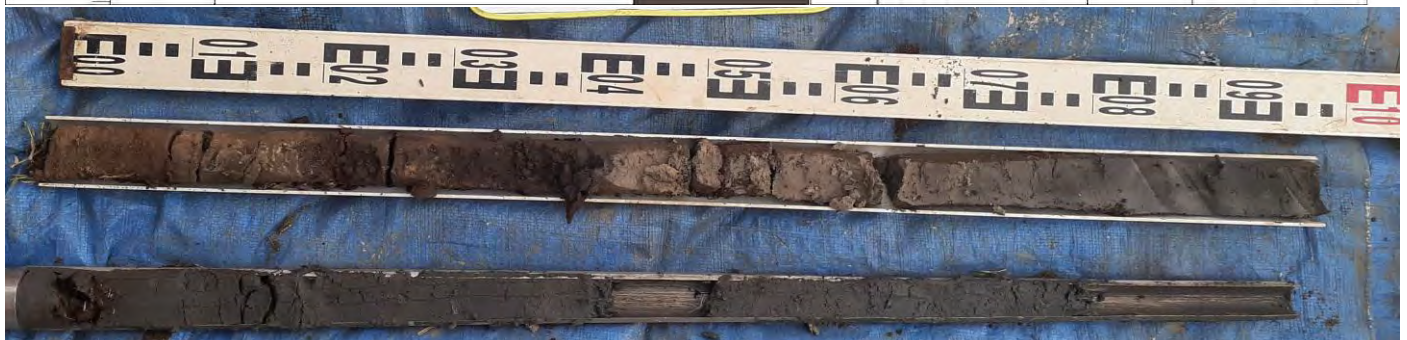
Project Number: 2018064 Profile ID: CA\_64  
 River/estuary: Clarence Sample date: 05/02/20  
 Easting: 524806 Sampled by: AJH GL  
 Northing: 6749176.0  
 Ground elevation (m AHD): 0.24  
 Hydraulic conductivity (m/d): 0.046

Surface water EC ( $\mu\text{S/cm}$ ): 17,000  
 Surface water pH: 7.1  
 Groundwater EC ( $\mu\text{S/cm}$ ): 9,334  
 Groundwater pH: 6.79
