# Clarence River Floodplain Prioritisation Study: Appendix A – L

WRL TR 2020/06, May 2023

# Appendix A Floodplain waterways

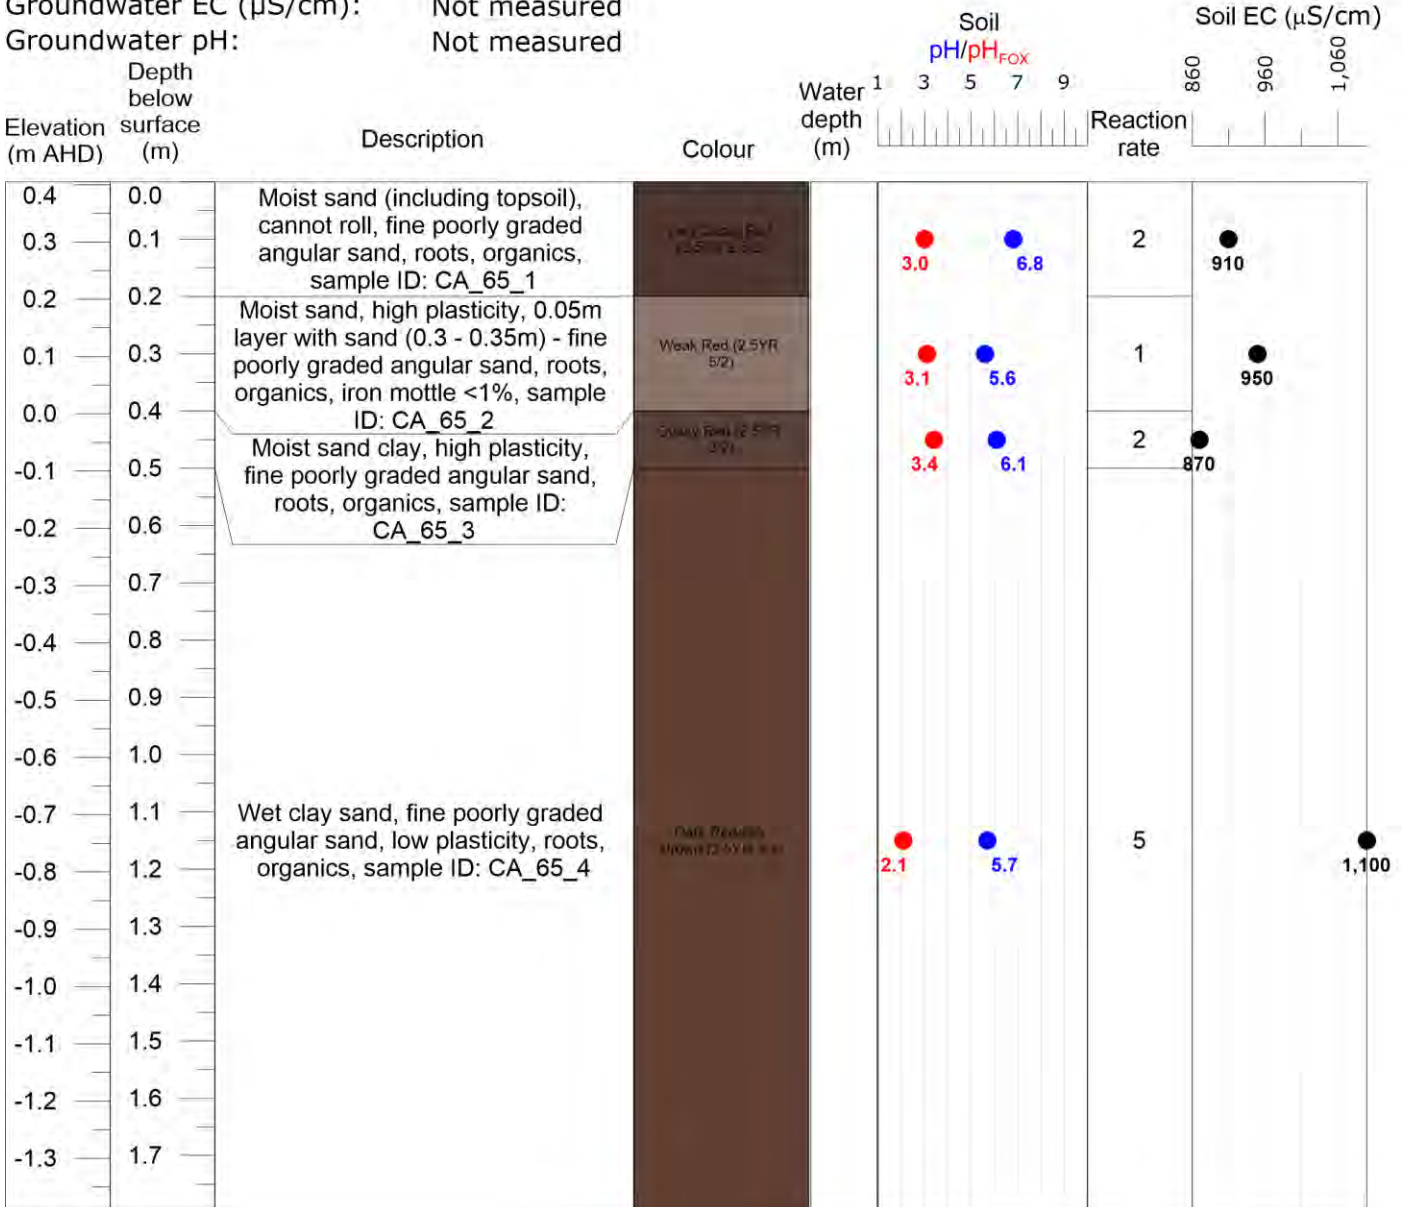
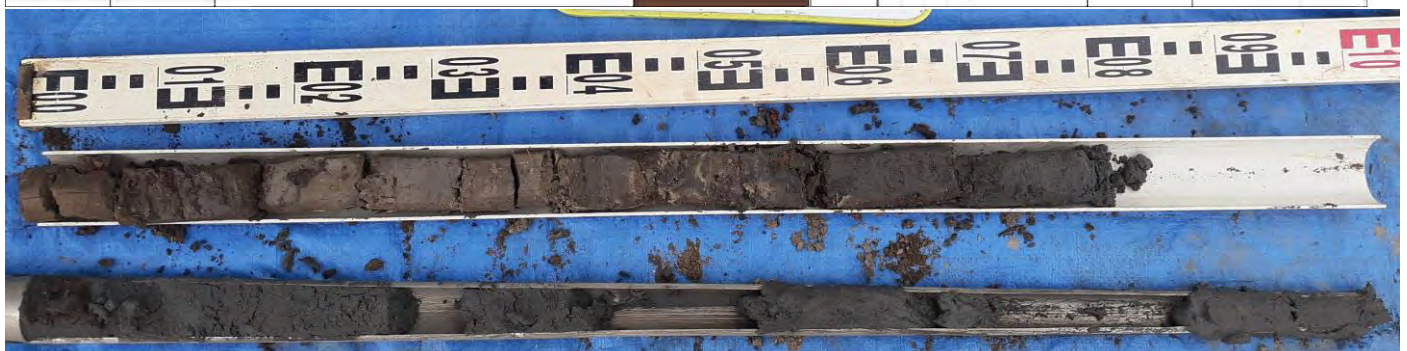
Project Number: 2018064 Profile ID: CA\_65  
 River/estuary: Clarence Sample date: 04/02/20  
 Easting: 525874.2 Sampled by: AJH GL  
 Northing: 6748327.1  
 Ground elevation (m AHD): 0.41  
 Hydraulic conductivity (m/d): 0.02

Surface water EC ( $\mu\text{S/cm}$ ): 11,660  
 Surface water pH: 5.53  
 Groundwater EC ( $\mu\text{S/cm}$ ): Not measured  
 Groundwater pH: Not measured

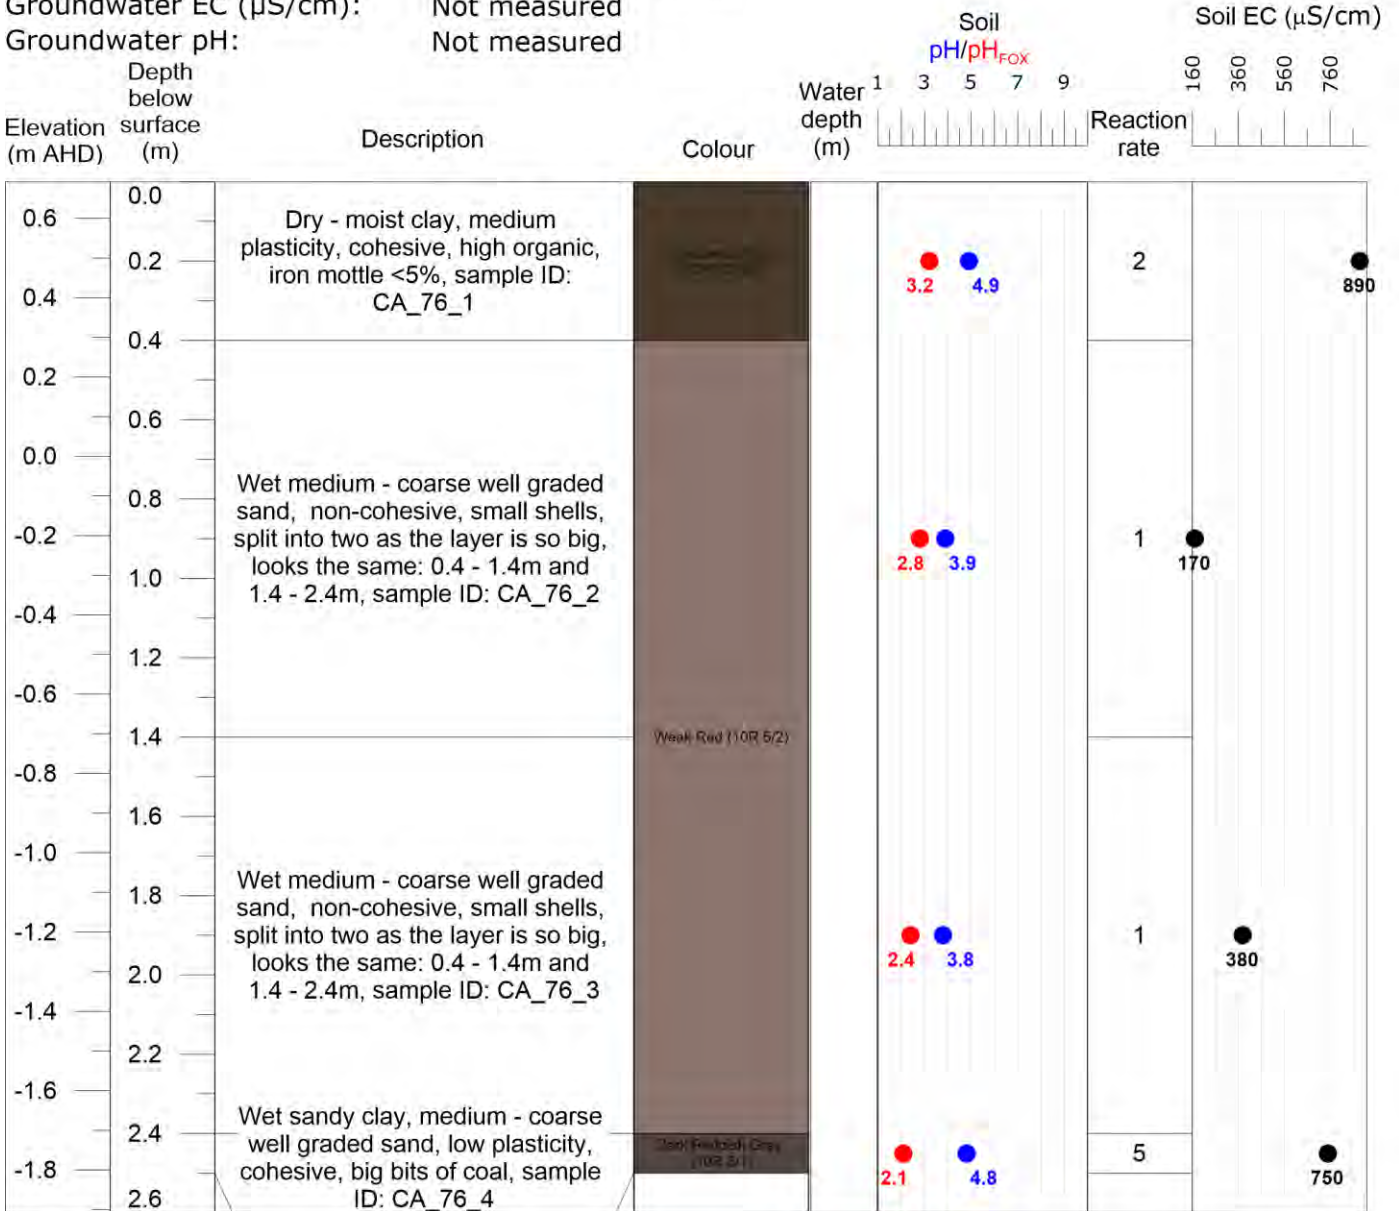
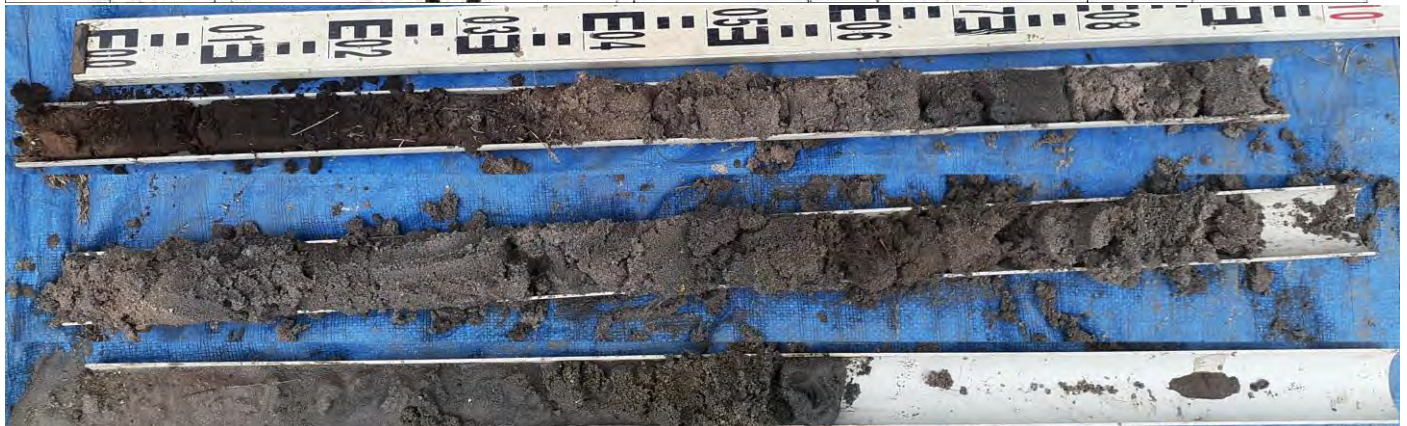
Project Number: 2018064 Profile ID: CA\_76  
 River/estuary: Clarence Sample date: 05/02/20  
 Easting: 509382.8 Sampled by: AJH GL  
 Northing: 6744863.1  
 Ground elevation (m AHD): 0.69  
 Hydraulic conductivity (m/d): 2.4

Surface water EC ( $\mu\text{S/cm}$ ): 760 (creek), 8,700 (lake)  
 Surface water pH: 5.7 (creek), 6.3 (lake)  
 Groundwater EC ( $\mu\text{S/cm}$ ): Not measured  
 Groundwater pH: Not measured

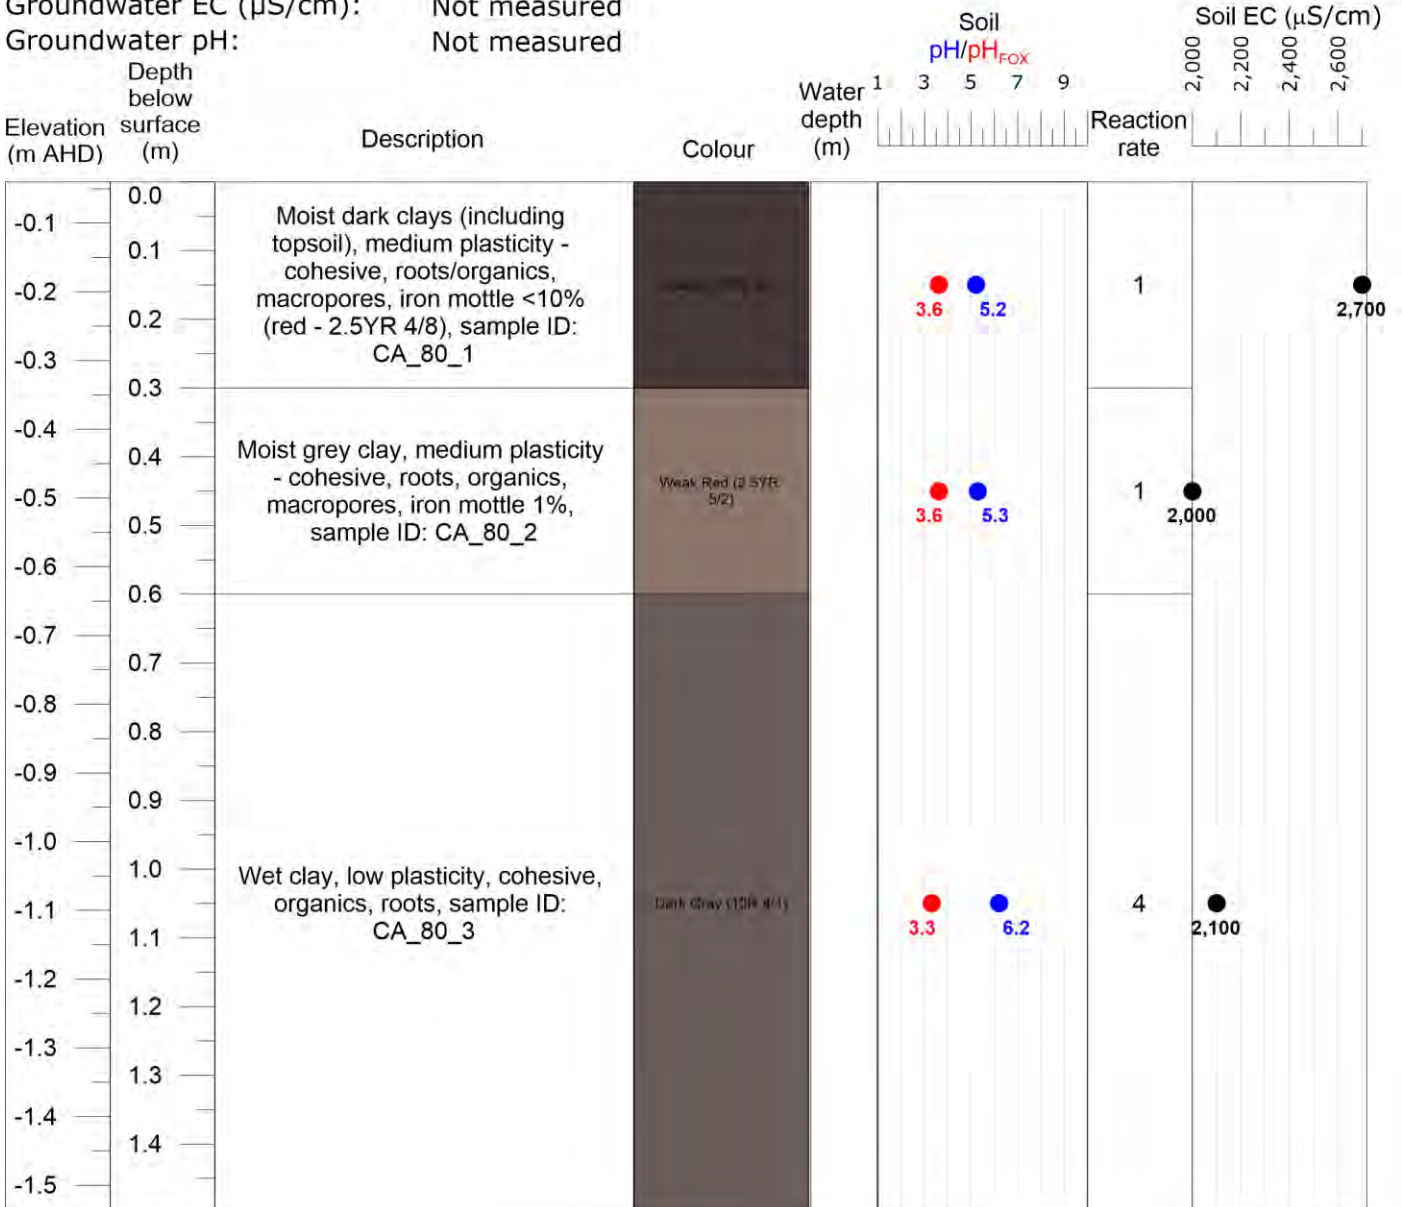
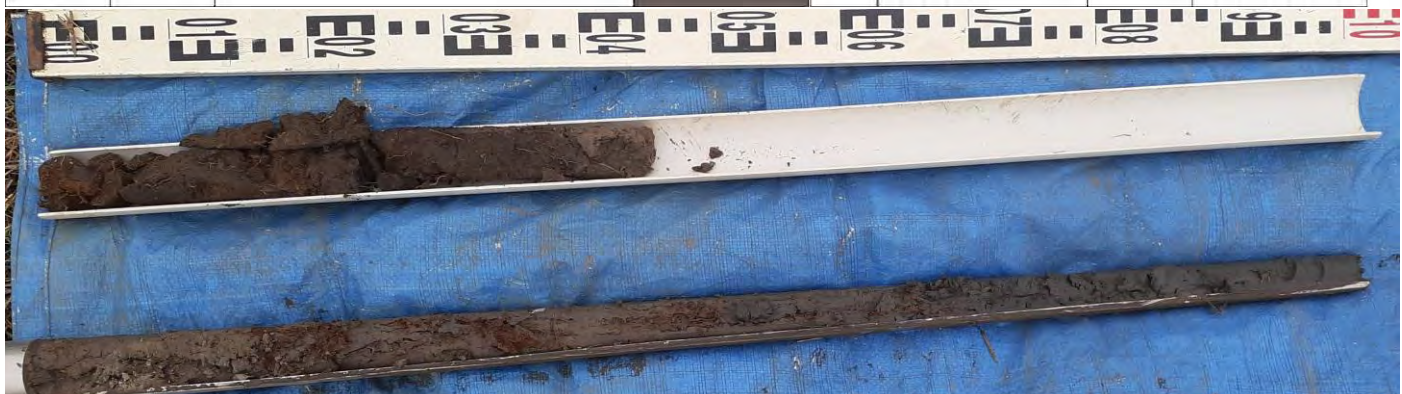
Project Number: 2018064 Profile ID: CA\_80  
 River/estuary: Clarence Sample date: 28/11/19  
 Easting: 520890.3 Sampled by: AJH GL  
 Northing: 6742837.6  
 Ground elevation (m AHD): -0.04  
 Hydraulic conductivity (m/d): 0.13

Surface water EC ( $\mu\text{S/cm}$ ): 52,630  
 Surface water pH: 6.91  
 Groundwater EC ( $\mu\text{S/cm}$ ): Not measured  
 Groundwater pH: Not measured

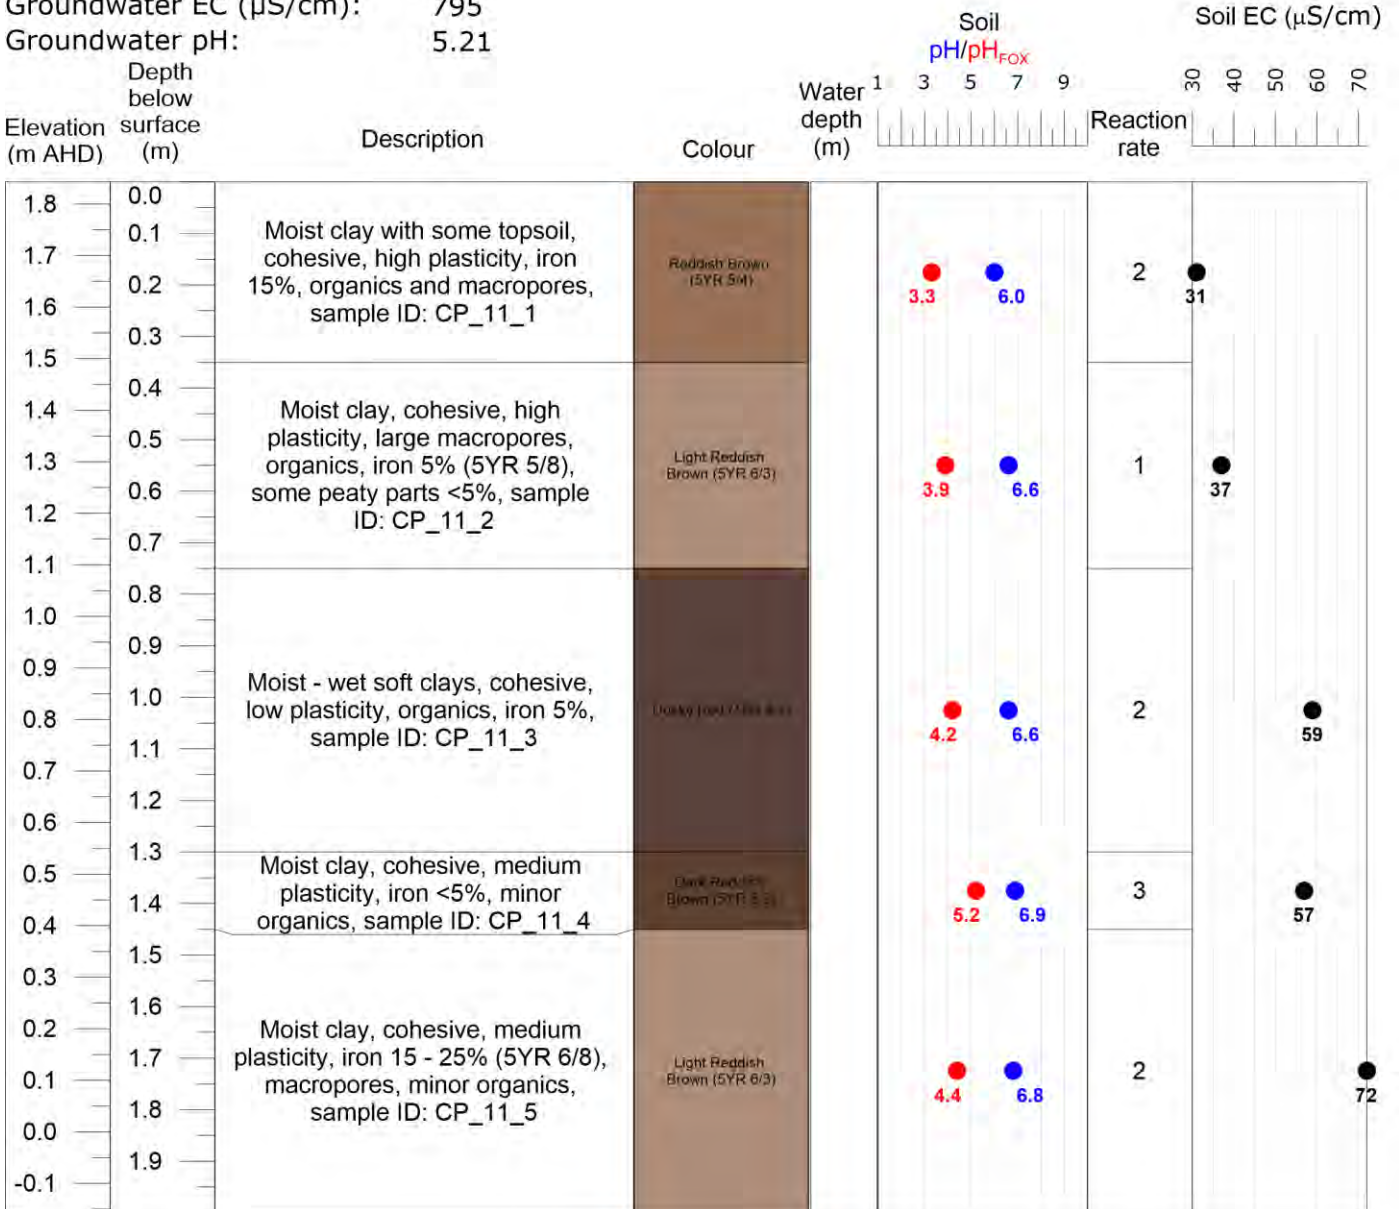
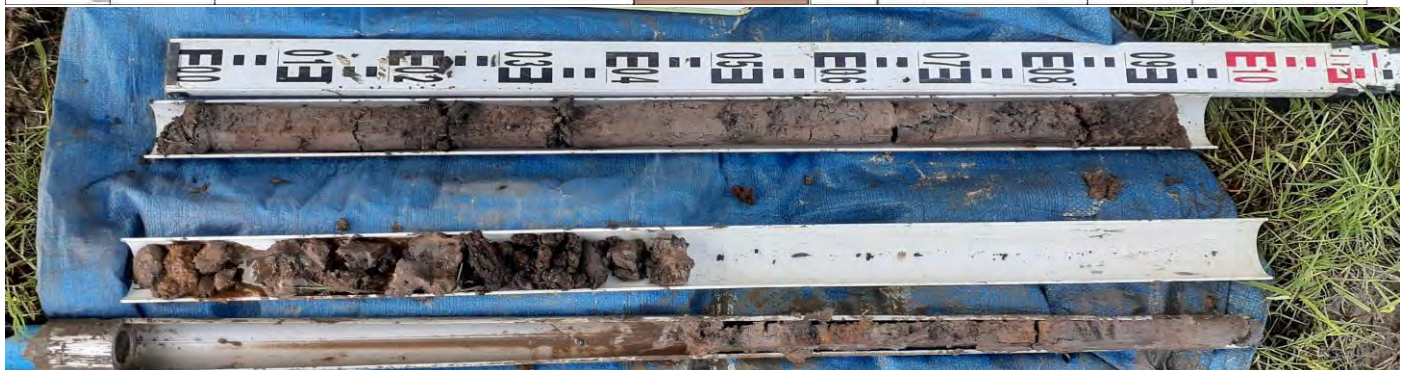
Project Number: 2018064 Profile ID: CP\_11  
 River/estuary: Clarence Sample date: 03/03/20  
 Easting: 492122.4 Sampled by: AJH KW  
 Northing: 6713745.0  
 Ground elevation (m AHD): 1.84  
 Hydraulic conductivity (m/d): 0.11

Surface water EC ( $\mu\text{S/cm}$ ): 227  
 Surface water pH: 7.21  
 Groundwater EC ( $\mu\text{S/cm}$ ): 795  
 Groundwater pH: 5.21

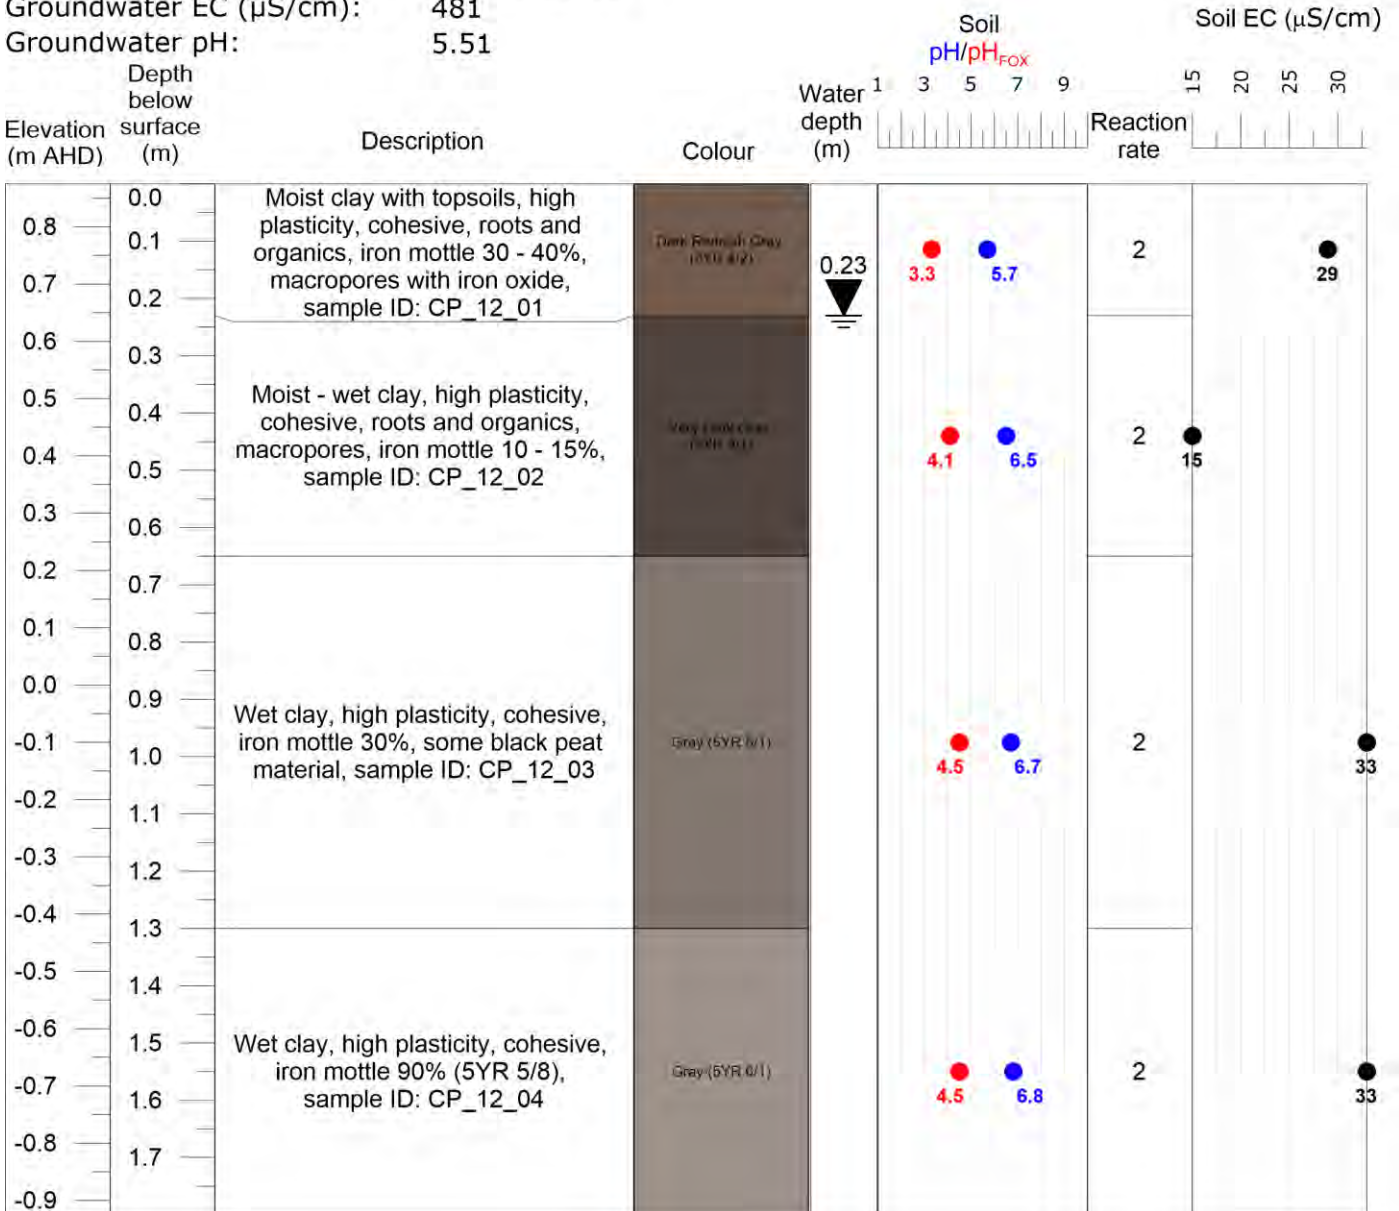
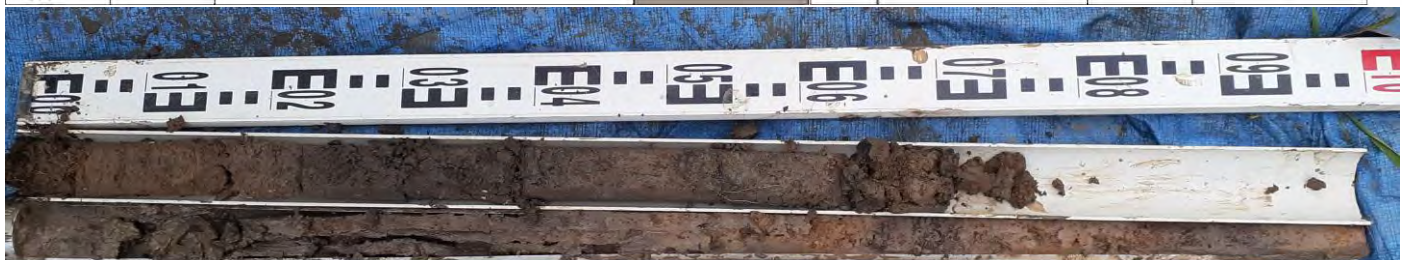
Project Number: 2018064 Profile ID: CP\_12  
 River/estuary: Clarence Sample date: 27/02/20  
 Easting: 489259.4 Sampled by: AJH DWJ  
 Northing: 6718301.0  
 Ground elevation (m AHD): 0.88  
 Hydraulic conductivity (m/d): 1.9

Surface water EC ( $\mu\text{S/cm}$ ): Not measured  
 Surface water pH: Not measured  
 Groundwater EC ( $\mu\text{S/cm}$ ): 481  
 Groundwater pH: 5.51

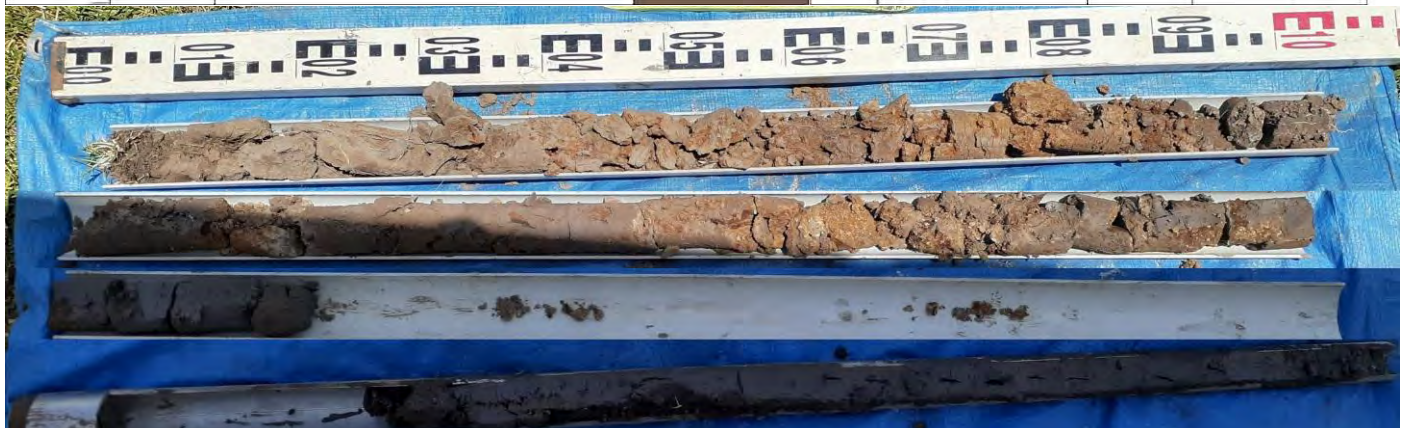
Project Number: 2018064 Profile ID: CP\_16  
 River/estuary: Clarence Sample date: 02/12/19  
 Easting: 501776.4 Sampled by: AJH GL  
 Northing: 6719716.4  
 Ground elevation (m AHD): 0.49  
 Hydraulic conductivity (m/d): 0.55

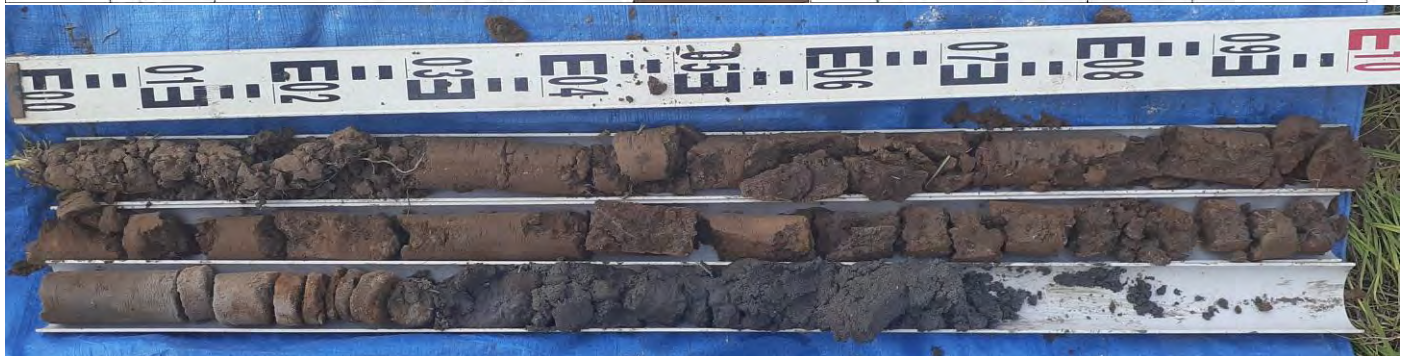
Project Number: 2018064 Profile ID: CP\_17  
 River/estuary: Clarence Sample date: 04/12/19  
 Easting: 501596.9 Sampled by: AJH GL  
 Northing: 6722914.1  
 Ground elevation (m AHD): 2.40  
 Hydraulic conductivity (m/d): 1.5

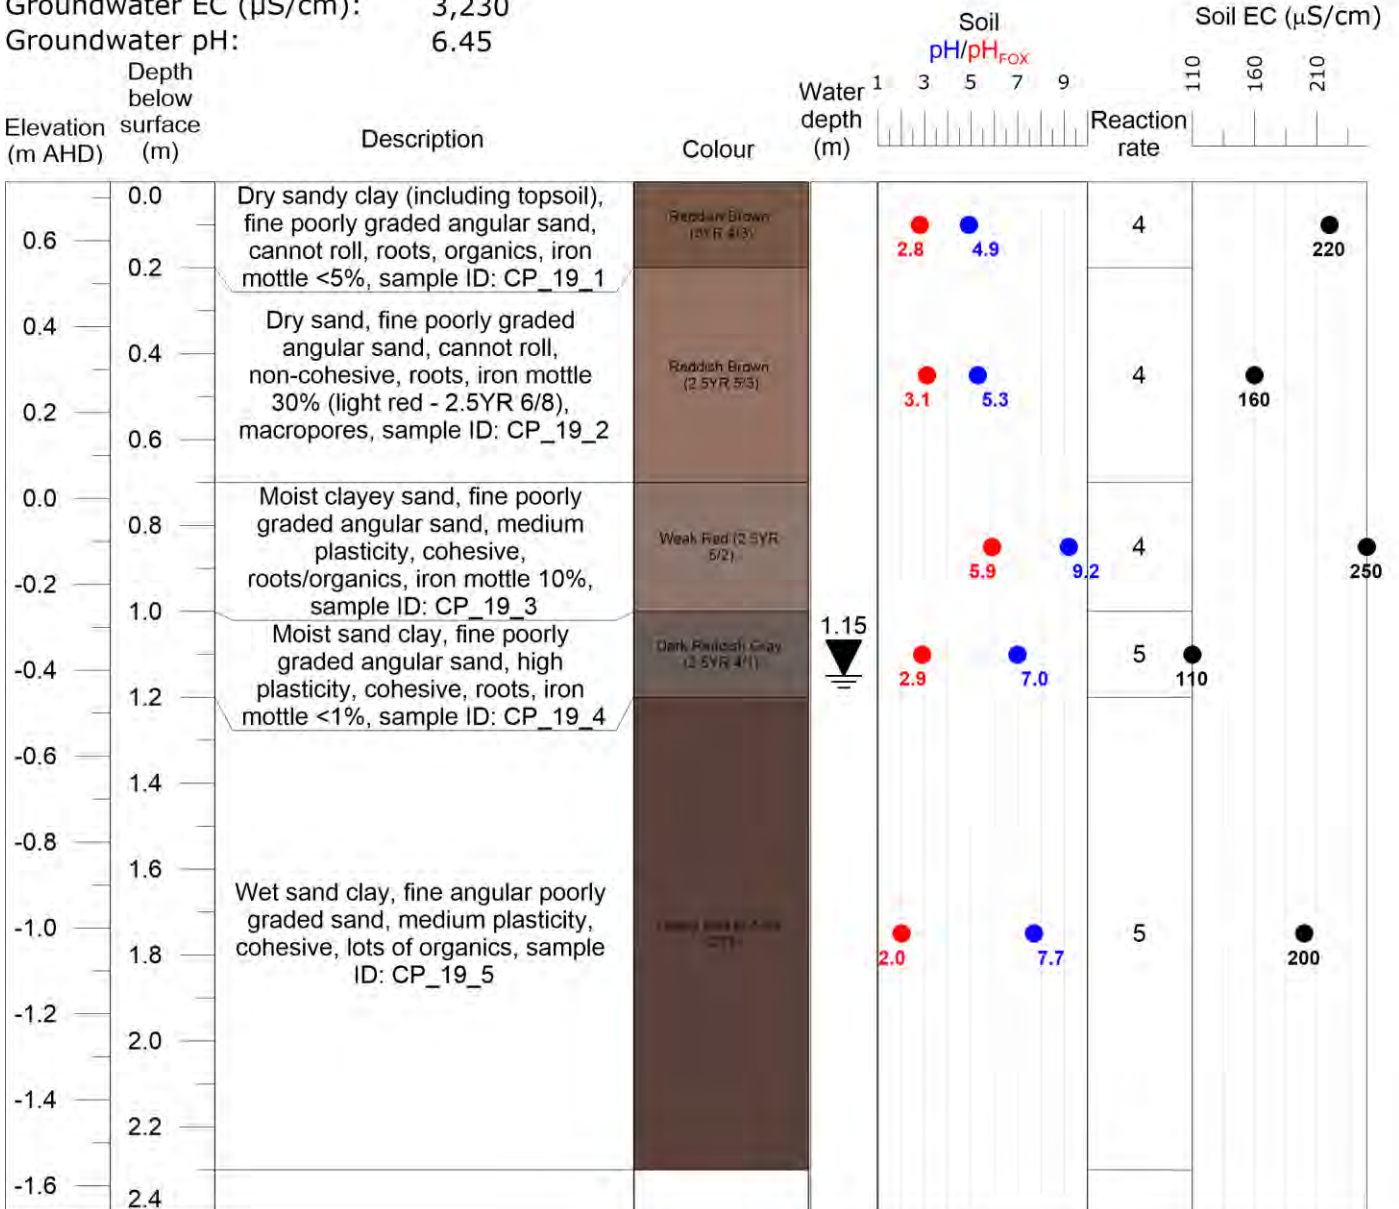
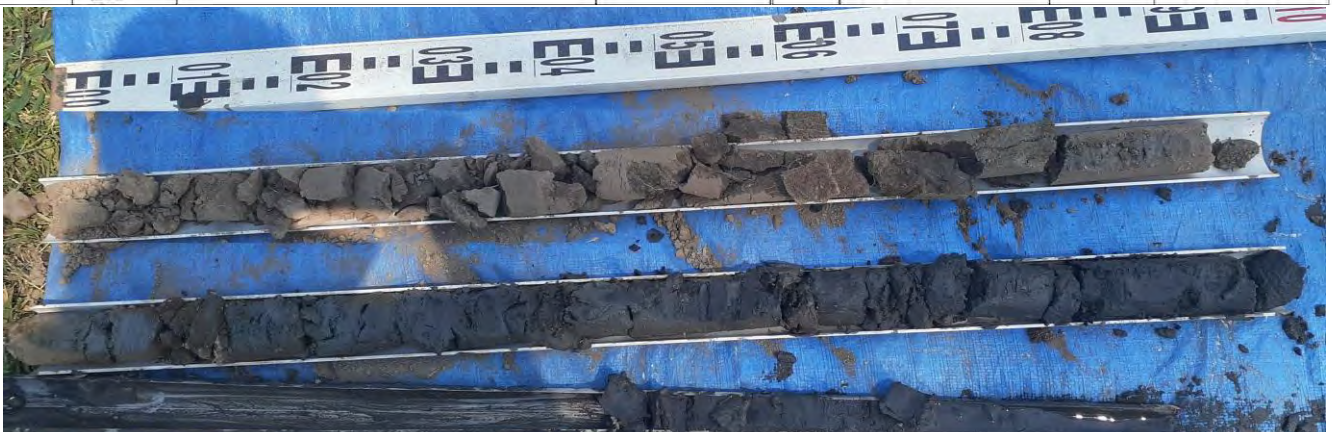
Project Number: 2018064 Profile ID: CP\_19  
 River/estuary: Clarence Sample date: 04/12/19  
 Easting: 501761.8 Sampled by: AJH GL  
 Northing: 6723802.0  
 Ground elevation (m AHD): 0.74  
 Hydraulic conductivity (m/d): 0.25

Surface water EC ( $\mu\text{S/cm}$ ): 28,904  
 Surface water pH: 7.85  
 Groundwater EC ( $\mu\text{S/cm}$ ): 3,230  
 Groundwater pH: 6.45

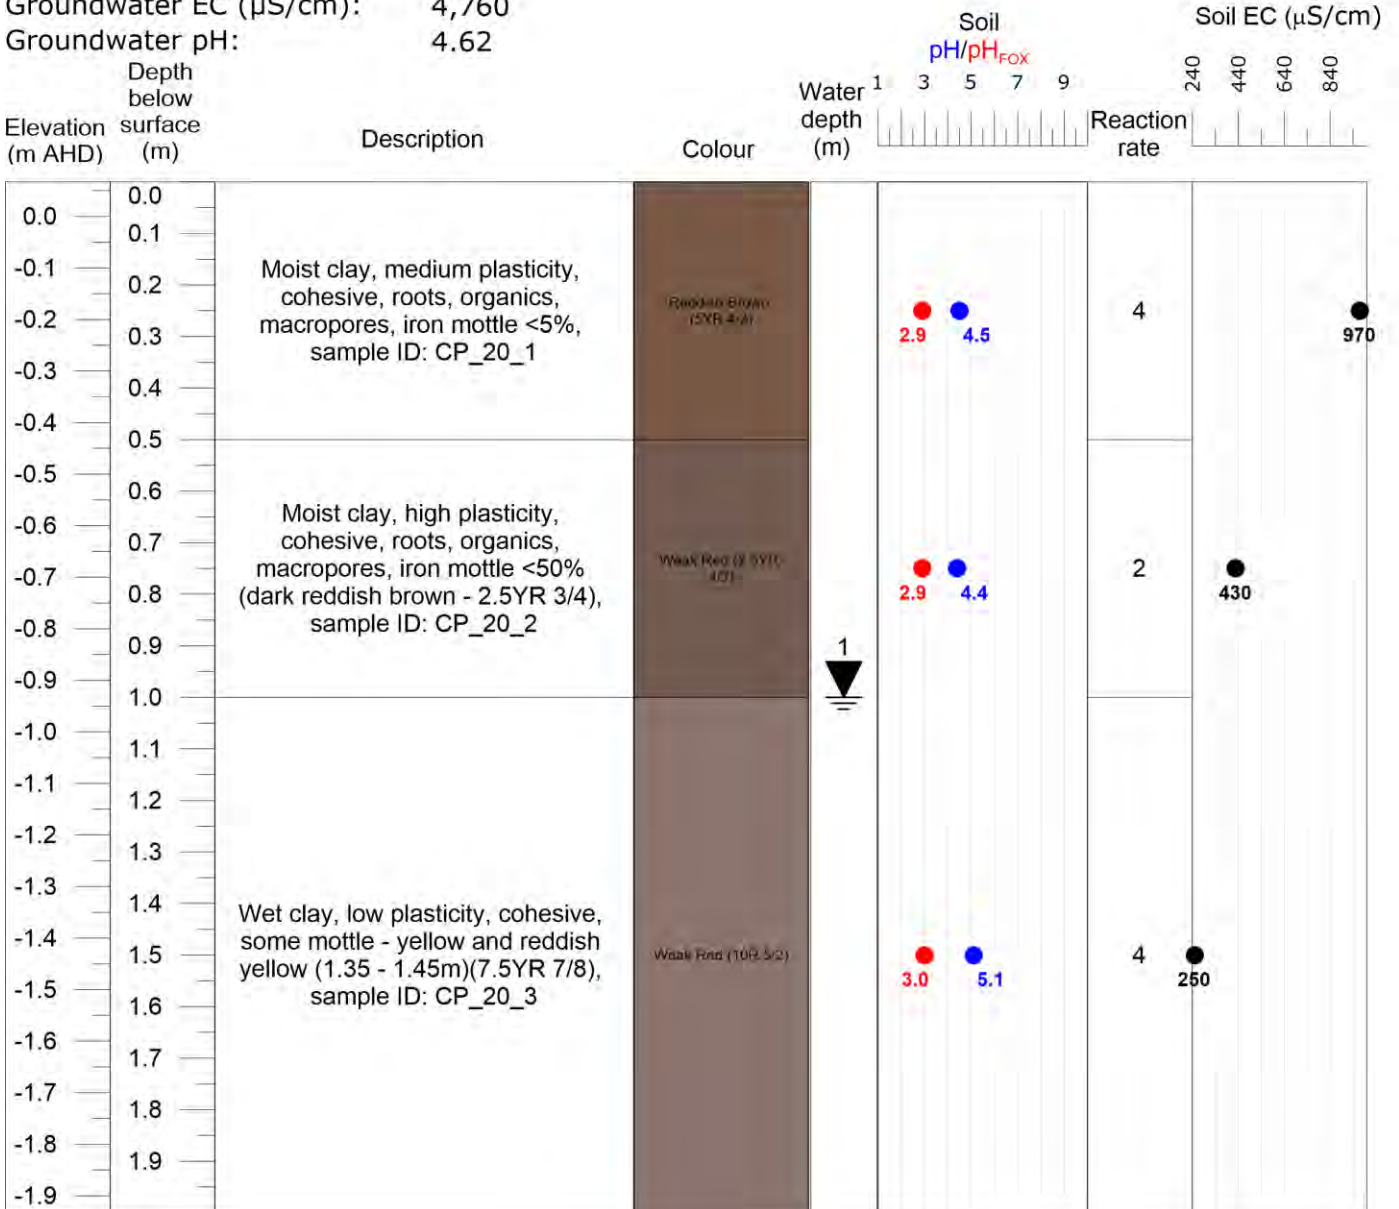
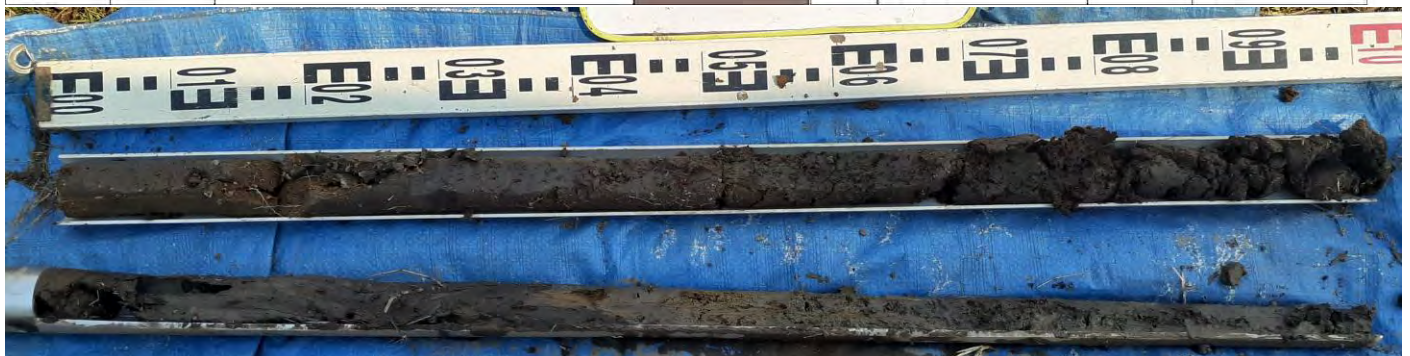
Project Number: 2018064 Profile ID: CP\_20  
 River/estuary: Clarence Sample date: 04/12/19  
 Easting: 497099.5 Sampled by: AJH GL  
 Northing: 6721006.3  
 Ground elevation (m AHD): 0.07  
 Hydraulic conductivity (m/d): 1.1

Surface water EC ( $\mu\text{S}/\text{cm}$ ): 30,000  
 Surface water pH: 7.19  
 Groundwater EC ( $\mu\text{S}/\text{cm}$ ): 4,760  
 Groundwater pH: 4.62

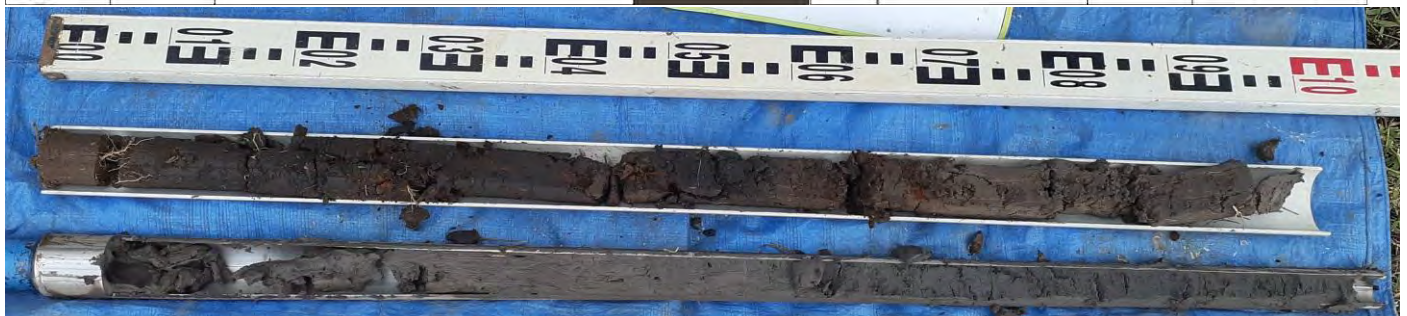
Project Number: 2018064 Profile ID: CP\_25  
 River/estuary: Clarence Sample date: 28/11/19  
 Easting: 509376.4 Sampled by: AJH GL  
 Northing: 6721704.8  
 Ground elevation (m AHD): 0.07  
 Hydraulic conductivity (m/d): 1.4

Surface water EC (µS/cm): 27,400  
 Surface water pH: 7.9  
 Groundwater EC (µS/cm): 15,200  
 Groundwater pH: 5.43

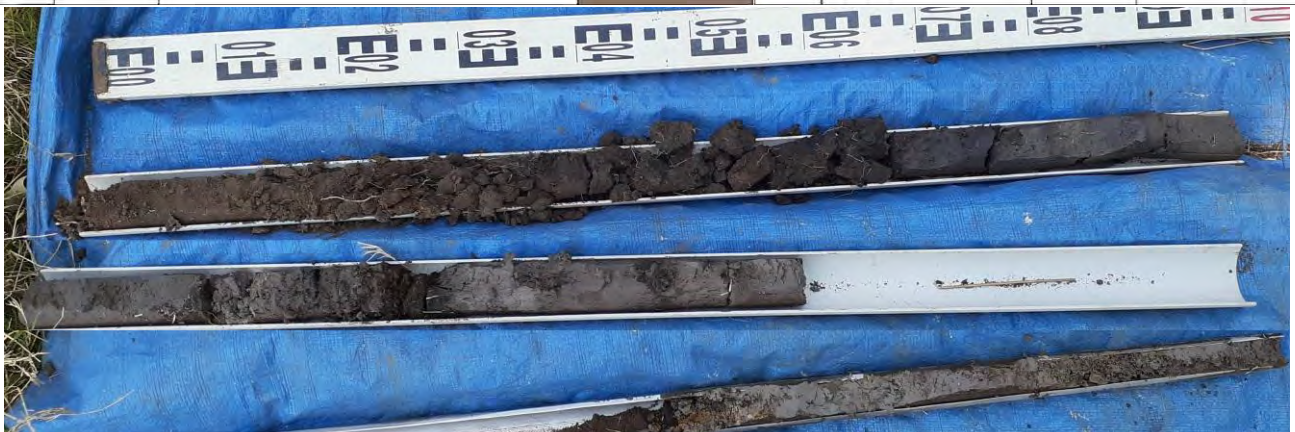
Project Number: 2018064 Profile ID: CP\_28  
 River/estuary: Clarence Sample date: 28/11/19  
 Easting: 510413.3 Sampled by: AJH GL  
 Northing: 6719595.1  
 Ground elevation (m AHD): 0.70  
 Hydraulic conductivity (m/d): 0.83

Surface water EC ( $\mu\text{S/cm}$ ): 24,450  
 Surface water pH: 8.5  
 Groundwater EC ( $\mu\text{S/cm}$ ): Not measured  
 Groundwater pH: Not measured

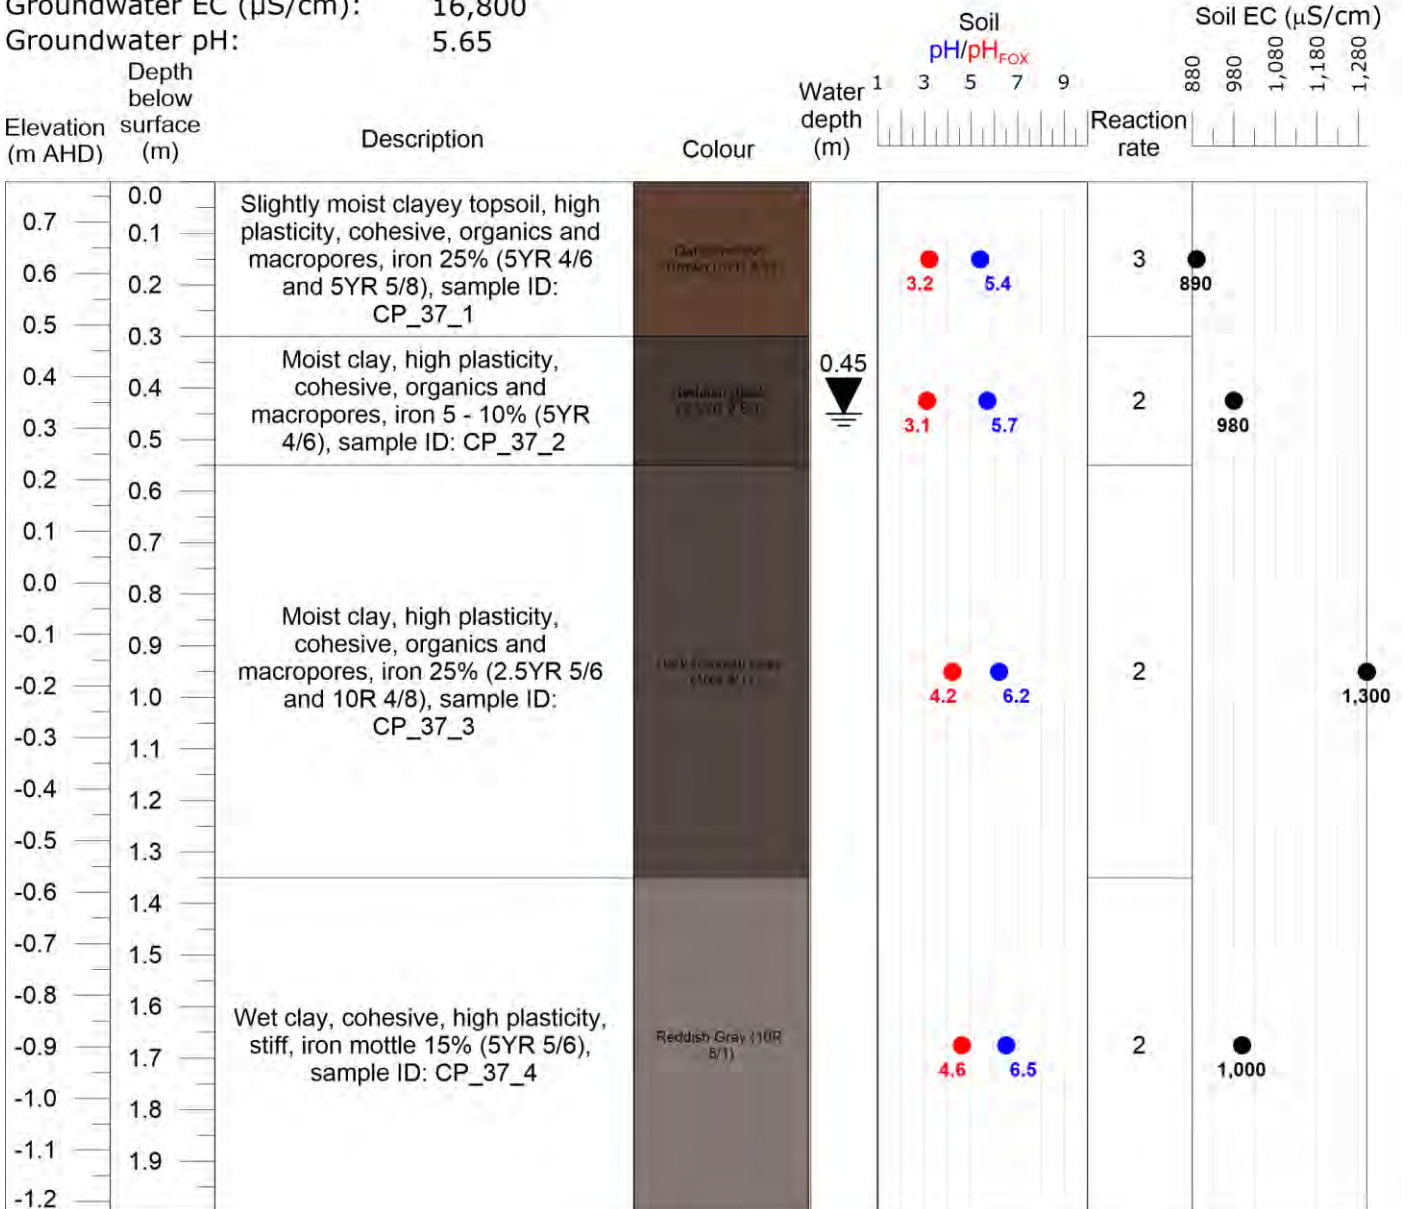
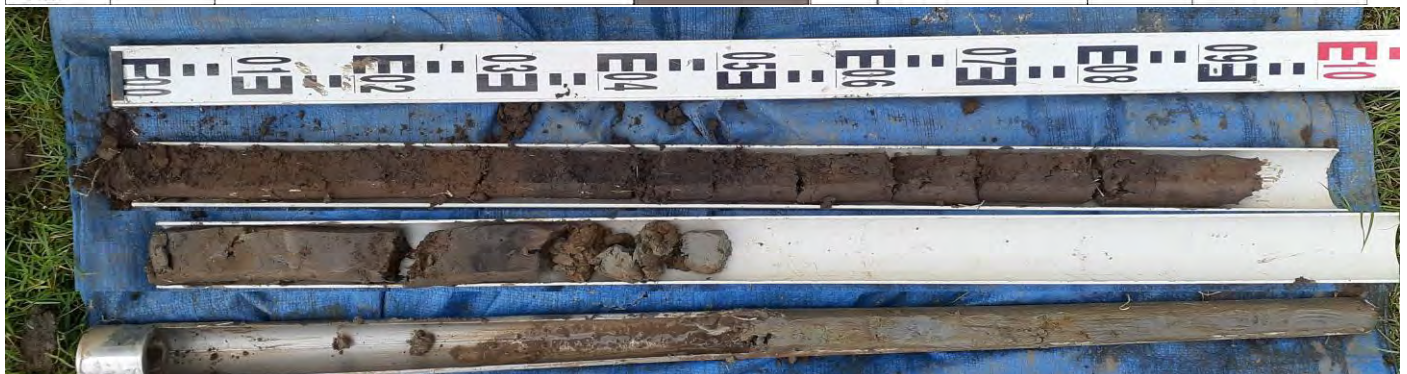
Project Number: 2018064 Profile ID: CP\_37  
 River/estuary: Clarence Sample date: 03/03/20  
 Easting: 511395.1 Sampled by: AJH KW  
 Northing: 6736943.2  
 Ground elevation (m AHD): 0.78  
 Hydraulic conductivity (m/d): 3.4

Surface water EC ( $\mu\text{S/cm}$ ): 4,700  
 Surface water pH: 5.8  
 Groundwater EC ( $\mu\text{S/cm}$ ): 16,800  
 Groundwater pH: 5.65

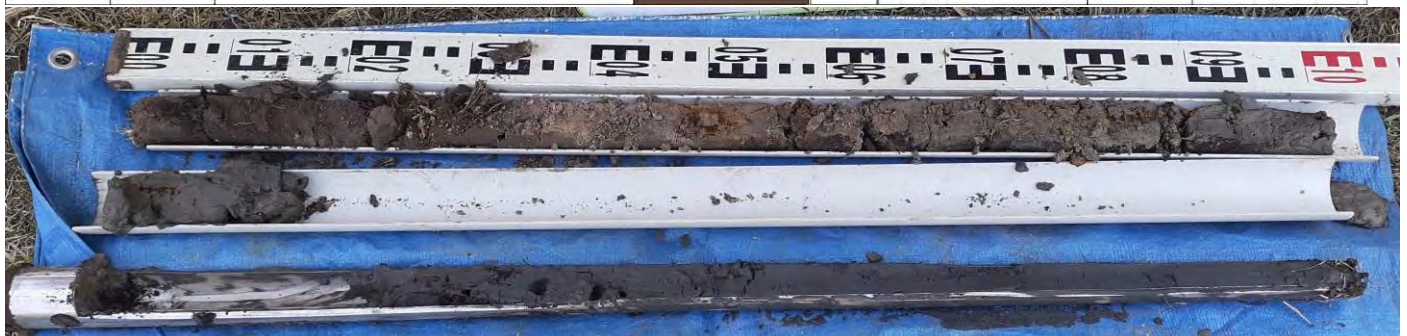
Project Number: 2018064 Profile ID: CP\_39  
 River/estuary: Clarence Sample date: 27/11/19  
 Easting: 517367.1 Sampled by: AJH GL  
 Northing: 6730094.5  
 Ground elevation (m AHD): 0.35  
 Hydraulic conductivity (m/d): 0.11

Surface water EC ( $\mu\text{S/cm}$ ): 2,400  
 Surface water pH: 7.8  
 Groundwater EC ( $\mu\text{S/cm}$ ): 14,700  
 Groundwater pH: 6.1
