# Clarence River Floodplain Prioritisation Study: Appendix A – L

WRL TR 2020/06, May 2023

# Appendix A Floodplain waterways

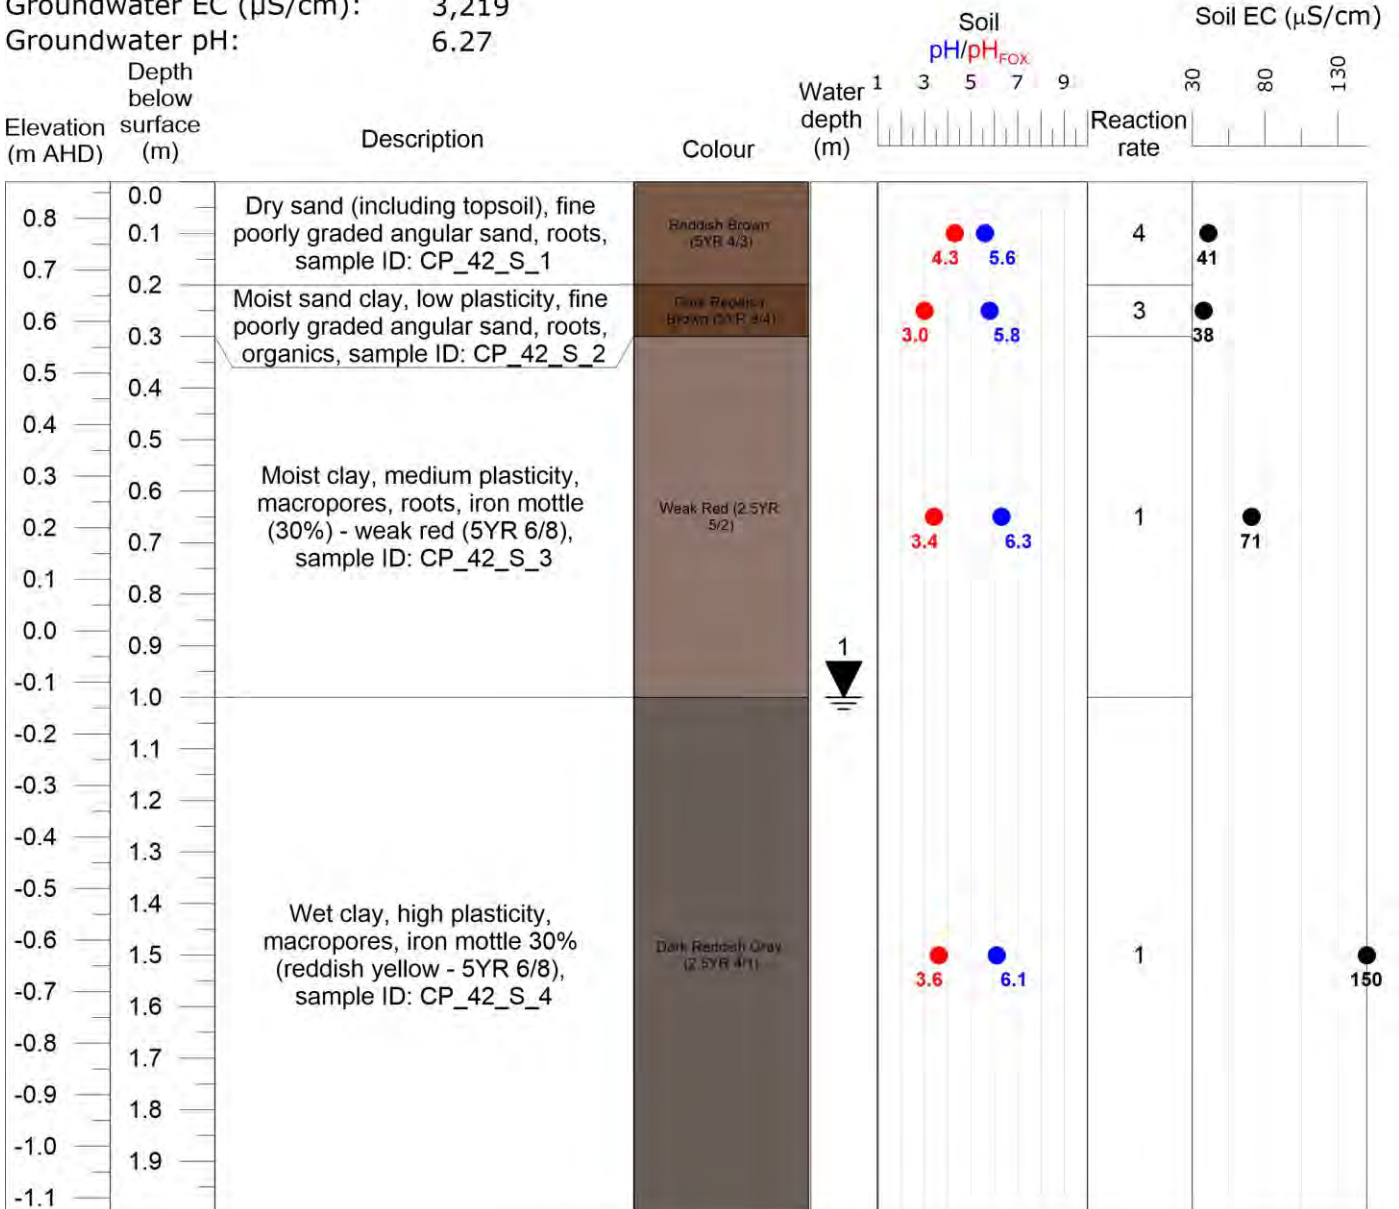
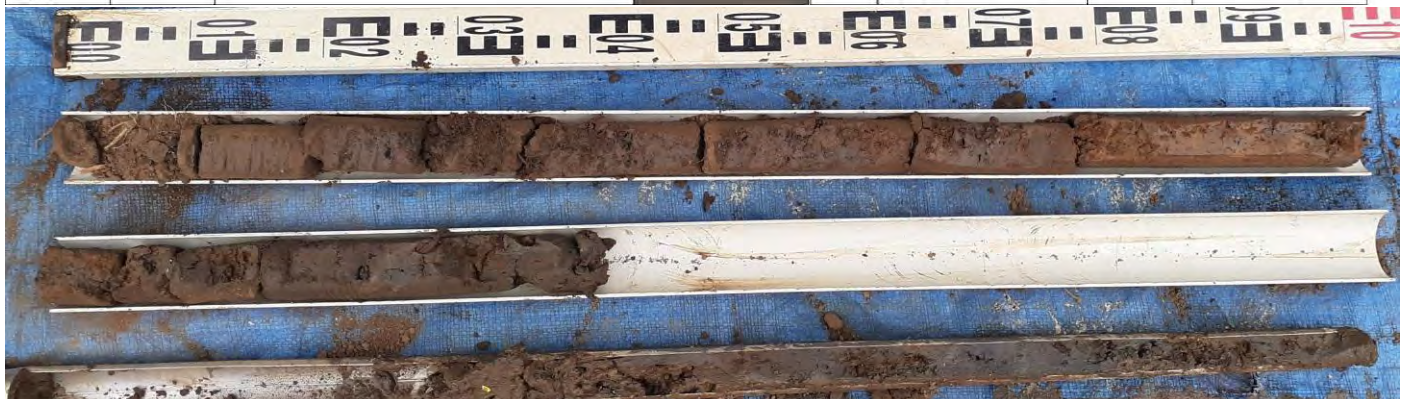
Project Number: 2018064 Profile ID: CP\_42\_S  
 River/estuary: Clarence Sample date: 04/02/20  
 Easting: 519880.7 Sampled by: AJH GL  
 Northing: 6733056.9  
 Ground elevation (m AHD): 0.87  
 Hydraulic conductivity (m/d): 0.43

Surface water EC ( $\mu\text{S/cm}$ ): 635  
 Surface water pH: 6.36  
 Groundwater EC ( $\mu\text{S/cm}$ ): 3,219  
 Groundwater pH: 6.27

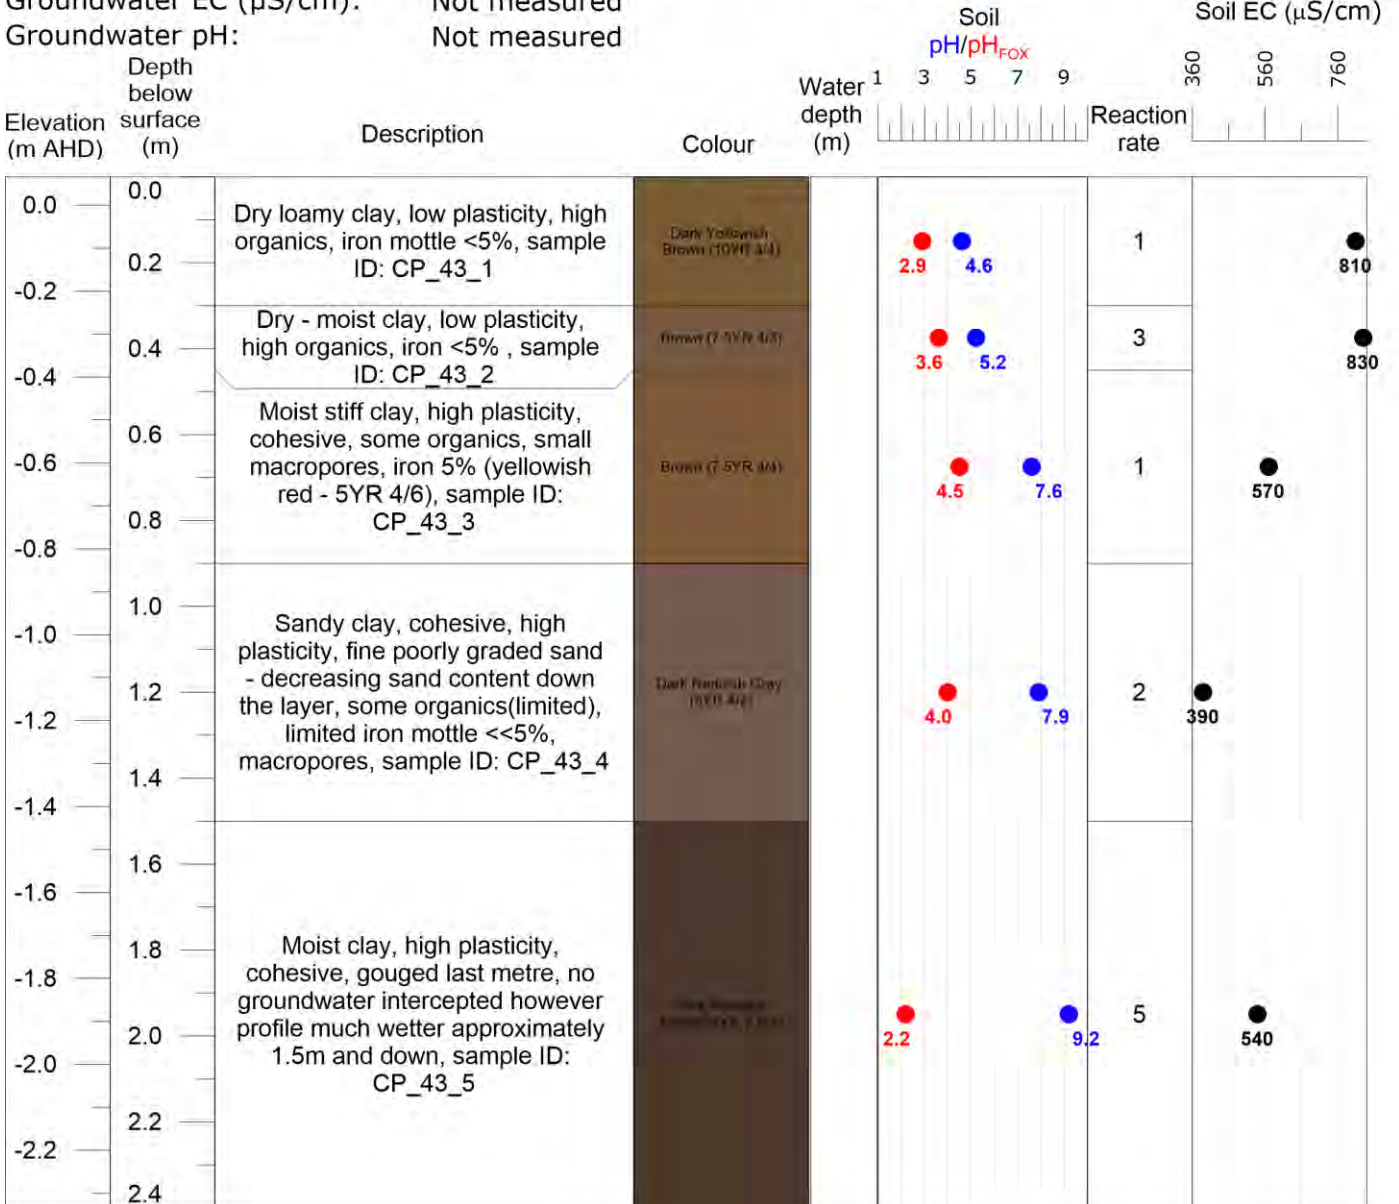
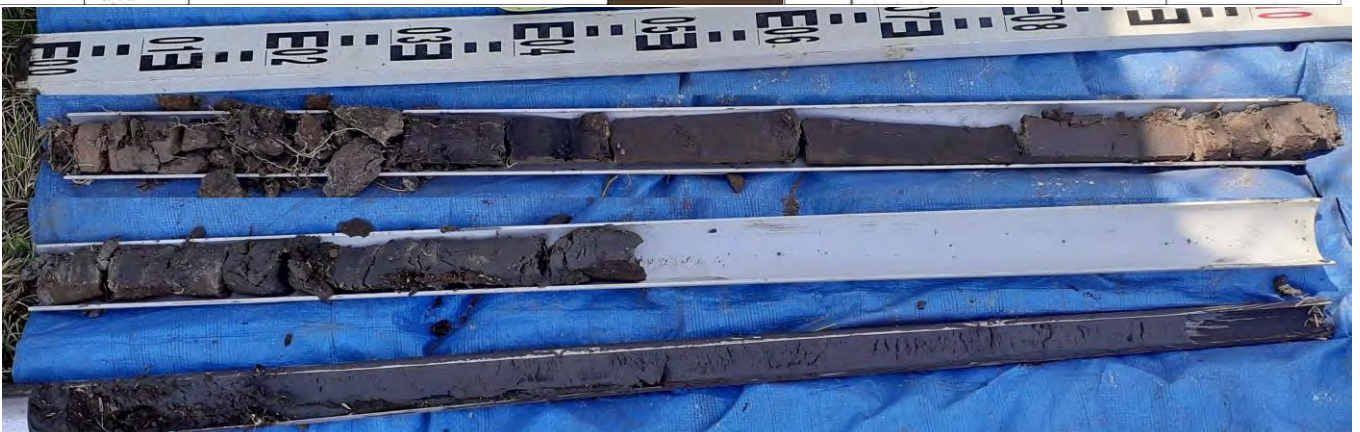
Project Number: 2018064 Profile ID: CP\_43  
 River/estuary: Clarence Sample date: 26/11/19  
 Easting: 517565.2 Sampled by: AJH GL  
 Northing: 6734520.7  
 Ground elevation (m AHD): 0.07  
 Hydraulic conductivity (m/d): Not measured

Surface water EC ( $\mu\text{S/cm}$ ): 12,232 (upstream of floodgate) , 34,132 (downstream of floodgate)  
 Surface water pH: 7.56 (upstream of floodgate), 7.26 (downstream of floodgate)  
 Groundwater EC ( $\mu\text{S/cm}$ ): Not measured  
 Groundwater pH: Not measured

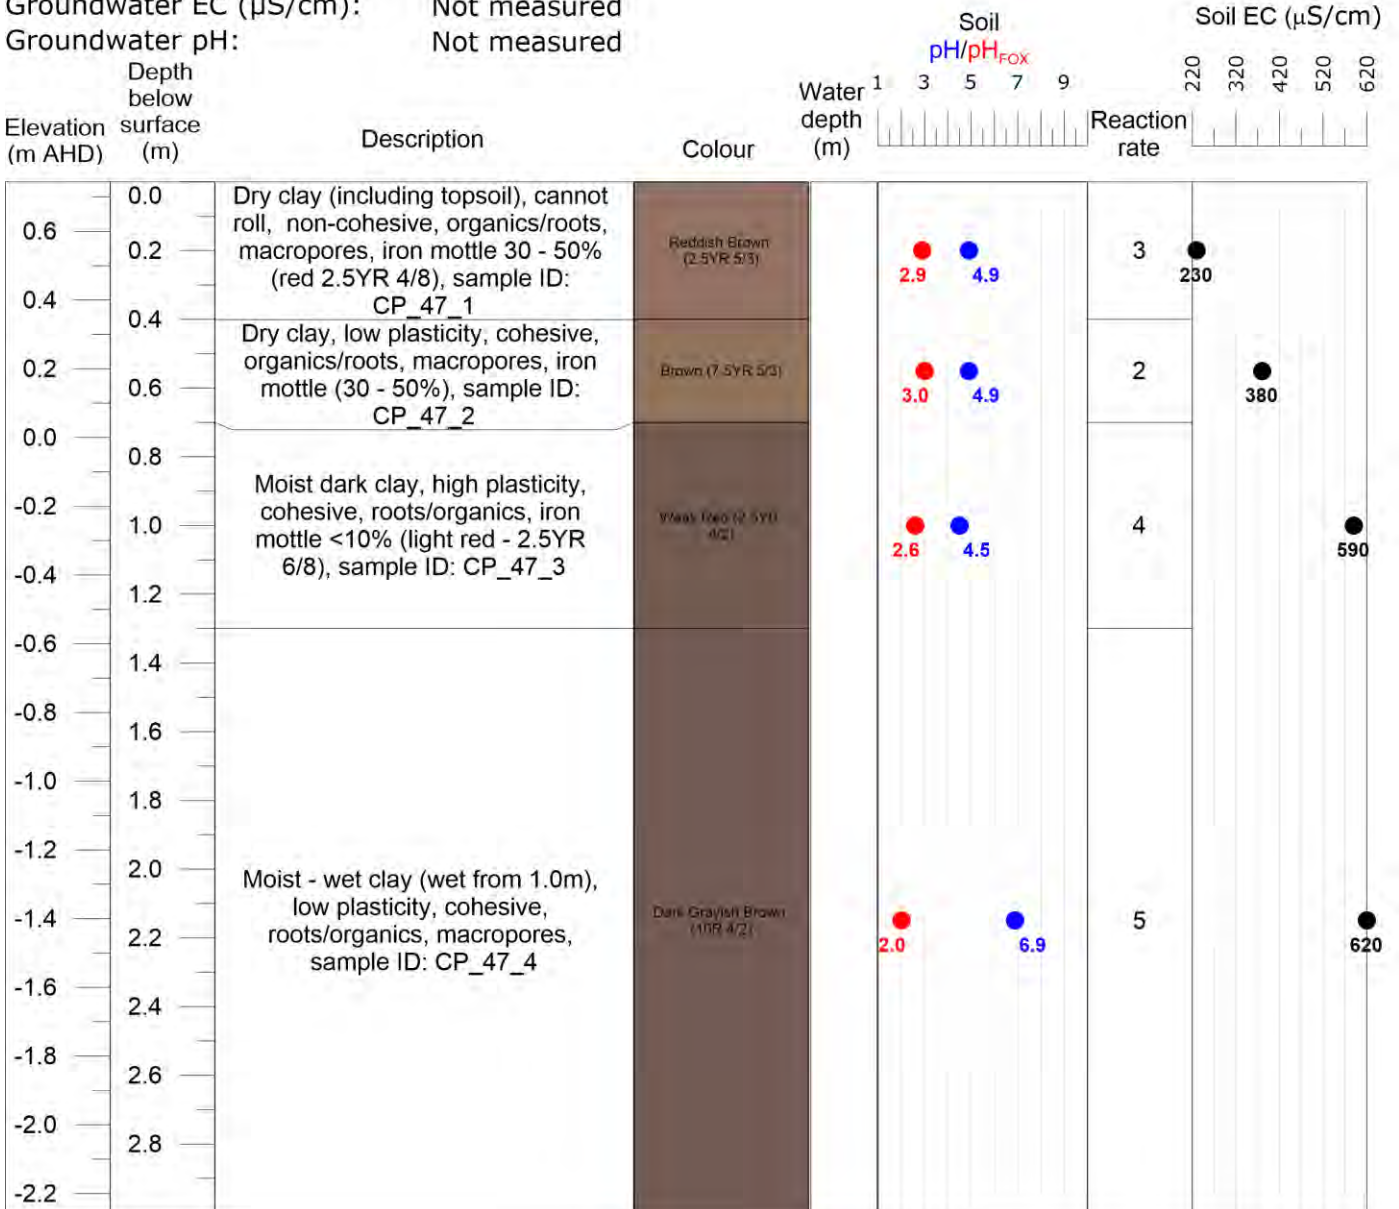
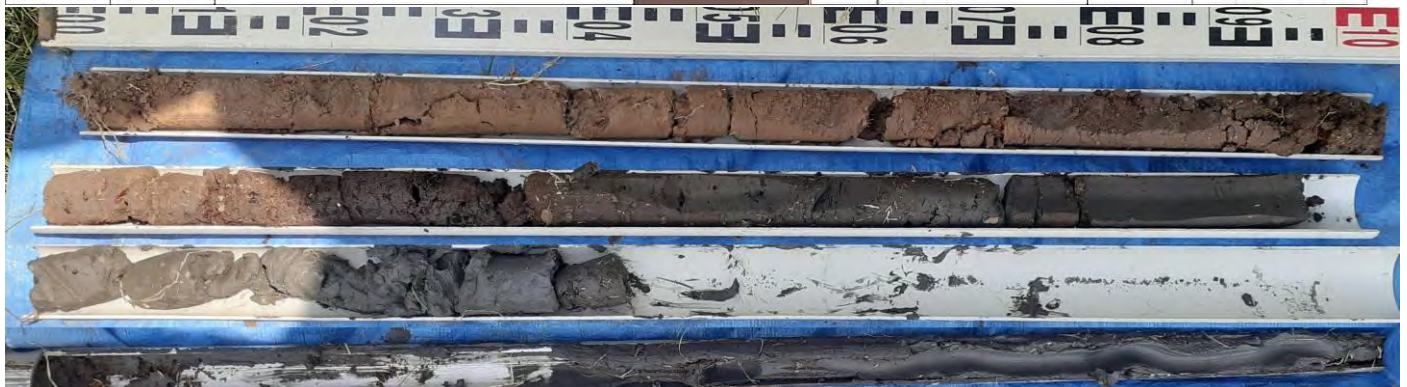
**Water quality:**

Surface water EC ( $\mu\text{S/cm}$ ): Not measured  
 Surface water pH: 6.9  
 Groundwater EC ( $\mu\text{S/cm}$ ): Not measured  
 Groundwater pH: Not measured

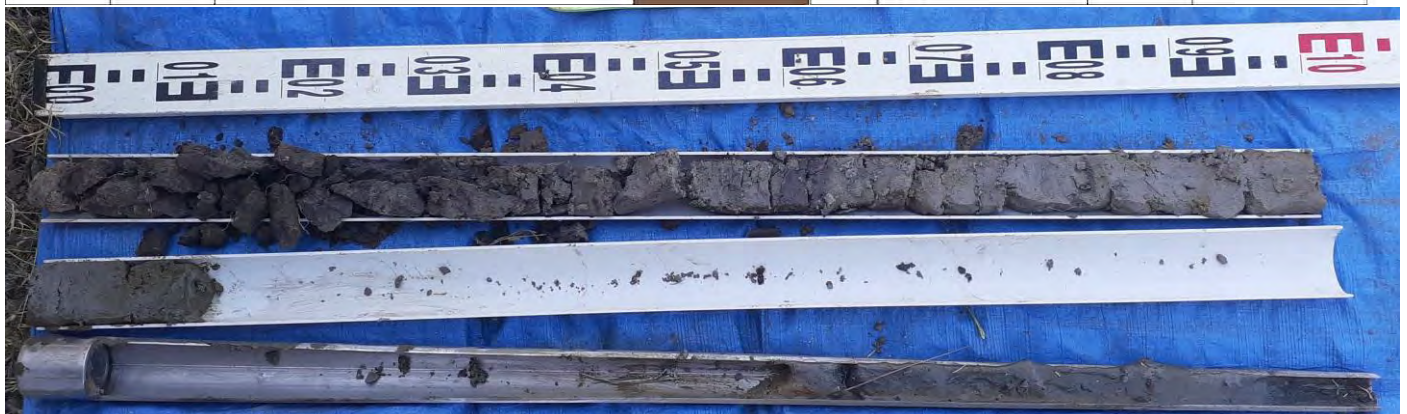
**Soil profile details:**

Project Number: 2018064 Profile ID: CP\_51  
 River/estuary: Clarence Sample date: 26/11/19  
 Easting: 519038.9 Sampled by: AJH GL  
 Northing: 6739813.8  
 Ground elevation (m AHD): 0.03  
 Hydraulic conductivity (m/d): Not measured

**Water quality:**

Surface water EC ( $\mu\text{S/cm}$ ): 64,400  
 Surface water pH: 8.3  
 Groundwater EC ( $\mu\text{S/cm}$ ): Not measured  
 Groundwater pH: Not measured

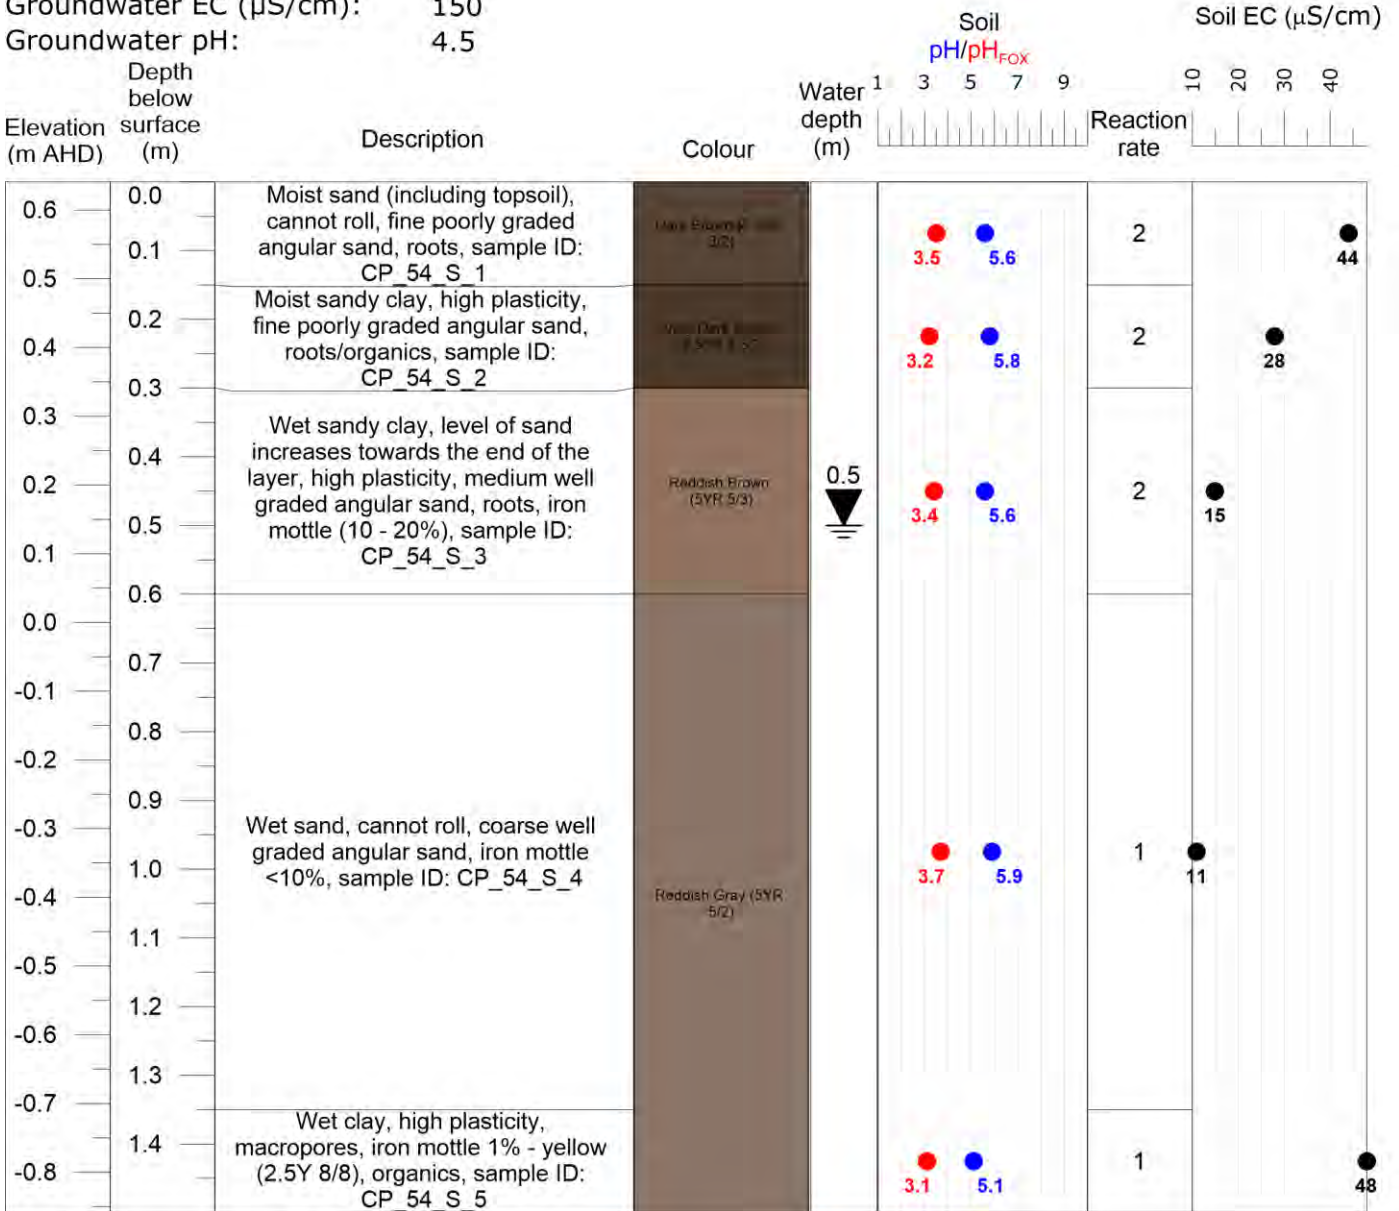
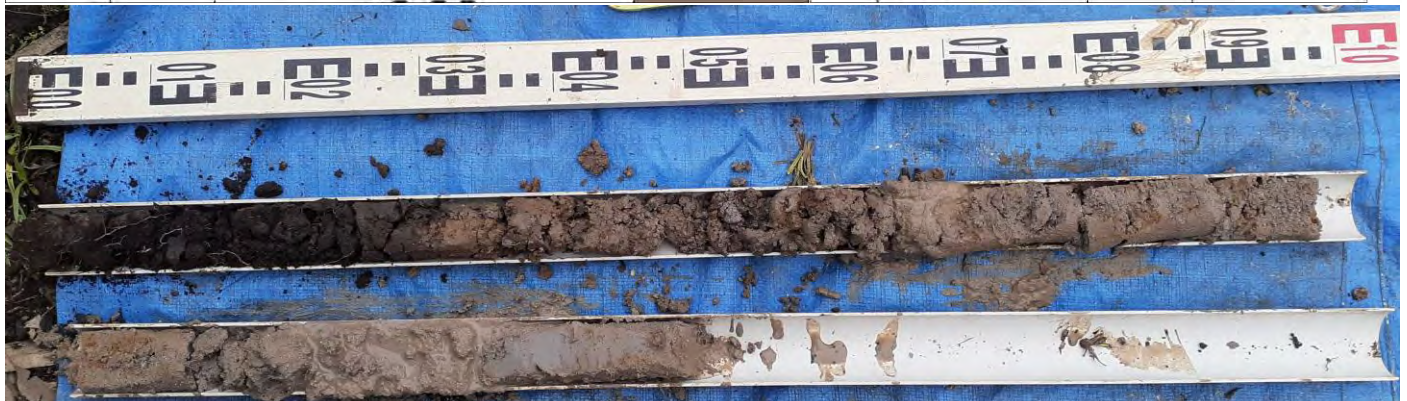
**Soil profile details:**

Project Number: 2018064 Profile ID: CP\_54\_S  
 River/estuary: Clarence Sample date: 04/02/20  
 Easting: 522182.5 Sampled by: AJH GL  
 Northing: 6734543.7  
 Ground elevation (m AHD): 0.64  
 Hydraulic conductivity (m/d): 0.44

**Water quality:**

Surface water EC ( $\mu\text{S/cm}$ ): 776  
 Surface water pH: 3.55  
 Groundwater EC ( $\mu\text{S/cm}$ ): 150  
 Groundwater pH: 4.5

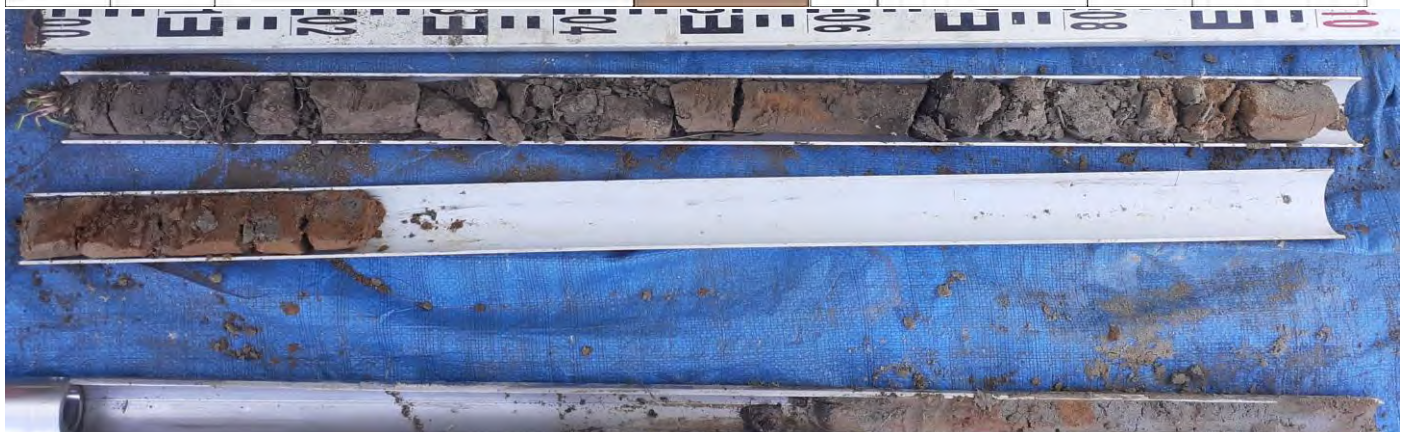
**Soil profile details:**

Project Number: 2018064 Profile ID: CP\_55\_S  
 River/estuary: Clarence Sample date: 04/02/20  
 Easting: 525455 Sampled by: AJH GL  
 Northing: 6740511.7  
 Ground elevation (m AHD): 1.65  
 Hydraulic conductivity (m/d): Not measured

**Water quality:**

Surface water EC ( $\mu\text{S/cm}$ ): 1,336  
 Surface water pH: 6.4  
 Groundwater EC ( $\mu\text{S/cm}$ ): Not measured  
 Groundwater pH: Not measured

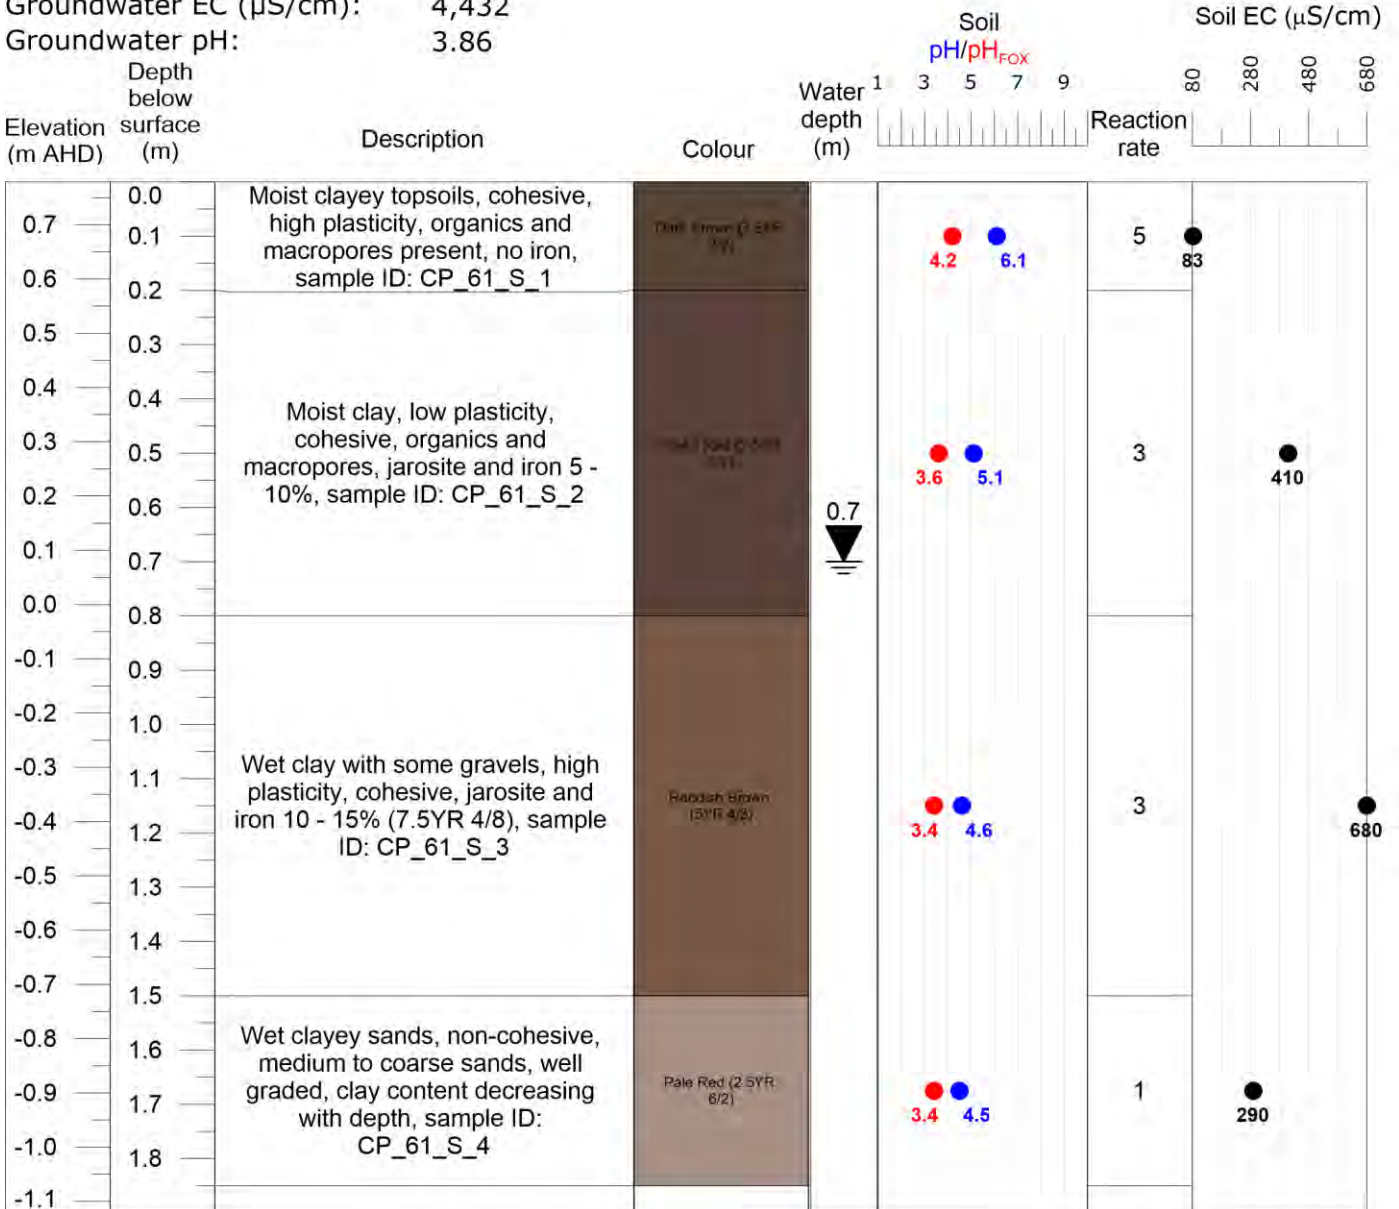
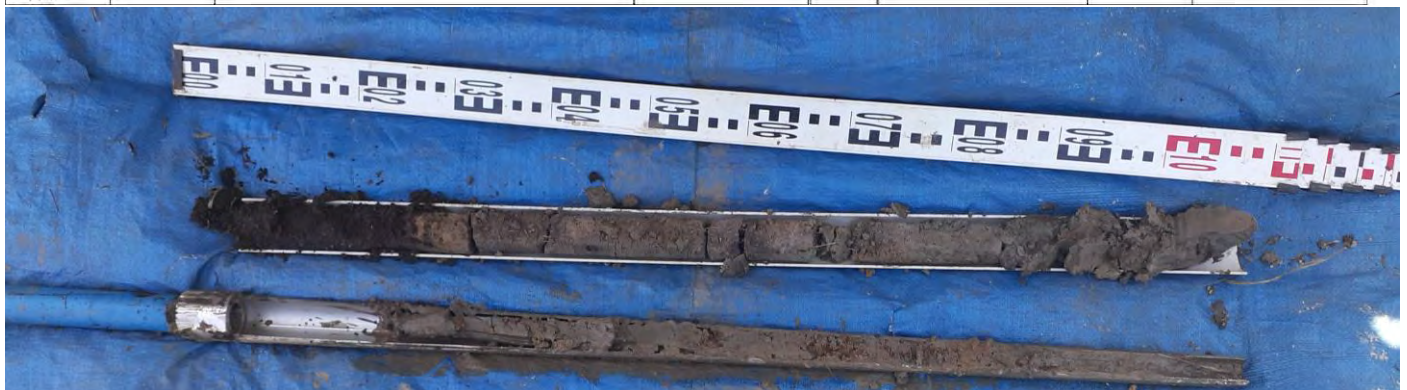
**Soil profile details:**

Project Number: 2018064 Profile ID: CP\_61\_S  
 River/estuary: Clarence Sample date: 02/03/20  
 Easting: 526171.6 Sampled by: AJH KW  
 Northing: 6732672.9  
 Ground elevation (m AHD): 0.78  
 Hydraulic conductivity (m/d): 60

**Water quality:**

Surface water EC ( $\mu\text{S/cm}$ ): 409  
 Surface water pH: 6.76  
 Groundwater EC ( $\mu\text{S/cm}$ ): 4,432  
 Groundwater pH: 3.86

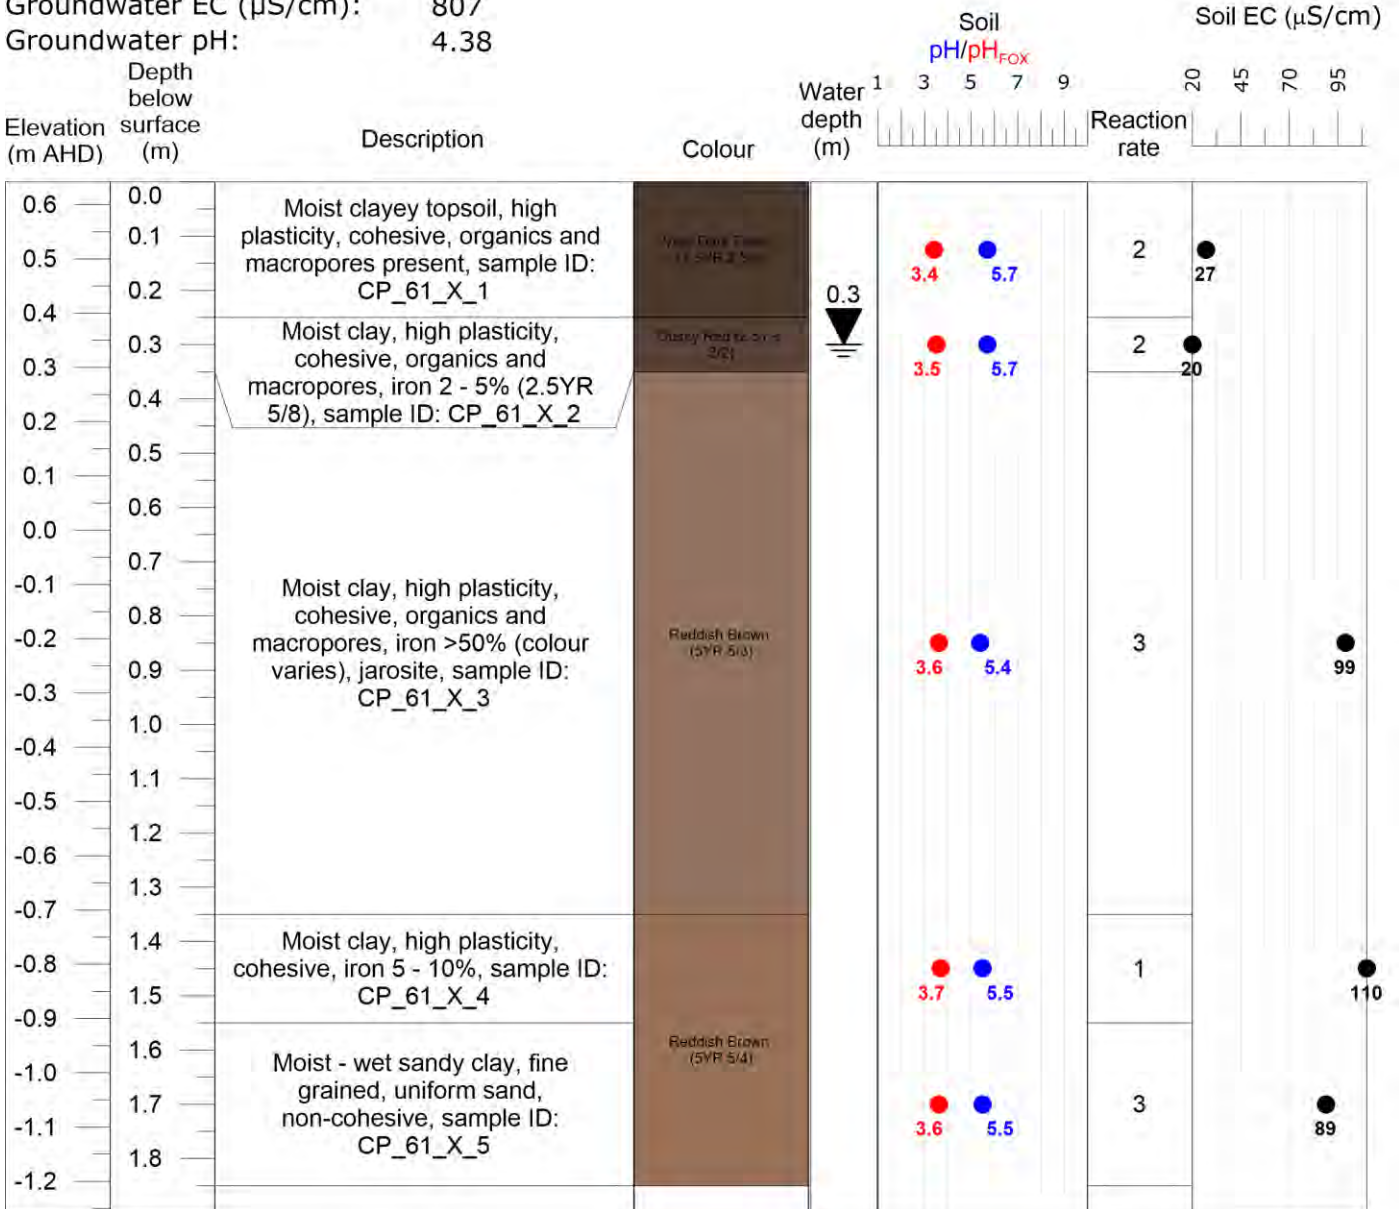
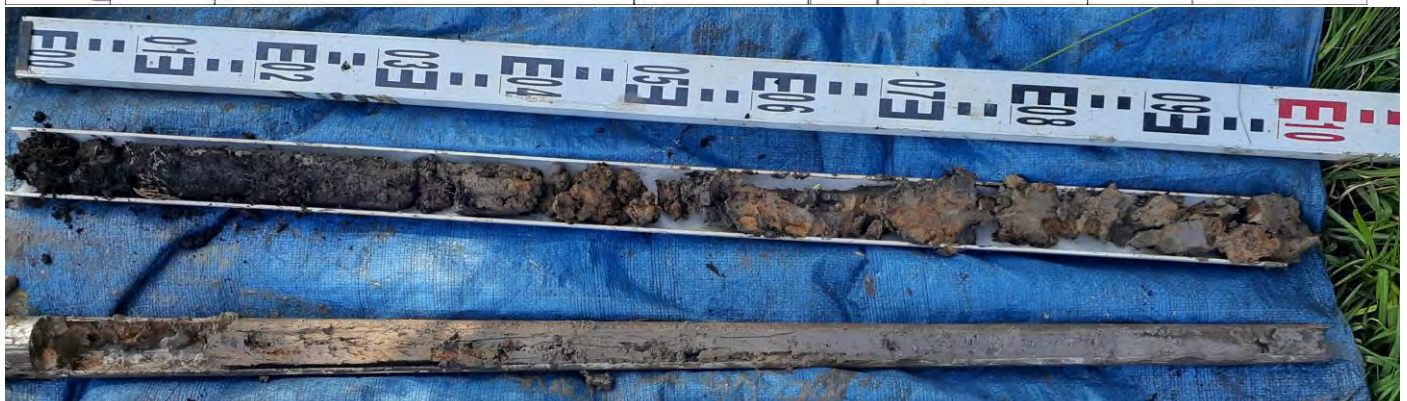
**Soil profile details:**

Project Number: 2018064 Profile ID: CP\_61\_X  
 River/estuary: Clarence Sample date: 02/03/20  
 Easting: 525416.2 Sampled by: AJH KW  
 Northing: 6733044.8  
 Ground elevation (m AHD): 0.64  
 Hydraulic conductivity (m/d): 0.072

**Water quality:**

Surface water EC (µS/cm): 112  
 Surface water pH: 5.38  
 Groundwater EC (µS/cm): 807  
 Groundwater pH: 4.38

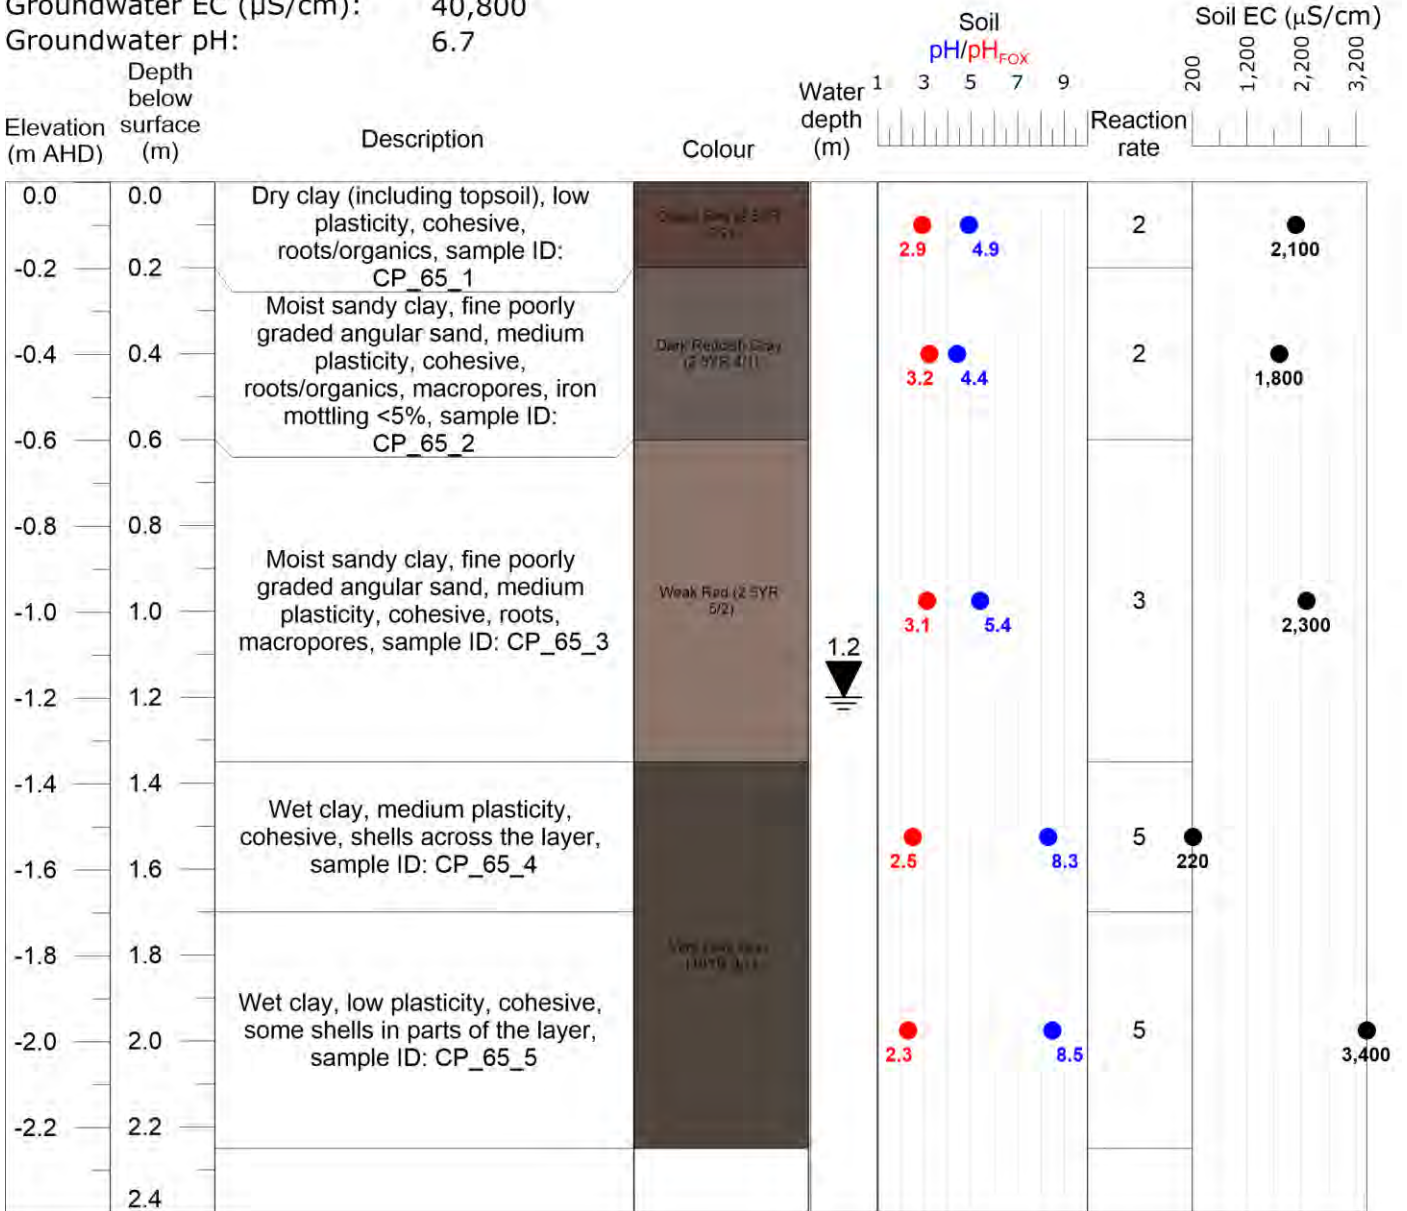
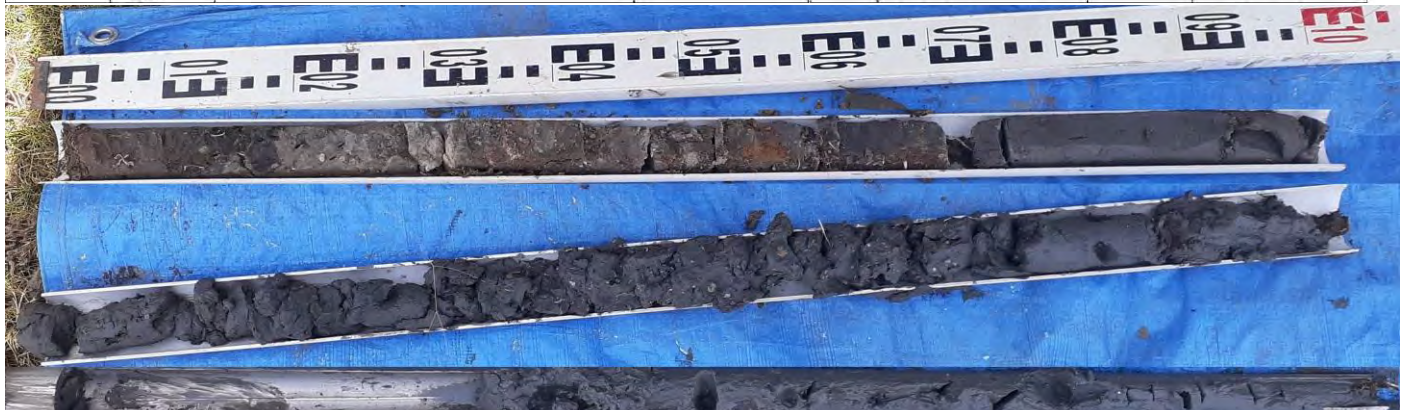
**Soil profile details:**

Project Number: 2018064 Profile ID: CP\_65  
 River/estuary: Clarence Sample date: 29/11/19  
 Easting: 529134.1 Sampled by: AJH GL  
 Northing: 6740719.4  
 Ground elevation (m AHD): 0.00  
 Hydraulic conductivity (m/d): 0.086

**Water quality:**

Surface water EC ( $\mu\text{S/cm}$ ): 81,400  
 Surface water pH: 7.5  
 Groundwater EC ( $\mu\text{S/cm}$ ): 40,800  
 Groundwater pH: 6.7

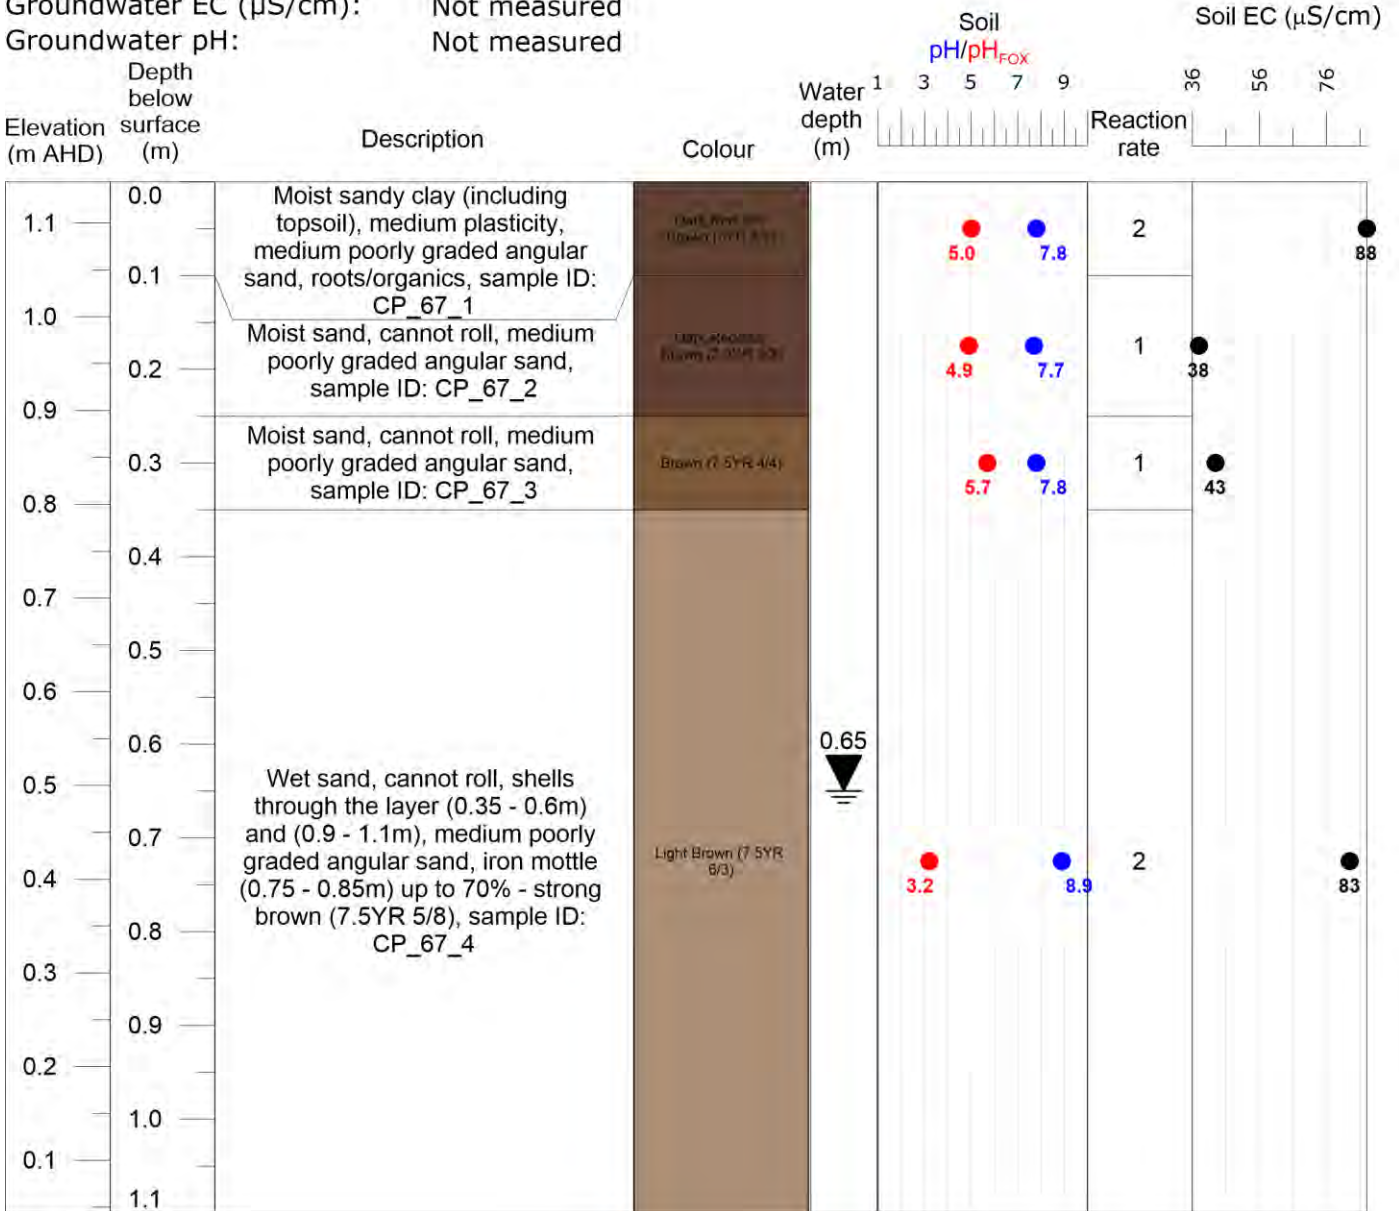
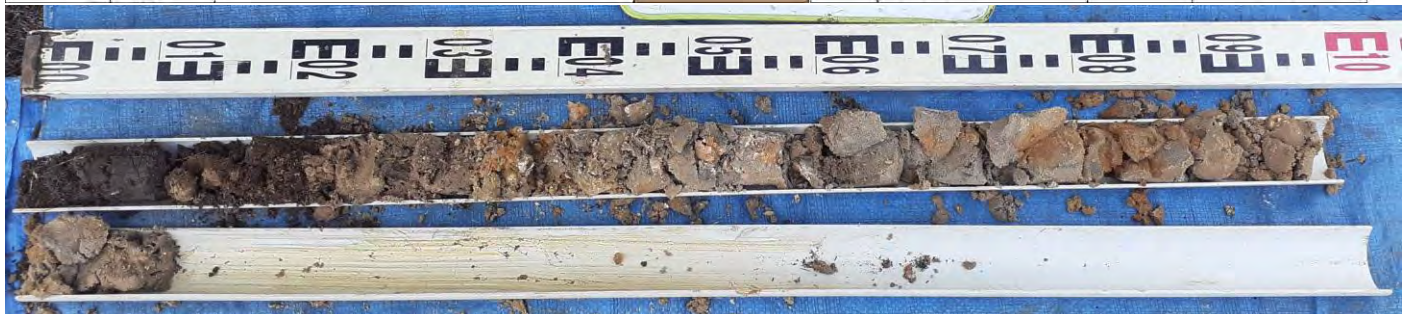
**Soil profile details:**

Project Number: 2018064 Profile ID: CP\_67  
 River/estuary: Clarence Sample date: 03/02/20  
 Easting: 531618.7 Sampled by: AJH GL  
 Northing: 6752206.8  
 Ground elevation (m AHD): 1.14  
 Hydraulic conductivity (m/d): Not measured

**Water quality:**

Surface water EC ( $\mu\text{S/cm}$ ): Not measured  
 Surface water pH: Not measured  
 Groundwater EC ( $\mu\text{S/cm}$ ): Not measured  
 Groundwater pH: Not measured

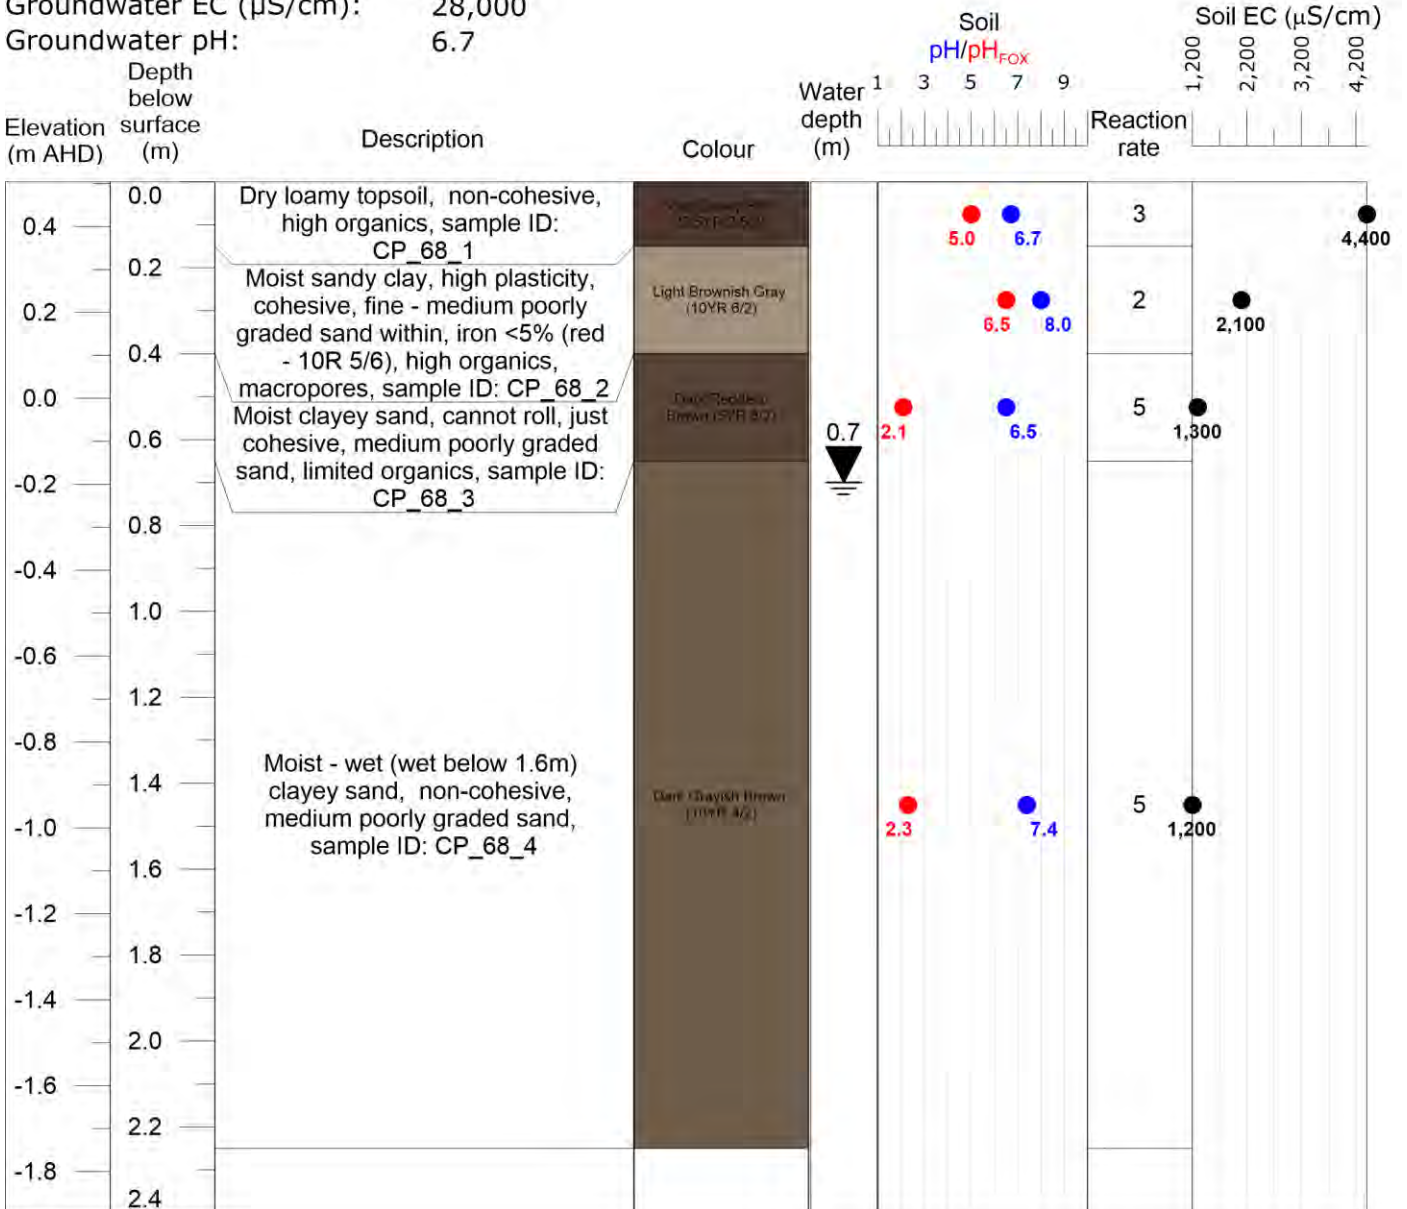
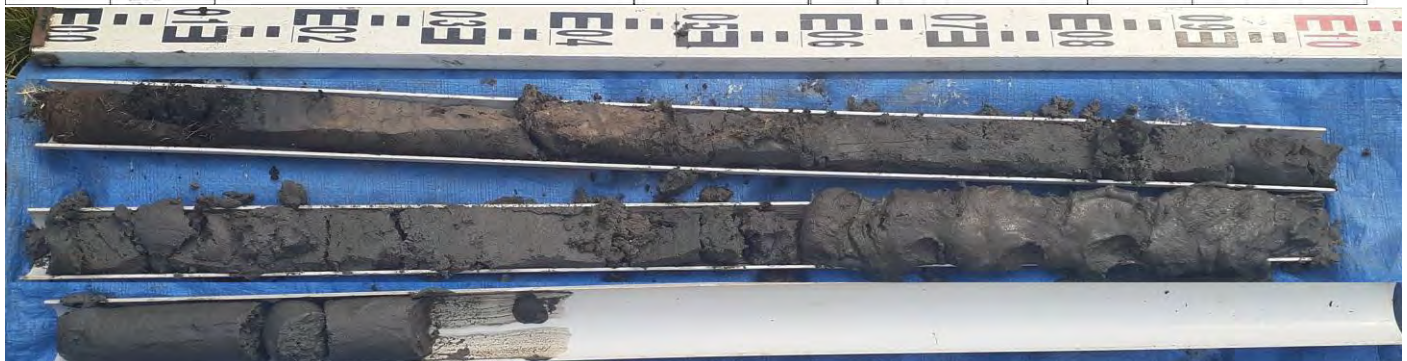
**Soil profile details:**

Project Number: 2018064 Profile ID: CP\_68  
 River/estuary: Clarence Sample date: 29/11/19  
 Easting: 530334.5 Sampled by: AJH GL  
 Northing: 6742929.3  
 Ground elevation (m AHD): 0.50  
 Hydraulic conductivity (m/d): 0.36

**Water quality:**

Surface water EC ( $\mu\text{S/cm}$ ): 66,821  
 Surface water pH: 7.8  
 Groundwater EC ( $\mu\text{S/cm}$ ): 28,000  
 Groundwater pH: 6.7
