# Clarence River Floodplain Prioritisation Study: Appendix A – L

WRL TR 2020/06, May 2023

# Appendix A Floodplain waterways

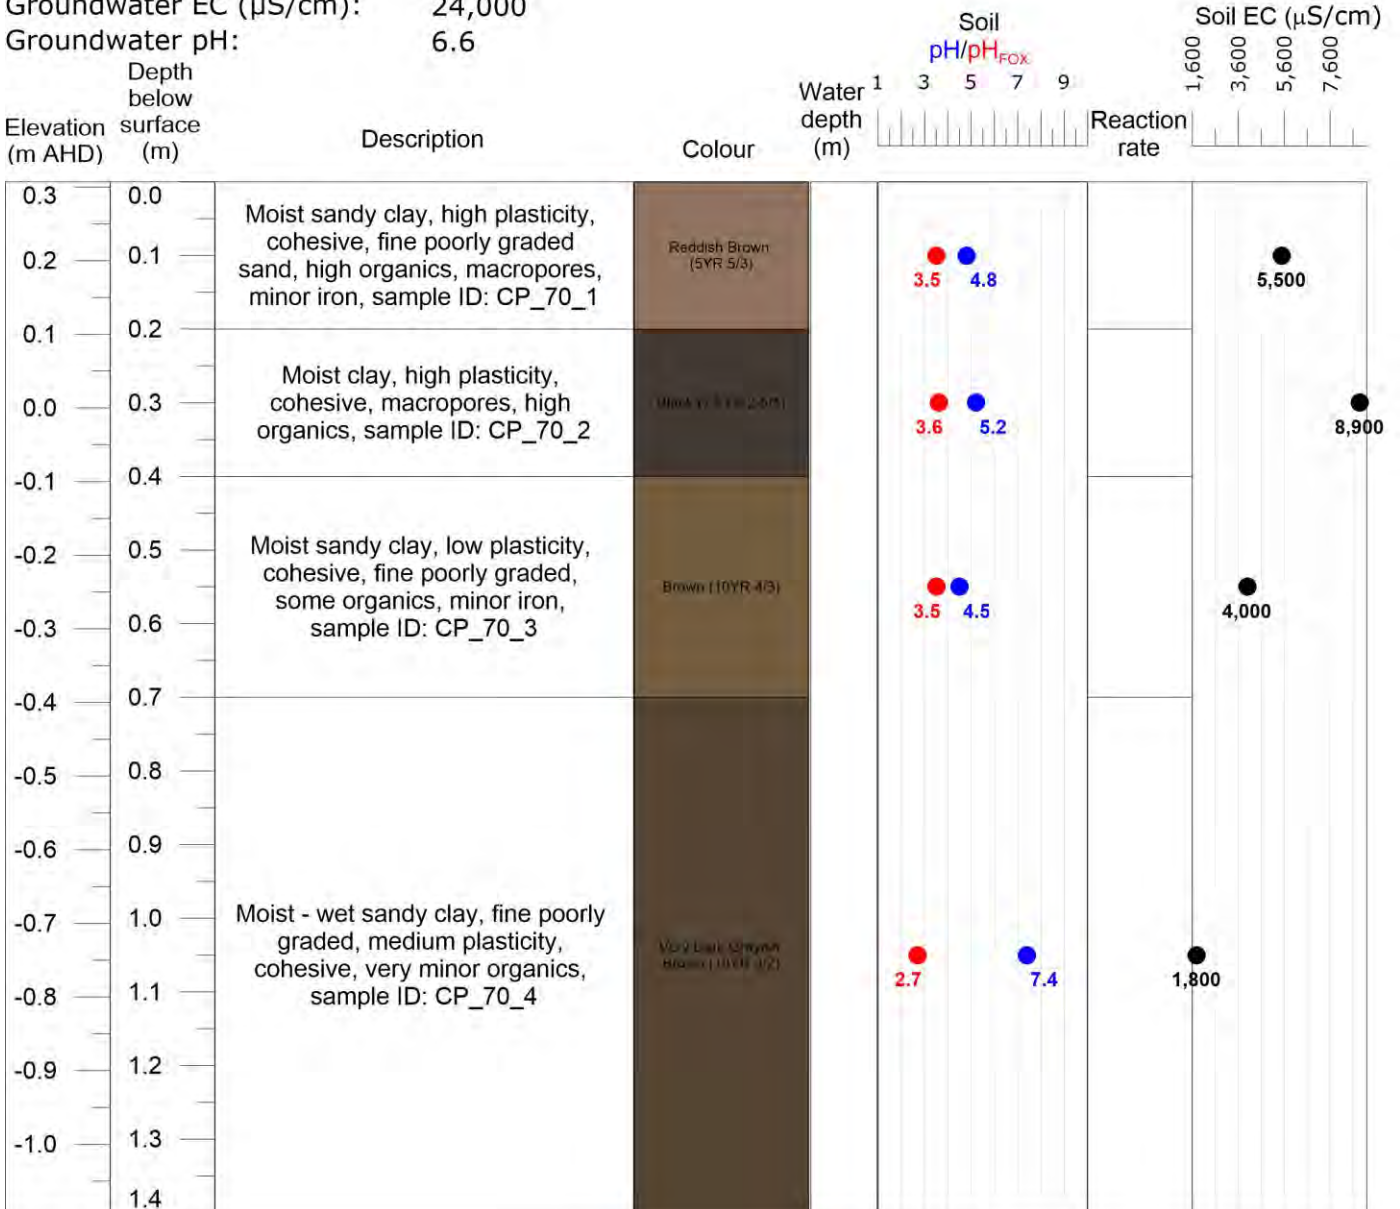
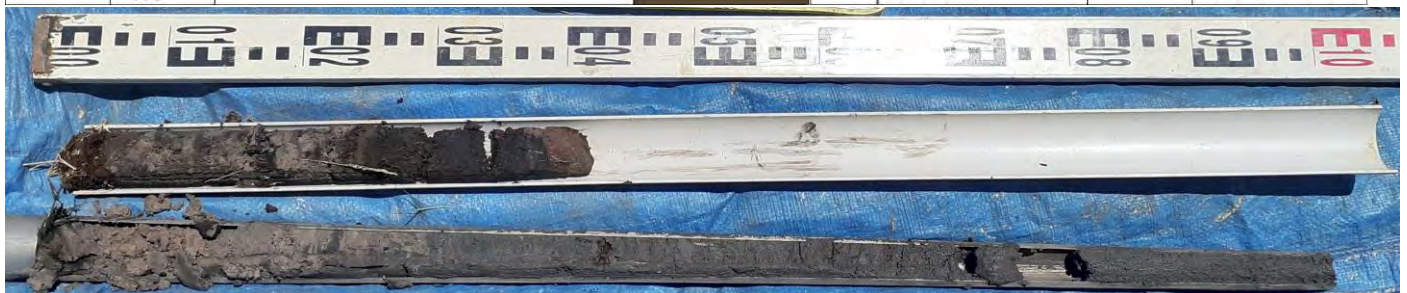
**Soil profile details:**

Project Number: 2018064 Profile ID: CP\_70  
 River/estuary: Clarence Sample date: 04/02/20  
 Easting: 529045.5 Sampled by: AJH GL  
 Northing: 6748258.3  
 Ground elevation (m AHD): 0.31  
 Hydraulic conductivity (m/d): 0.07

**Water quality:**

Surface water EC ( $\mu\text{S/cm}$ ): 11,000  
 Surface water pH: 6.85  
 Groundwater EC ( $\mu\text{S/cm}$ ): 24,000  
 Groundwater pH: 6.6

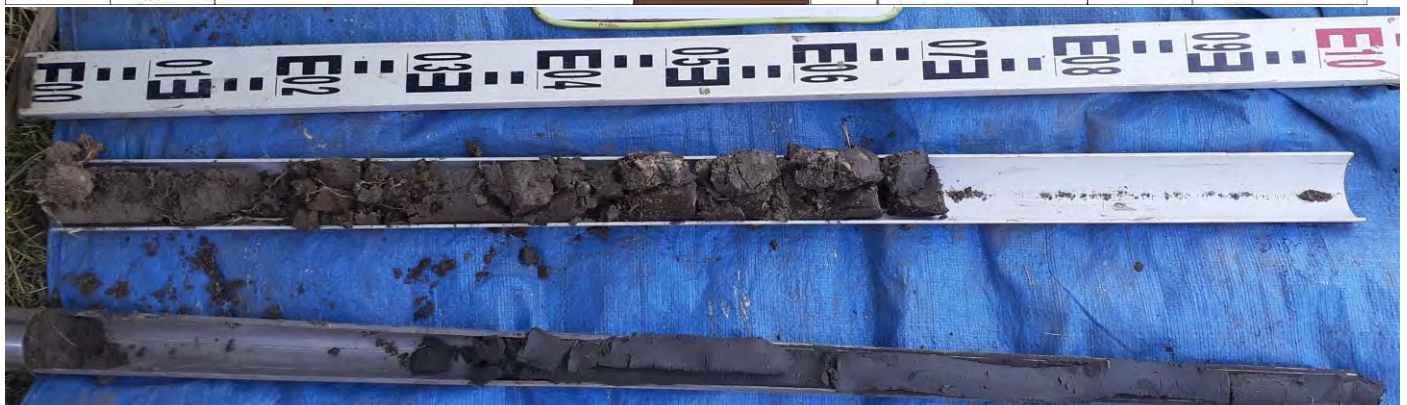
**Soil profile details:**

Project Number: 2018064 Profile ID: CP\_72  
 River/estuary: Clarence Sample date: 05/12/19  
 Easting: 527017.9 Sampled by: AJH GL  
 Northing: 6750089.1  
 Ground elevation (m AHD): 0.17  
 Hydraulic conductivity (m/d): 0.18

**Water quality:**

Surface water EC ( $\mu\text{S/cm}$ ): Not measured  
 Surface water pH: Not measured  
 Groundwater EC ( $\mu\text{S/cm}$ ): Not measured  
 Groundwater pH: Not measured

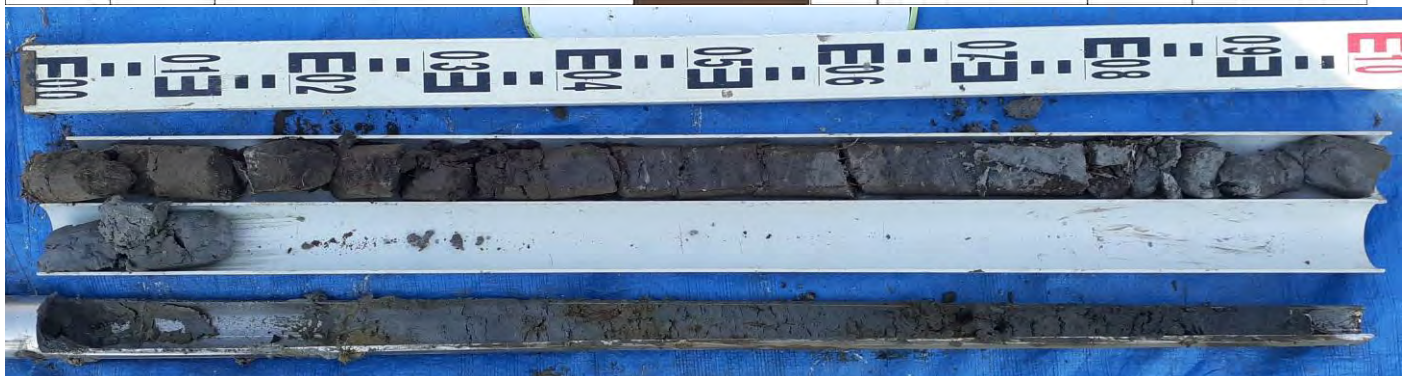
**Soil profile details:**

Project Number: 2018064 Profile ID: CP\_76  
 River/estuary: Clarence Sample date: 05/12/19  
 Easting: 523473.8 Sampled by: AJH GL  
 Northing: 6747741.4  
 Ground elevation (m AHD): 0.54  
 Hydraulic conductivity (m/d): 0.13

**Water quality:**

Surface water EC ( $\mu\text{S/cm}$ ): 64,286  
 Surface water pH: 7.62  
 Groundwater EC ( $\mu\text{S/cm}$ ): 27,059  
 Groundwater pH: 6.76

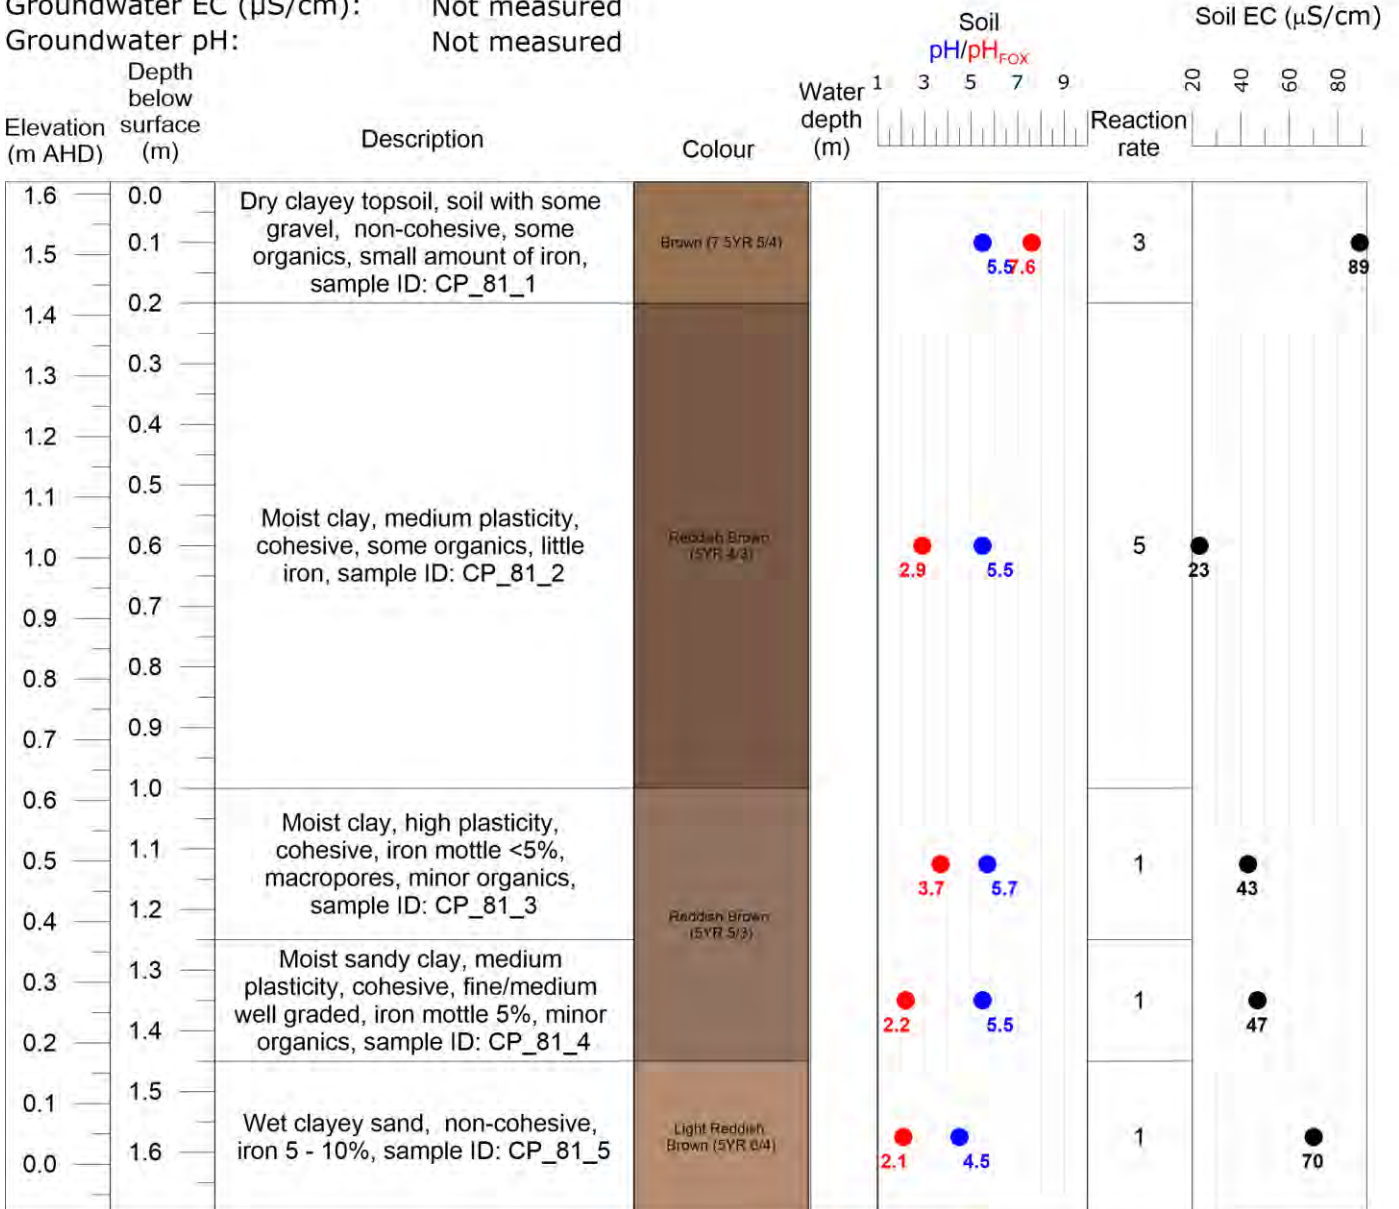
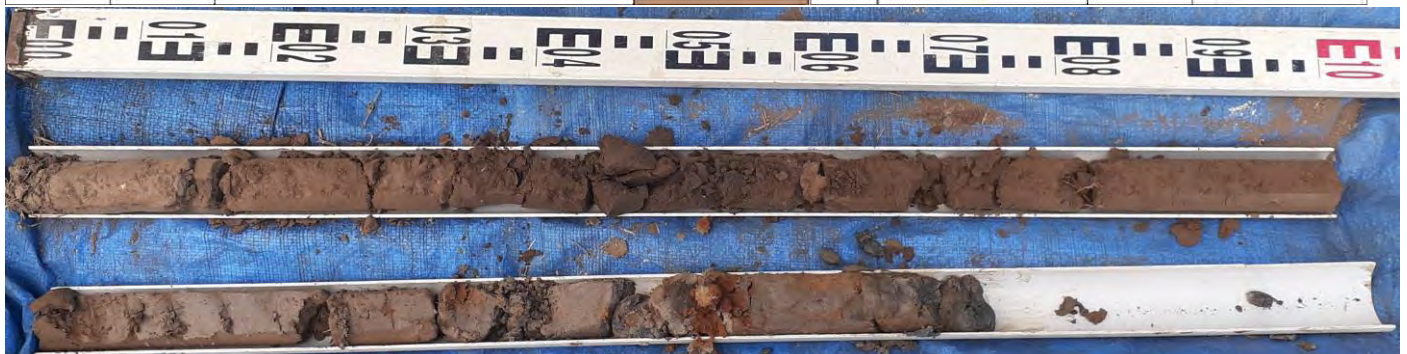
**Soil profile details:**

Project Number: 2018064 Profile ID: CP\_81  
 River/estuary: Clarence Sample date: 03/02/20  
 Easting: 526240.8 Sampled by: AJH GL  
 Northing: 6747490.8  
 Ground elevation (m AHD): 1.62  
 Hydraulic conductivity (m/d): 0.31

**Water quality:**

Surface water EC ( $\mu\text{S/cm}$ ): Not measured  
 Surface water pH: Not measured  
 Groundwater EC ( $\mu\text{S/cm}$ ): Not measured  
 Groundwater pH: Not measured

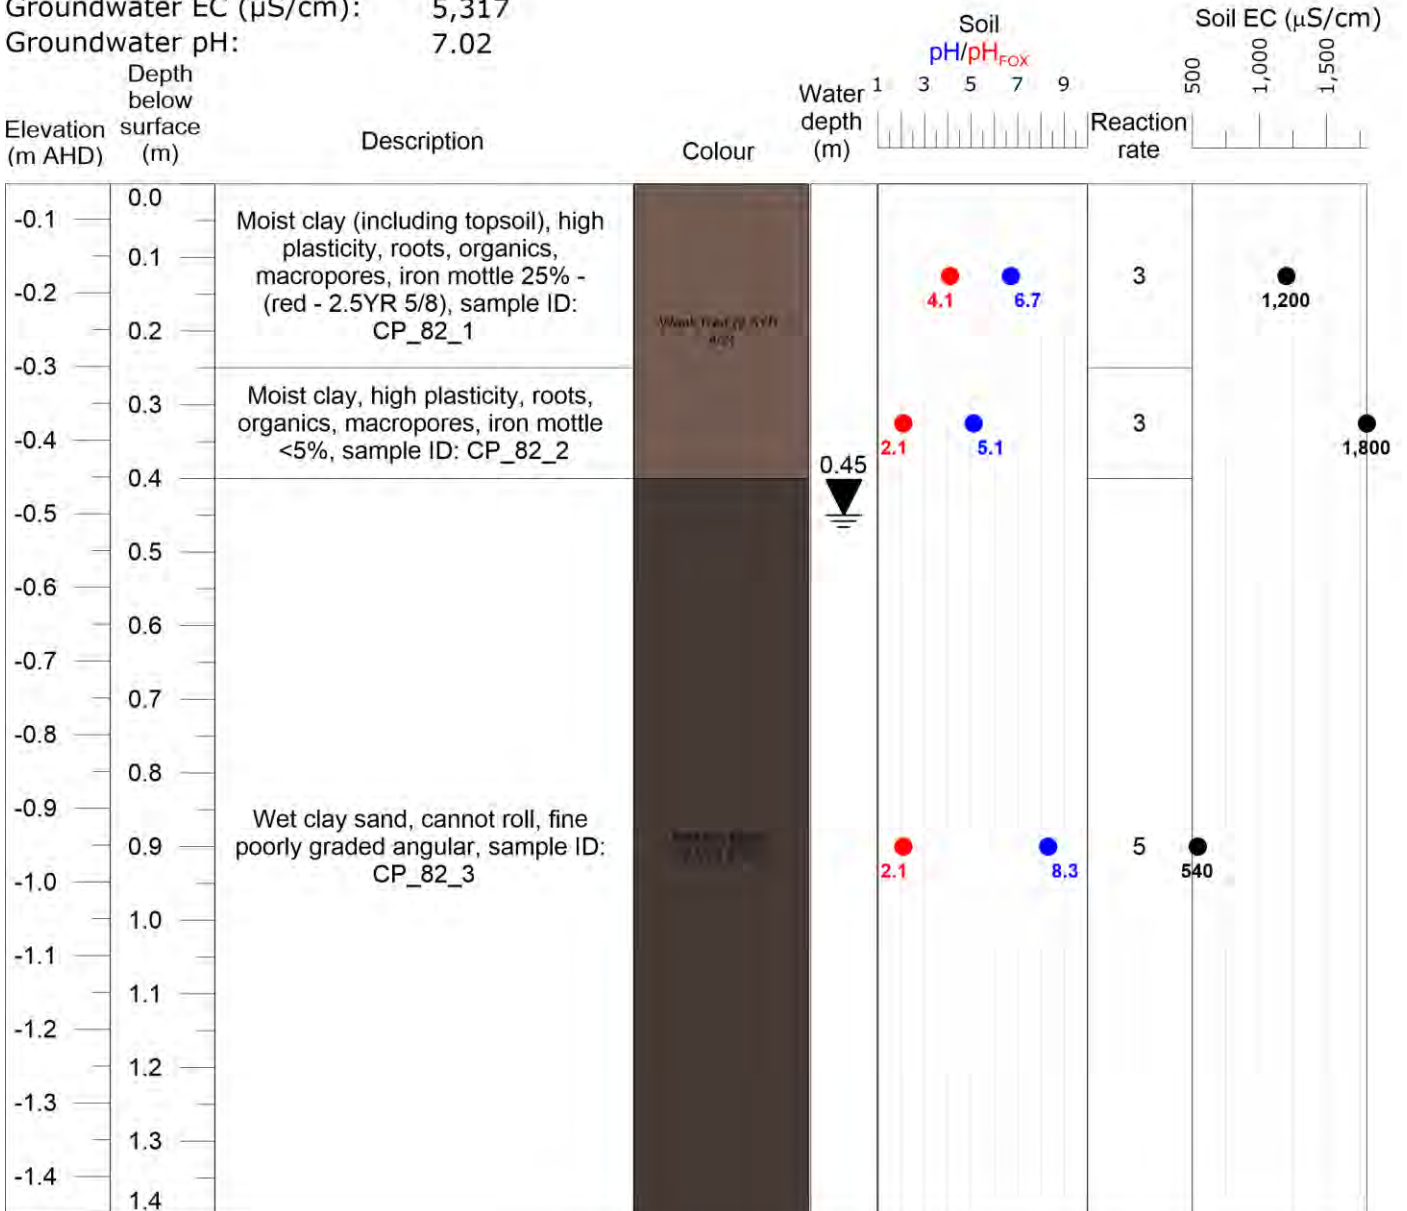
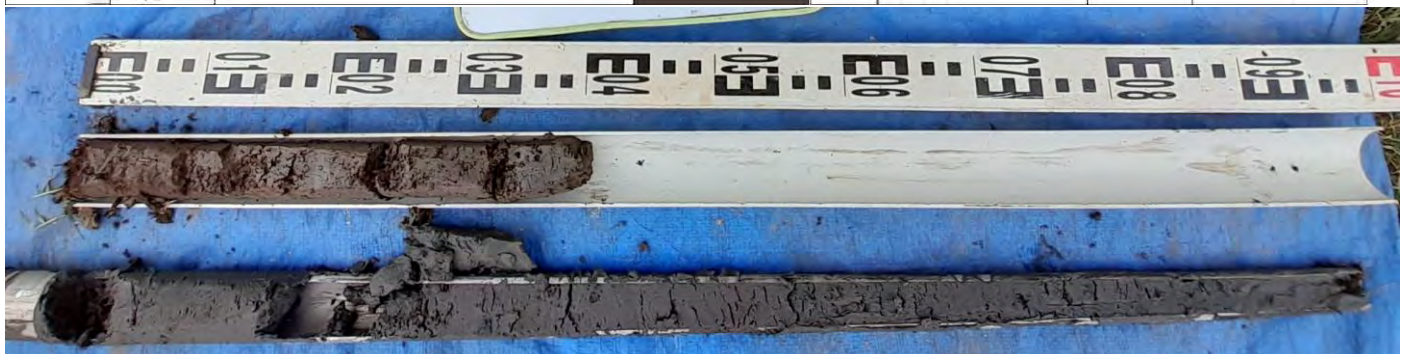
**Soil profile details:**

Project Number: 2018064 Profile ID: CP\_82  
 River/estuary: Clarence Sample date: 05/02/20  
 Easting: 522465 Sampled by: AJH GL  
 Northing: 6750013.0  
 Ground elevation (m AHD): -0.05  
 Hydraulic conductivity (m/d): 0.11

**Water quality:**

Surface water EC ( $\mu\text{S/cm}$ ): 15,430  
 Surface water pH: 6.82  
 Groundwater EC ( $\mu\text{S/cm}$ ): 5,317  
 Groundwater pH: 7.02

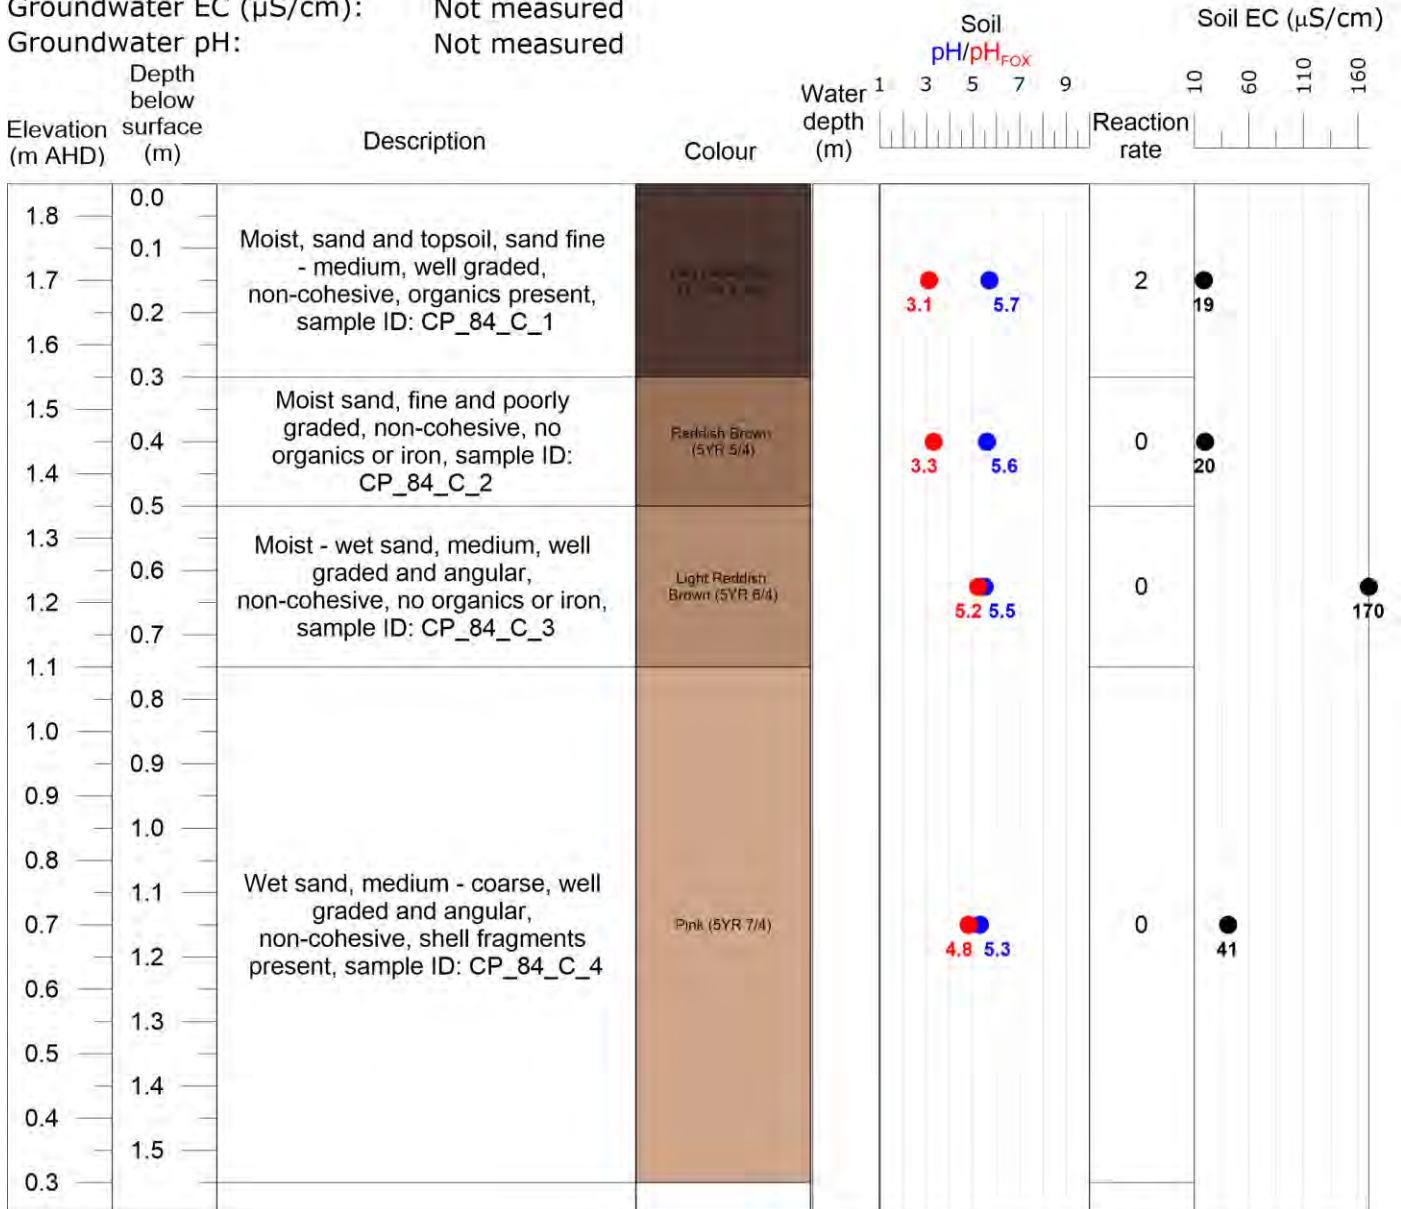
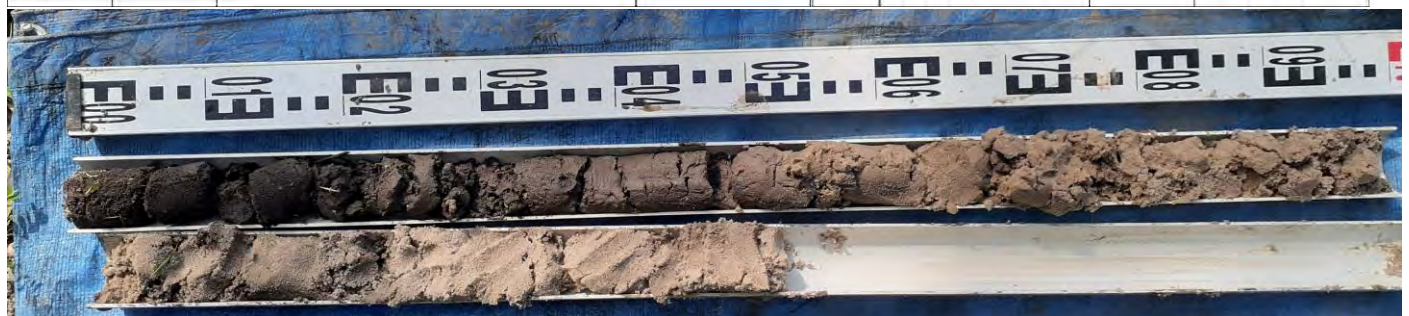
**Soil profile details:**

Project Number: 2018064 Profile ID: CP\_84\_C  
 River/estuary: Clarence Sample date: 28/02/20  
 Easting: 523623.4 Sampled by: AJH DWJ  
 Northing: 6752251.9  
 Ground elevation (m AHD): 1.85  
 Hydraulic conductivity (m/d): Not measured

**Water quality:**

Surface water EC ( $\mu\text{S/cm}$ ): Not measured  
 Surface water pH: Not measured  
 Groundwater EC ( $\mu\text{S/cm}$ ): Not measured  
 Groundwater pH: Not measured

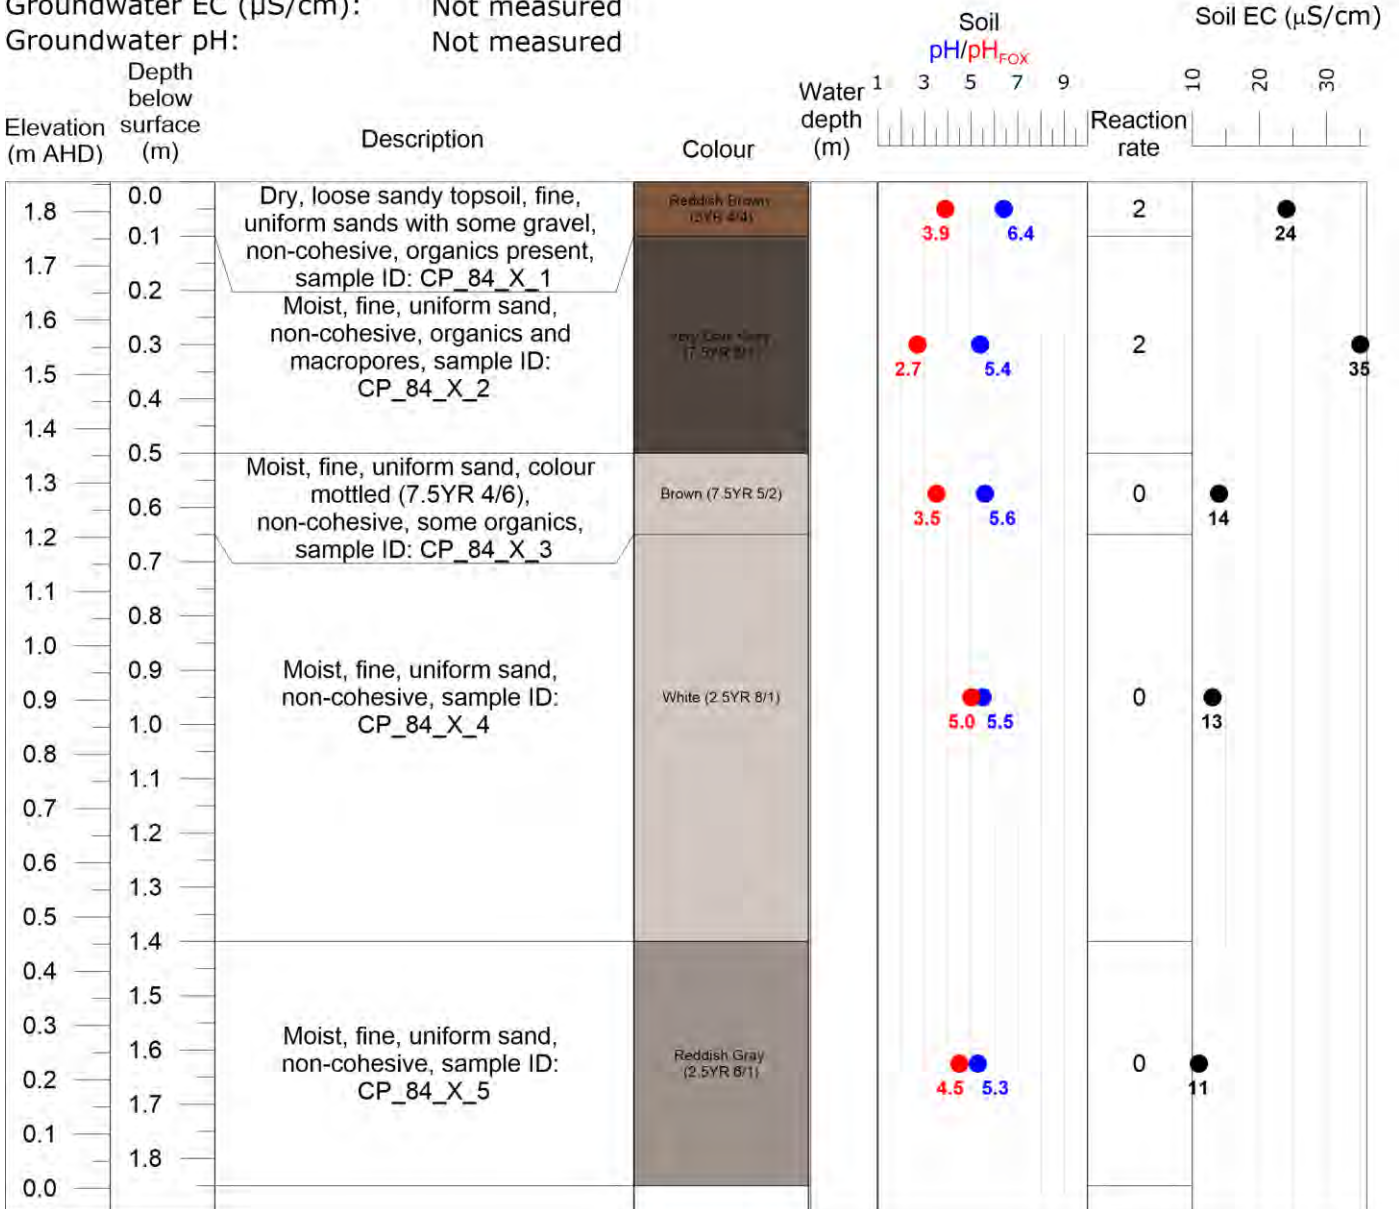
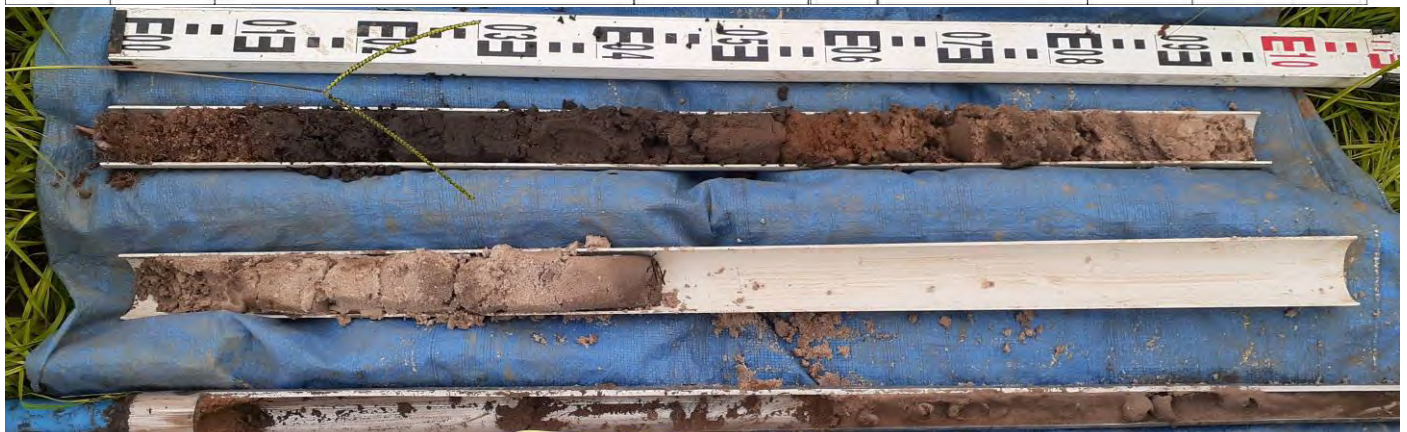
**Soil profile details:**

Project Number: 2018064 Profile ID: CP\_84\_X  
 River/estuary: Clarence Sample date: 03/03/20  
 Easting: 523630.4 Sampled by: AJH KW  
 Northing: 6752244.3  
 Ground elevation (m AHD): 1.85  
 Hydraulic conductivity (m/d): Not measured

**Water quality:**

Surface water EC ( $\mu\text{S/cm}$ ): Not measured  
 Surface water pH: Not measured  
 Groundwater EC ( $\mu\text{S/cm}$ ): Not measured  
 Groundwater pH: Not measured

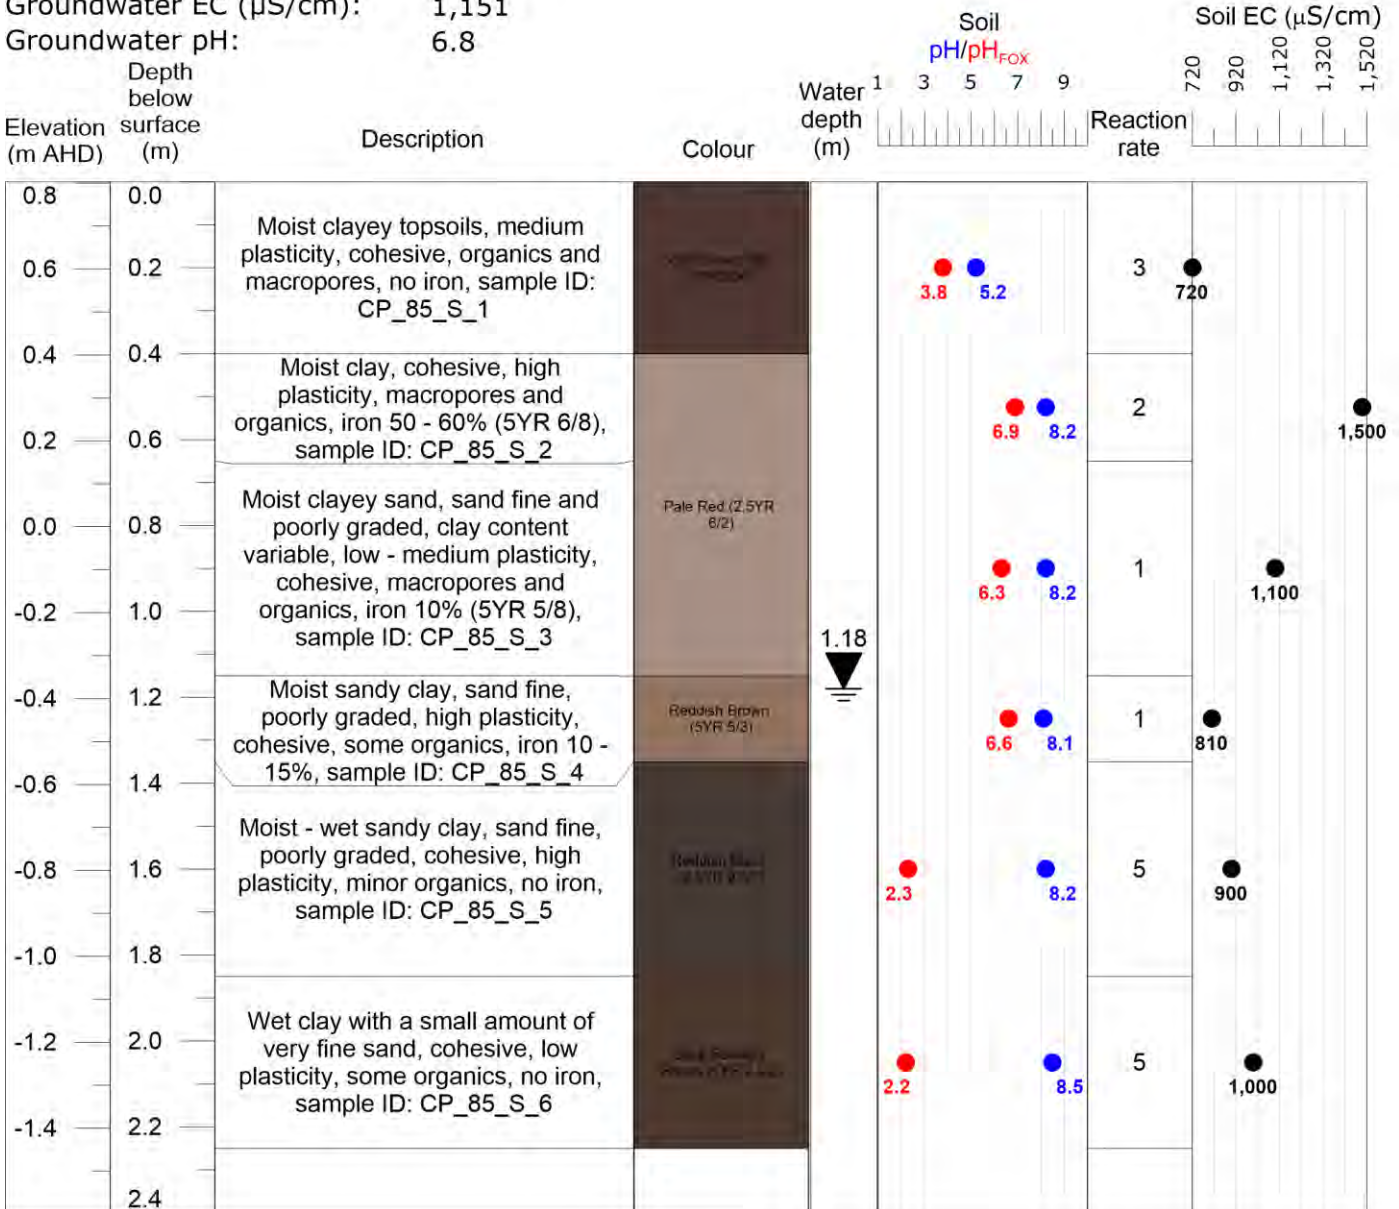
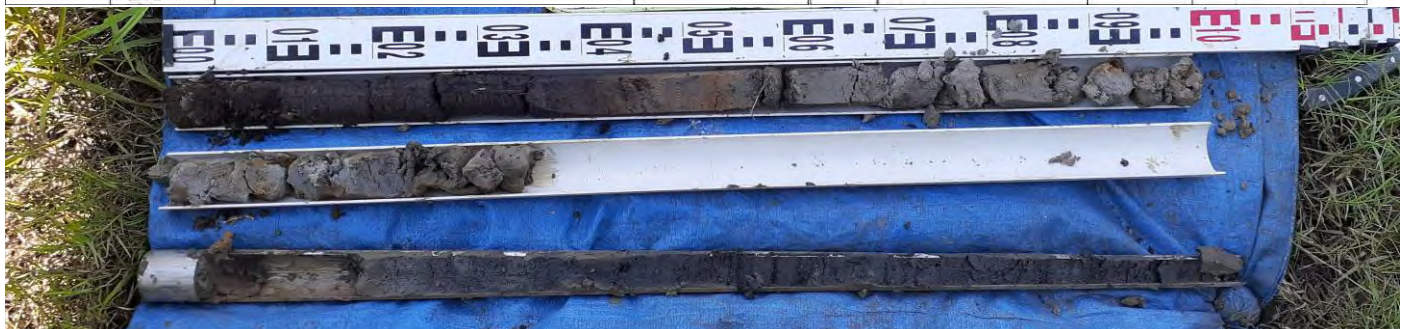
**Soil profile details:**

Project Number: 2018064 Profile ID: CP\_85\_S  
 River/estuary: Clarence Sample date: 26/02/20  
 Easting: 524187.8 Sampled by: AJH DWJ  
 Northing: 6750590.2  
 Ground elevation (m AHD): 0.80  
 Hydraulic conductivity (m/d): 0.37

**Water quality:**

Surface water EC ( $\mu\text{S/cm}$ ): 3.66  
 Surface water pH: 6.43  
 Groundwater EC ( $\mu\text{S/cm}$ ): 1,151  
 Groundwater pH: 6.8
