Tweed River Floodplain Prioritisation Study: Appendix A – L

WRL TR 2020/04, June 2023

UNSW
Water Research
Laboratory

Appendix A Floodplain drainage

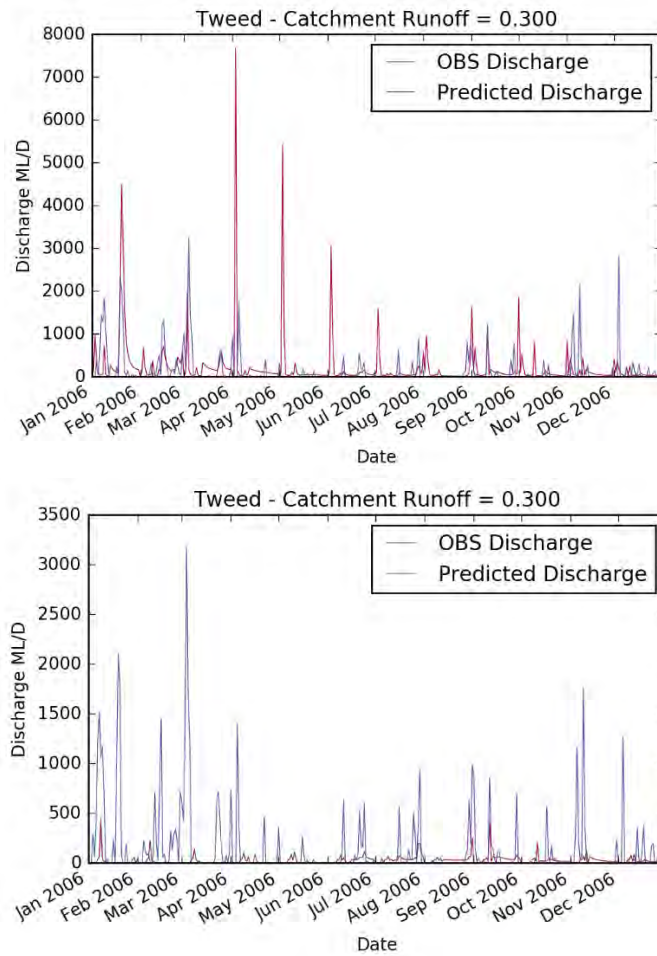
Figure B-3: Predicted and observed runoff for the catchment area upstream of river gauging station 201001 (top) and station 201005 (bottom)

The runoff co-efficient was selected by comparing the annual time-series of streamflow data for the predicted runoff volume calculated for the selected gauging stations. Figure B-3 shows an example time-series of predicted and observed runoff for 2006. This analysis yielded an estimated runoff coefficient of 0.3, which was applied to Tweed River floodplain subcatchments for the acid prioritisation assessment.

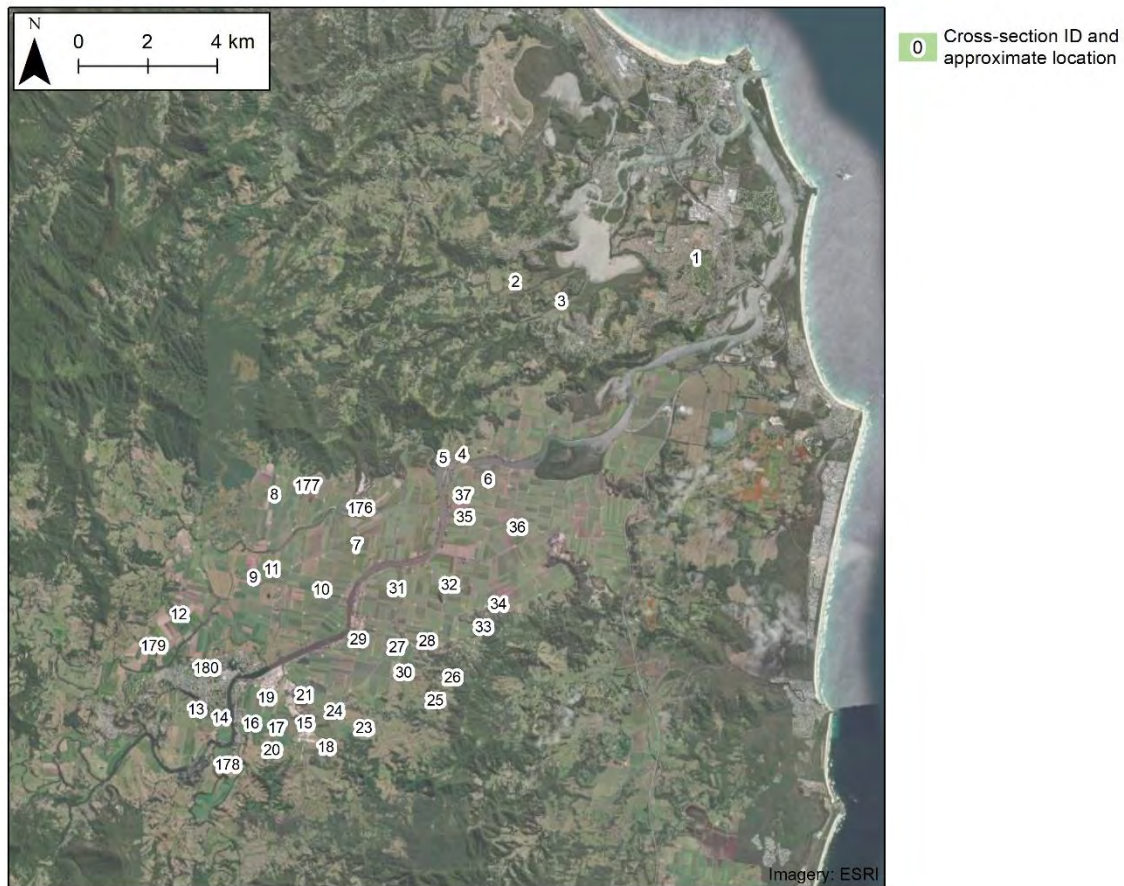
Figure G-1: General location of cross-sections surveyed on the Tweed River floodplain

During field investigations, floodplain drainage channels and waterways were surveyed opportunistically. Measurements were taken using Trimble GNSS RTK survey equipment as specified in Appendix A of the Methods report (Rayner et al., 2023). Locations of cross-sectional measurements surveyed across the Tweed River floodplain are shown in Figure G-1. All sections were surveyed from left bank to right bank (when looking downstream). Table G-1 provides the start and end coordinates for each cross-section, and individual cross-section profiles are shown from Figure G-2 to Figure G-42.

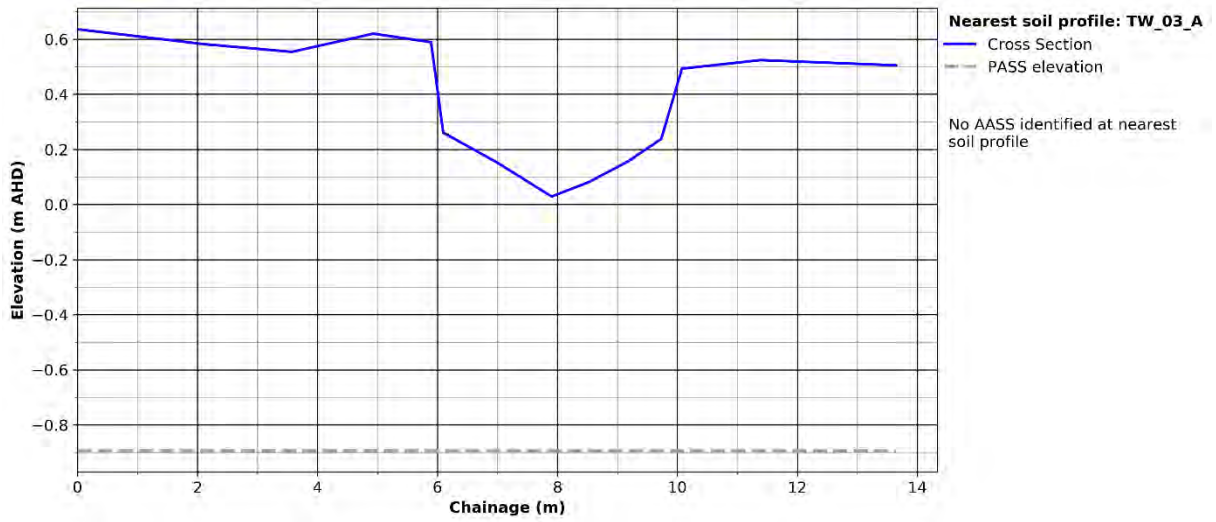
Figure G-5: Tweed cross-section 4

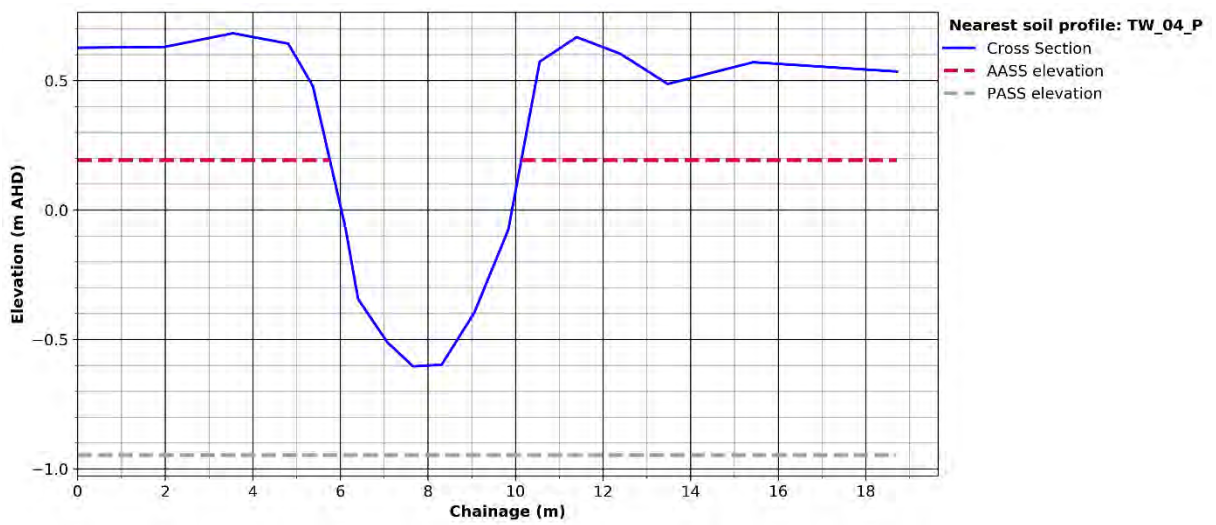
Figure G-6: Tweed cross-section 5

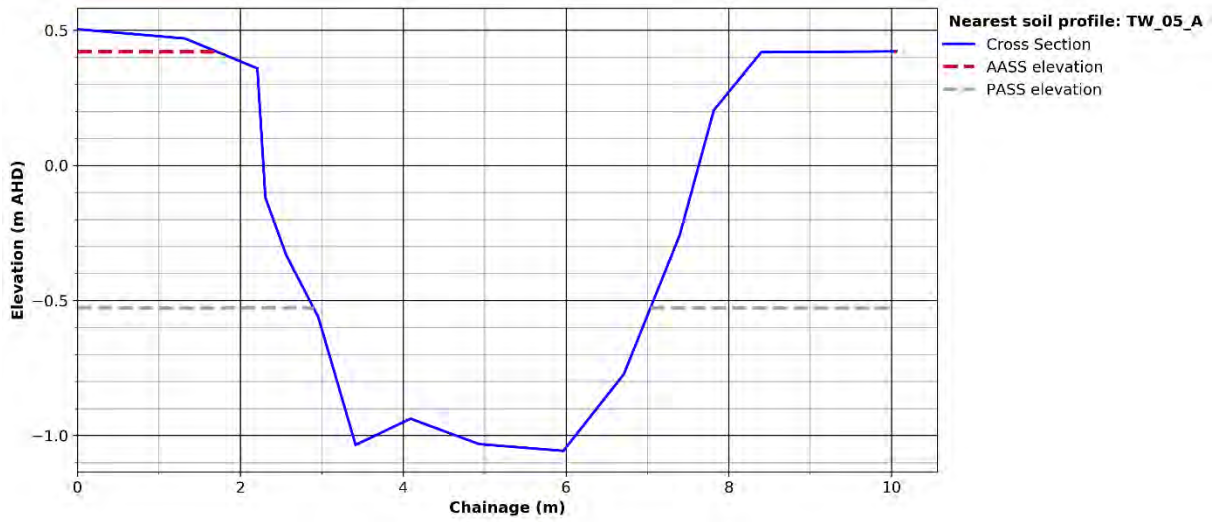
Figure G-8: Tweed cross-section 7

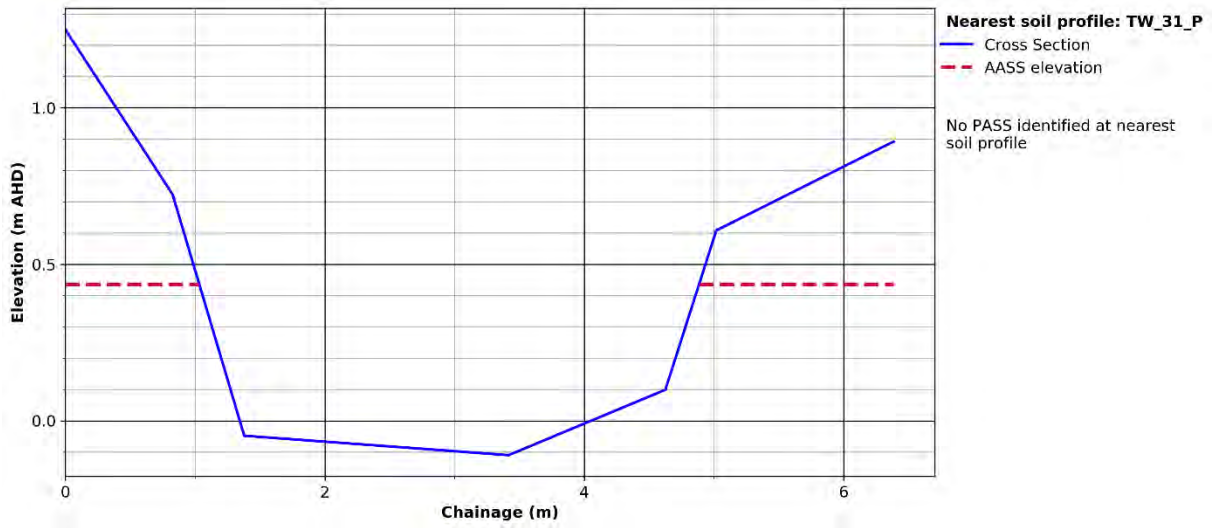
Figure G-41: Tweed cross-section 179

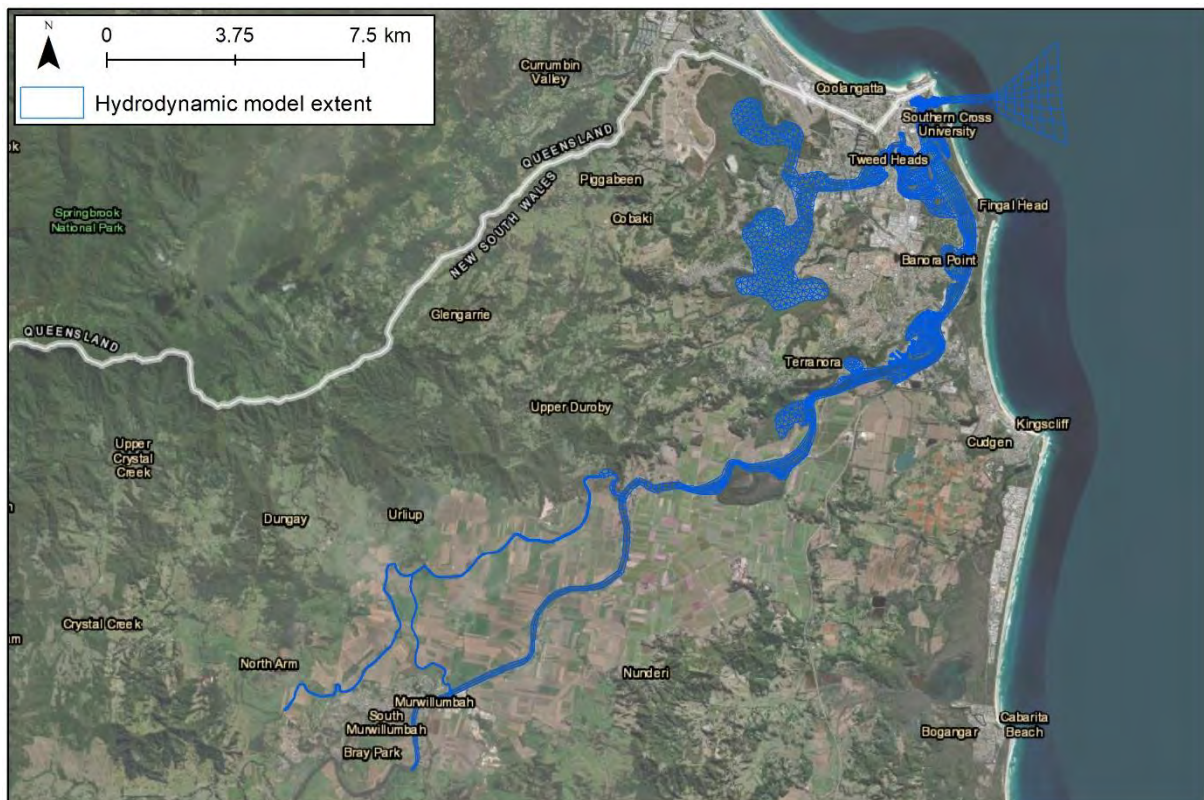
Figure I-1: Tweed River estuary – tidal hydrodynamic model extent

A 1-D/2-D hydrodynamic model of the Tweed River estuary was developed to simulate the typical tidal water level variations within the estuary. The hydrodynamic model extends to the tidal limits of major rivers, tributaries and creeks in the estuary, including the Tweed River, Rous River and Terranora Creek. The model also includes smaller tributaries and creeks in the lower estuary that contained important floodgate structures. A model grid representing the study area provided increased resolution in areas around the lower estuary where complex 2-D flows were expected and lower resolution in the upper reaches of the estuary where flows were modelled using 1-D elements. The model area is shown in Figure I-1.

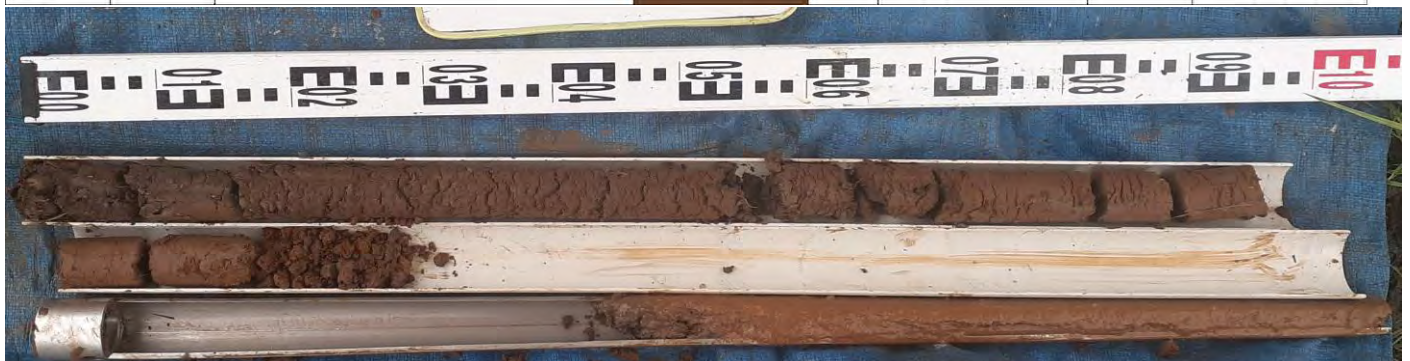
Soil profile details:

Project Number: 2018064 Profile ID: TP_33_S
 River/estuary: Tweed Sample date: 24/02/20
 Easting: 538982.5 Sampled by: AJH DWJ
 Northing: 6863861.9
 Ground elevation (m AHD): 2.35
 Hydraulic conductivity (m/d): 211.28

Water quality:

Surface water EC ($\mu\text{S/cm}$): 1,196
 Surface water pH: 6.25
 Groundwater EC ($\mu\text{S/cm}$): 387
 Groundwater pH: 5.63

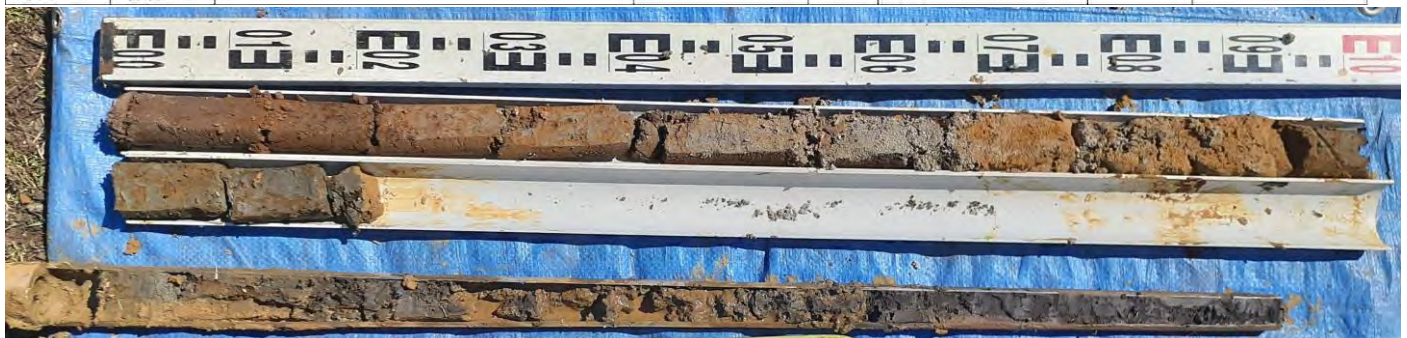
Soil profile details:

Project Number: 2018064 Profile ID: TW_01_A
 River/estuary: Tweed Sample date: 25/10/19
 Easting: 547286.9 Sampled by: TAT DWJ
 Northing: 6877932.9
 Ground elevation (m AHD): 0.78
 Hydraulic conductivity (m/d): 0.27

Water quality:

Surface water EC ($\mu\text{S/cm}$): 66,201
 Surface water pH: 7.65
 Groundwater EC ($\mu\text{S/cm}$): 13,520
 Groundwater pH: 5.85

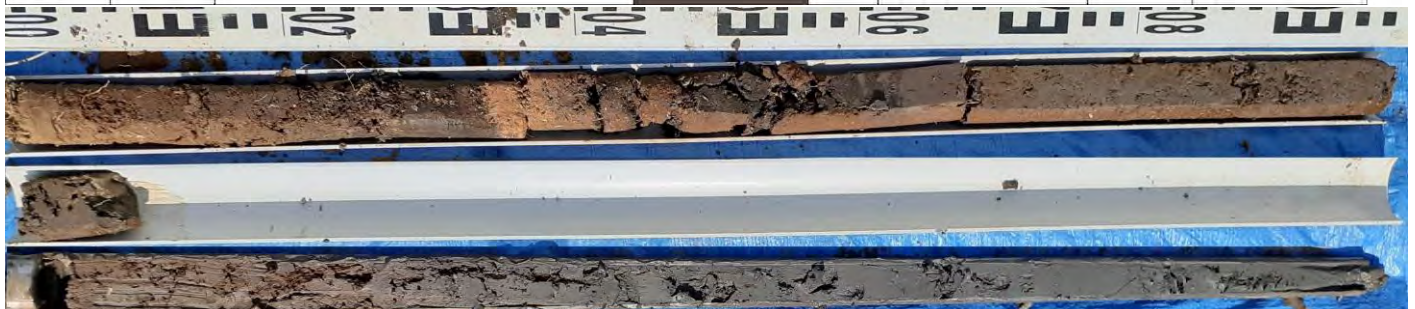
Water quality:

Surface water EC (µS/cm): Not measured
 Surface water pH: Not measured
 Groundwater EC (µS/cm): 14,176
 Groundwater pH: 5.67

Soil profile details:

Project Number: 2018064 Profile ID: TW_04_P
 River/estuary: Tweed Sample date: 17/10/19
 Easting: 545155.8 Sampled by: TAT DWJ
 Northing: 6872789.3
 Ground elevation (m AHD): 0.58
 Hydraulic conductivity (m/d): 0.28

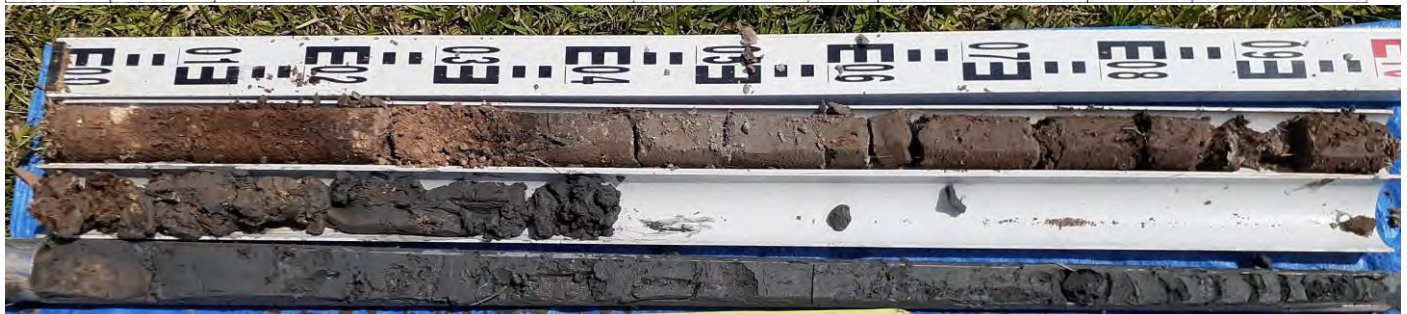
Water quality:

Surface water EC ($\mu\text{S/cm}$): 37,796
 Surface water pH: 7.69
 Groundwater EC ($\mu\text{S/cm}$): 11,866
 Groundwater pH: 5.88

Soil profile details:

Project Number: 2018064 Profile ID: TW_05_A
 River/estuary: Tweed Sample date: 21/10/19
 Easting: 542691.4 Sampled by: TAT DWJ
 Northing: 6870240.2
 Ground elevation (m AHD): 0.42
 Hydraulic conductivity (m/d): Not measured

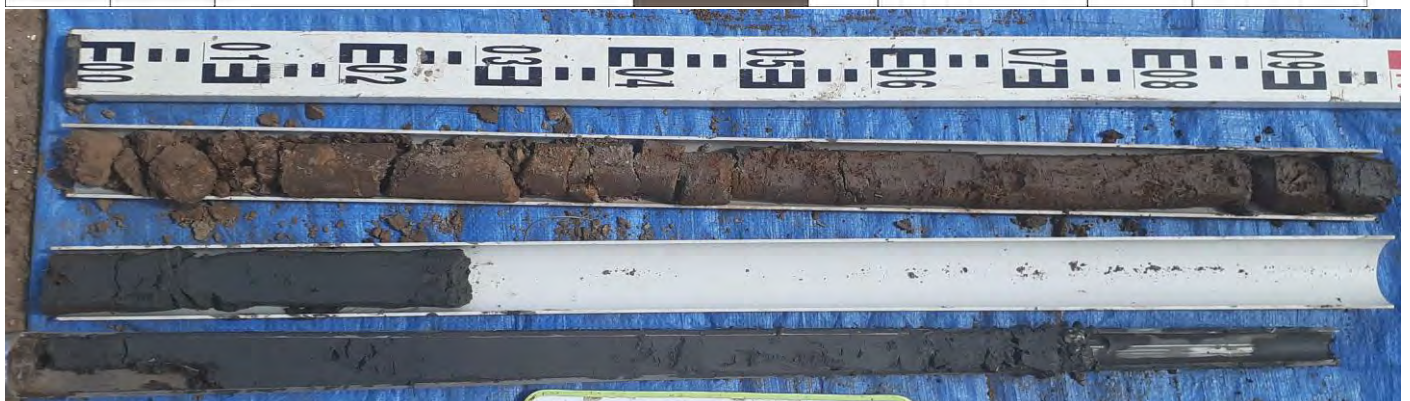
Water quality:

Surface water EC ($\mu\text{S/cm}$): 28,213
 Surface water pH: 6.04
 Groundwater EC ($\mu\text{S/cm}$): Not measured
 Groundwater pH: Not measured

Soil profile details:

Project Number: 2018064 Profile ID: TW_05_P
 River/estuary: Tweed Sample date: 16/10/19
 Easting: 544820 Sampled by: TAT DWJ
 Northing: 6871473.4
 Ground elevation (m AHD): 0.60
 Hydraulic conductivity (m/d): 0.30

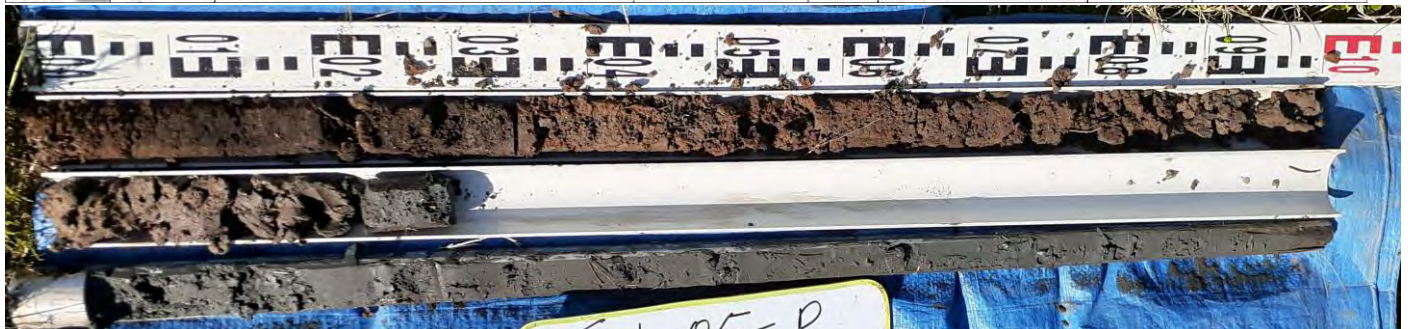
Water quality:

Surface water EC ($\mu\text{S/cm}$): Not measured
 Surface water pH: Not measured
 Groundwater EC ($\mu\text{S/cm}$): 7,215
 Groundwater pH: 6.11

Soil profile details:

Project Number: 2018064 Profile ID: TW_07_A
 River/estuary: Tweed Sample date: 24/10/19
 Easting: 537526.5 Sampled by: TAT DWJ
 Northing: 6868235.8
 Ground elevation (m AHD): 1.23
 Hydraulic conductivity (m/d): 0.10

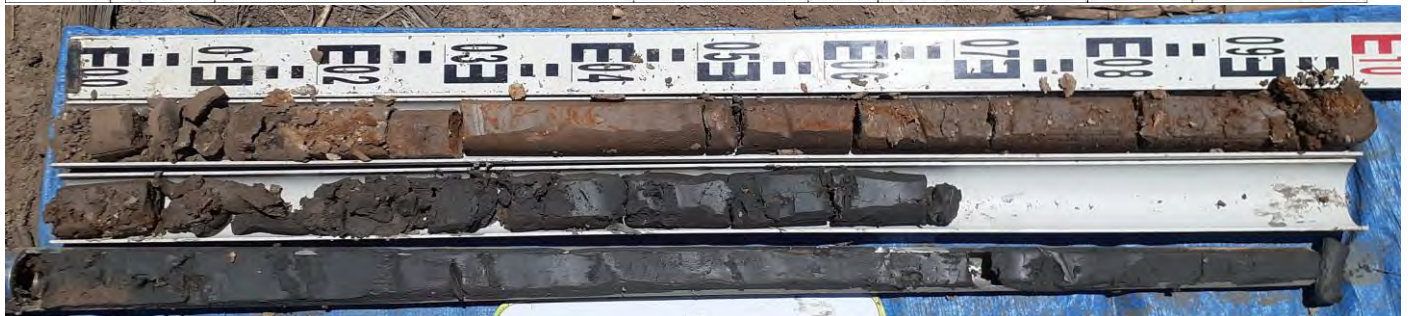
Water quality:

Surface water EC ($\mu\text{S/cm}$): 5,814
 Surface water pH: 7.09
 Groundwater EC ($\mu\text{S/cm}$): 2,009
 Groundwater pH: 6.77

Soil profile details:

Project Number: 2018064 Profile ID: TW_10_A
 River/estuary: Tweed Sample date: 23/10/19
 Easting: 538147.6 Sampled by: TAT DWJ
 Northing: 6865632.6
 Ground elevation (m AHD): 1.54
 Hydraulic conductivity (m/d): 0.10

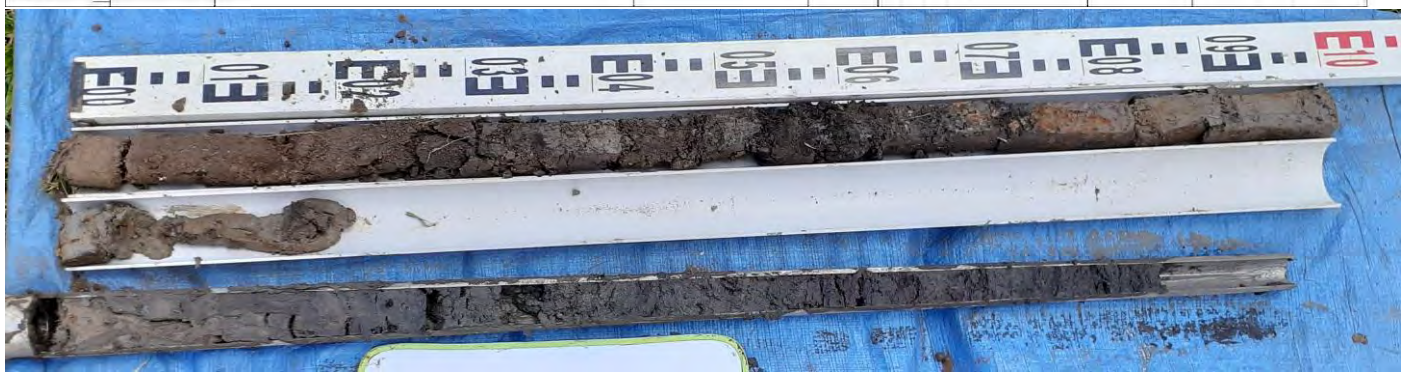
Water quality:

Surface water EC ($\mu\text{S/cm}$): 3162 (creek), 250 (nearby dam)
 Surface water pH: 3.83 (creek), 6.25 (nearby dam)
 Groundwater EC ($\mu\text{S/cm}$): 618
 Groundwater pH: 6.08

Soil profile details:

Project Number: 2018064 Profile ID: TW_11_P
 River/estuary: Tweed Sample date: 23/10/19
 Easting: 538013 Sampled by: TAT DWJ
 Northing: 6865486.9
 Ground elevation (m AHD): 1.36
 Hydraulic conductivity (m/d): Not measured

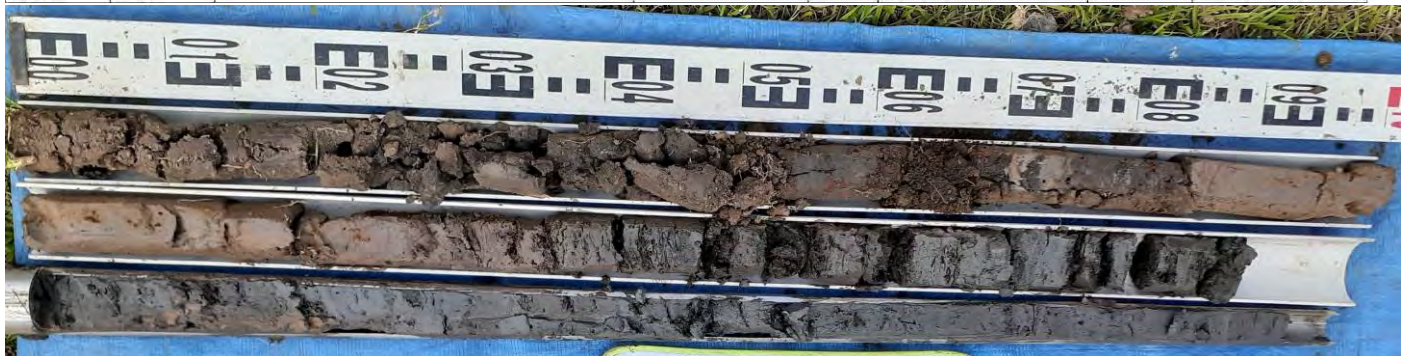
Soil profile details:

Project Number: 2018064 Profile ID: TW_12_A
 River/estuary: Tweed Sample date: 08/11/19
 Easting: 540027.8 Sampled by: AJH GL
 Northing: 6865836.7
 Ground elevation (m AHD): 1.56
 Hydraulic conductivity (m/d): 0.34

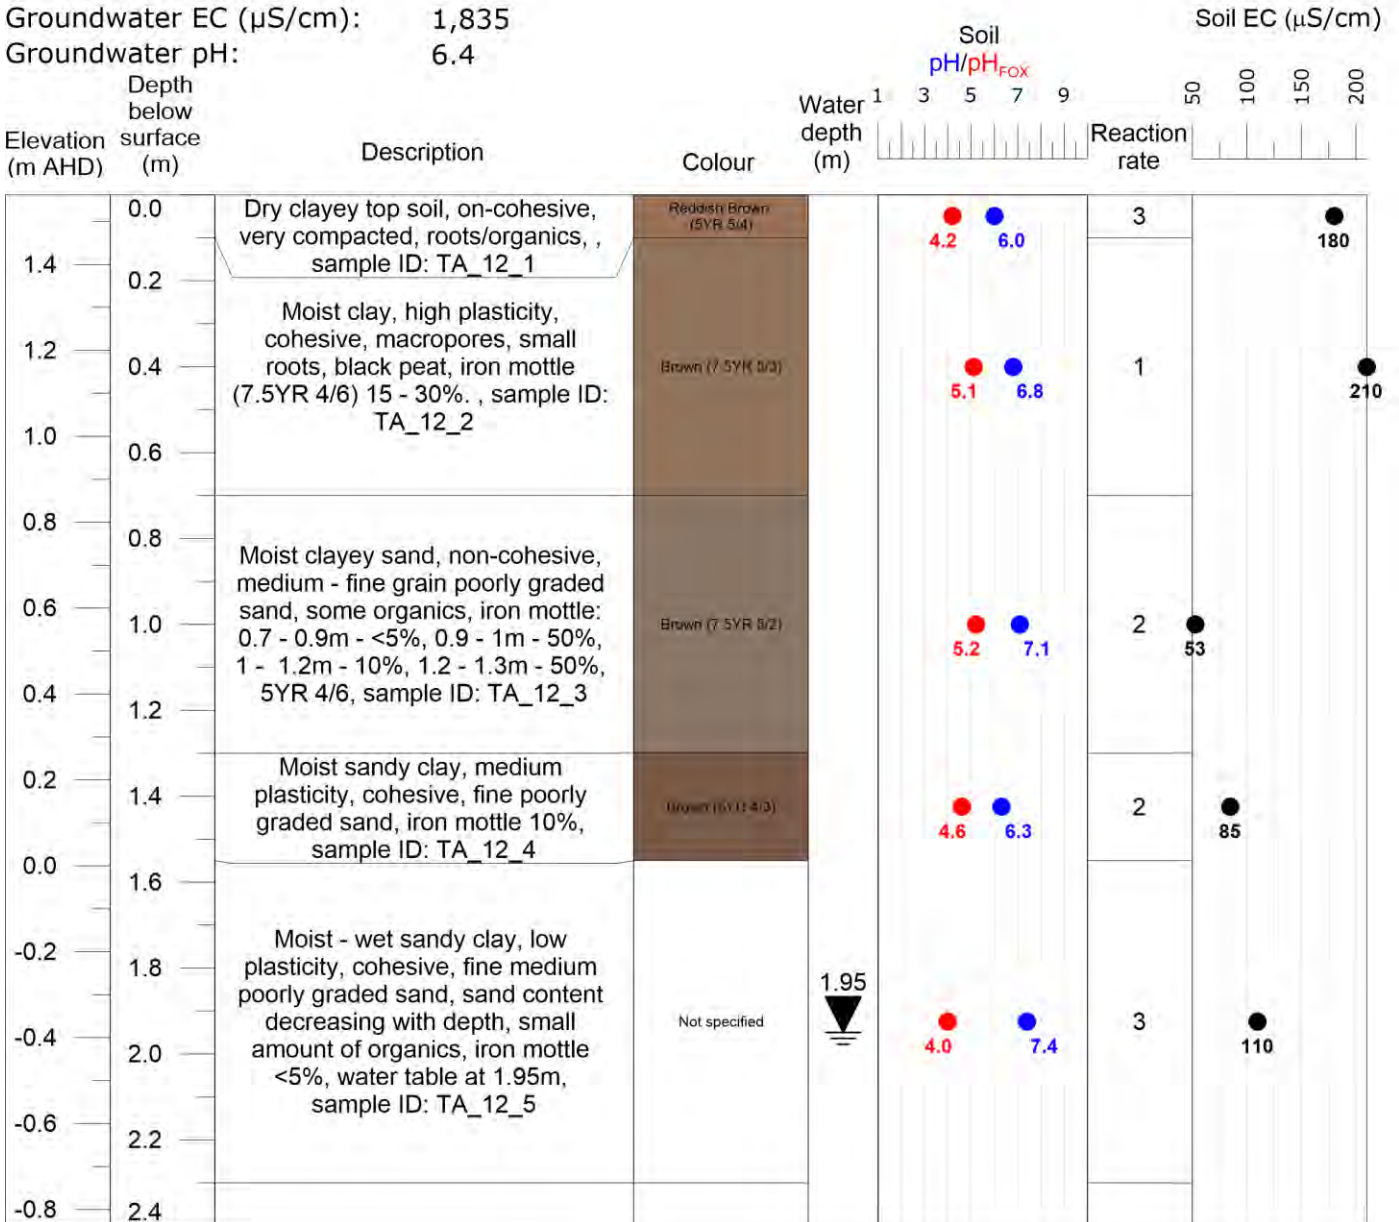
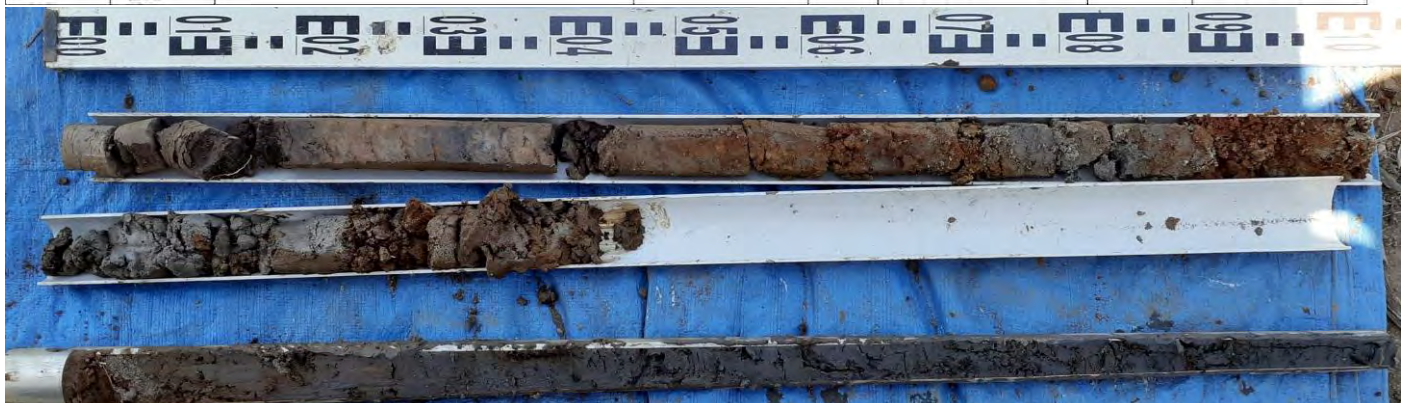
Water quality:

Surface water EC ($\mu\text{S}/\text{cm}$): 1,500
 Surface water pH: 7.79
 Groundwater EC ($\mu\text{S}/\text{cm}$): 1,835
 Groundwater pH: 6.4

Soil profile details:

Project Number: 2018064 Profile ID: TW_13_A
 River/estuary: Tweed Sample date: 08/11/19
 Easting: 542040.1 Sampled by: AJH GL
 Northing: 6865445.9
 Ground elevation (m AHD): 1.03
 Hydraulic conductivity (m/d): 0.20

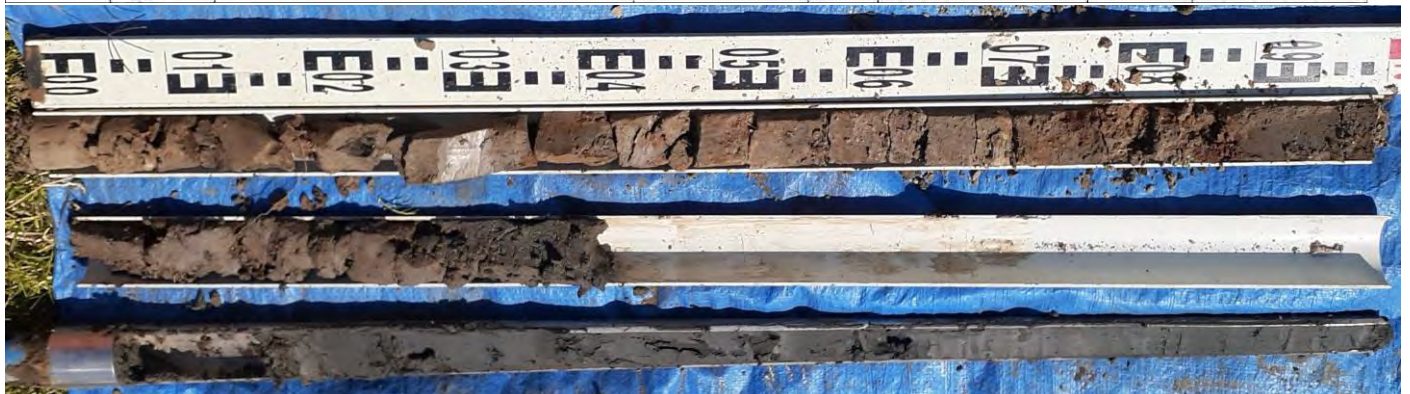
Water quality:

Surface water EC (µS/cm): 840
 Surface water pH: 6.6
 Groundwater EC (µS/cm): 1,520
 Groundwater pH: 6.4

Soil profile details:

Project Number: 2018064 Profile ID: TW_13_P
 River/estuary: Tweed Sample date: 22/10/19
 Easting: 543855.7 Sampled by: TAT DWJ
 Northing: 6869001.7
 Ground elevation (m AHD): 0.78
 Hydraulic conductivity (m/d): 2.84

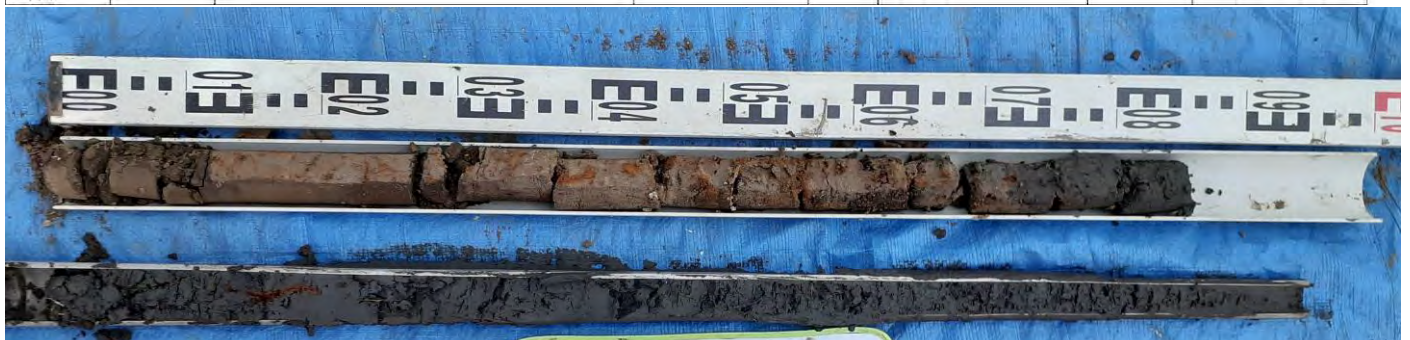
Water quality:

Surface water EC ($\mu\text{S/cm}$): 36,551
 Surface water pH: 6.87
 Groundwater EC ($\mu\text{S/cm}$): 3,737
 Groundwater pH: 6.66

Soil profile details:

Project Number: 2018064 Profile ID: TW_14_P
 River/estuary: Tweed Sample date: 15/10/19
 Easting: 547887.7 Sampled by: TAT DWJ
 Northing: 6870903.2
 Ground elevation (m AHD): 0.34
 Hydraulic conductivity (m/d): Not measured

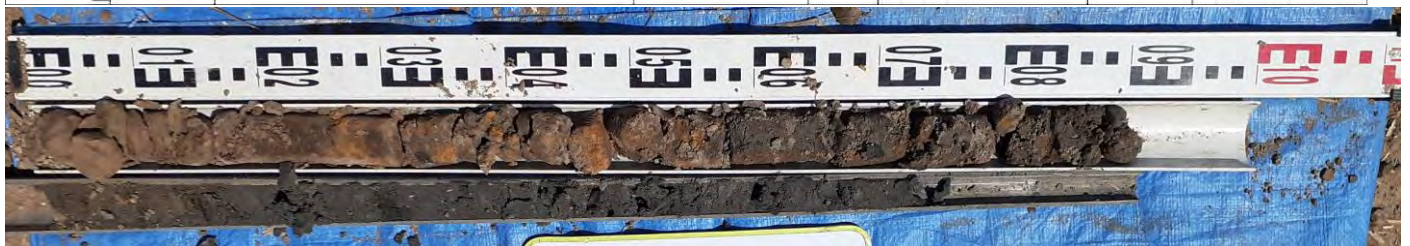
Soil profile details:

Project Number: 2018064 Profile ID: TW_20_P
 River/estuary: Tweed Sample date: 21/10/19
 Easting: 552417 Sampled by: TAT DWJ
 Northing: 6878457.6
 Ground elevation (m AHD): 0.37
 Hydraulic conductivity (m/d): Not measured

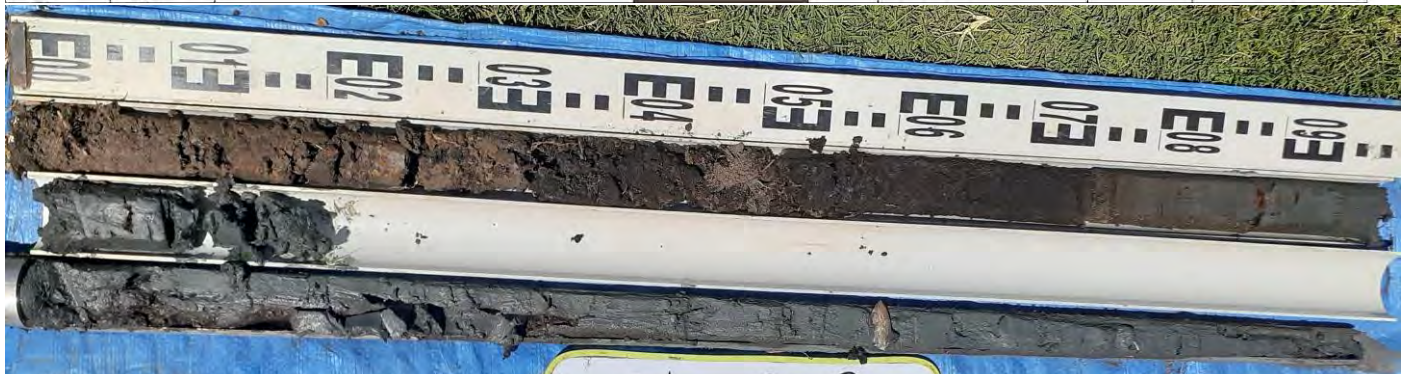
Soil profile details:

Project Number: 2018064 Profile ID: TW_22_A
 River/estuary: Tweed Sample date: 21/10/19
 Easting: 552524.6 Sampled by: TAT DWJ
 Northing: 6878598.9
 Ground elevation (m AHD): -0.01
 Hydraulic conductivity (m/d): Not measured

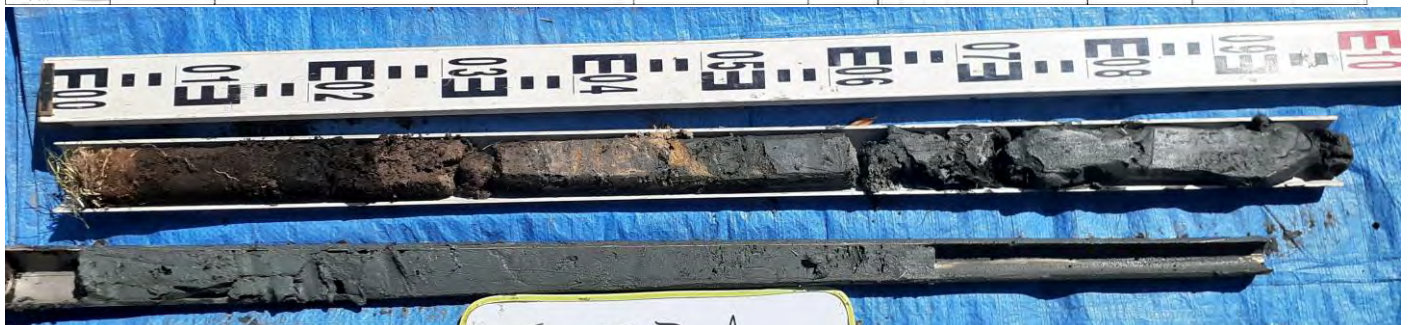
Water quality:

Surface water EC ($\mu\text{S/cm}$): 3,118
 Surface water pH: 7.81
 Groundwater EC ($\mu\text{S/cm}$): Not measured
 Groundwater pH: Not measured

Soil profile details:

Project Number: 2018064 Profile ID: TW_26_A
 River/estuary: Tweed Sample date: 17/10/19
 Easting: 540293.4 Sampled by: TAT DWJ
 Northing: 6871721.5
 Ground elevation (m AHD): 0.74
 Hydraulic conductivity (m/d): Not measured

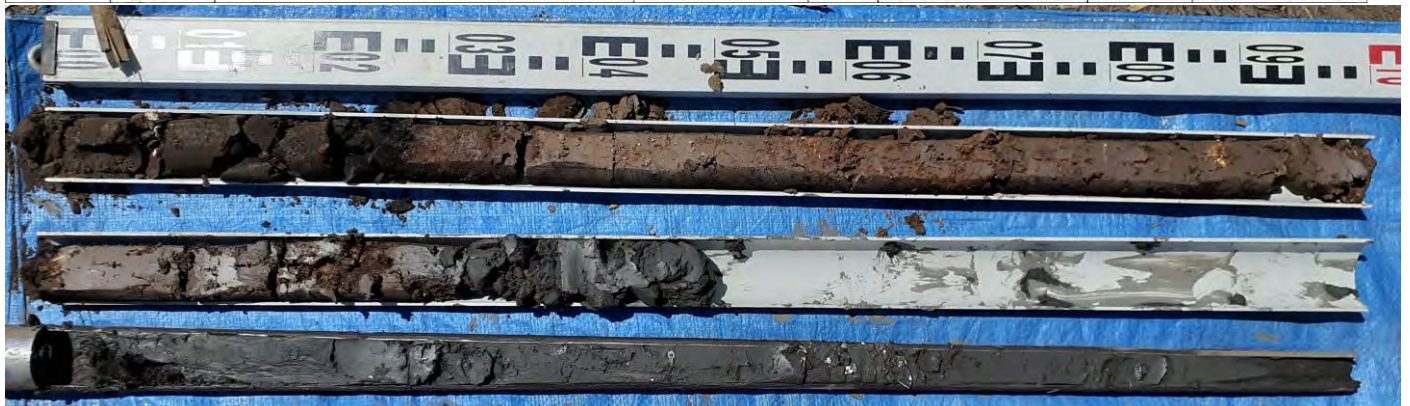
Water quality:

Surface water EC ($\mu\text{S/cm}$): 4,467
 Surface water pH: 5.74
 Groundwater EC ($\mu\text{S/cm}$): Not measured
 Groundwater pH: Not measured

Soil profile details:

Project Number: 2018064 Profile ID: TW_27_A
 River/estuary: Tweed Sample date: 18/10/19
 Easting: 540215.8 Sampled by: TAT DWJ
 Northing: 6869551.5
 Ground elevation (m AHD): 0.84
 Hydraulic conductivity (m/d): 3.27

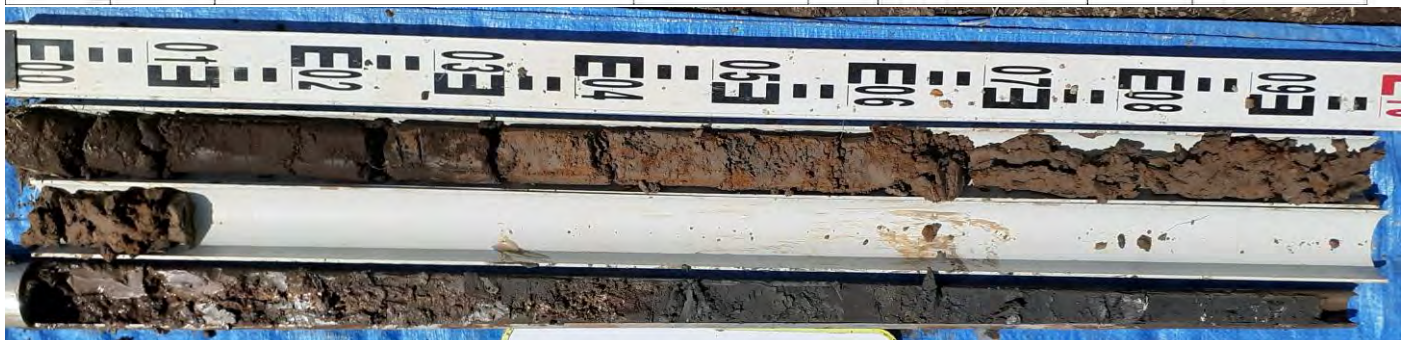
Water quality:

Surface water EC ($\mu\text{S/cm}$): 20,751
 Surface water pH: 7.07
 Groundwater EC ($\mu\text{S/cm}$): 3,547
 Groundwater pH: 5.04

Soil profile details:

Project Number: 2018064 Profile ID: TW_27_P
 River/estuary: Tweed Sample date: 18/10/19
 Easting: 539680.5 Sampled by: TAT DWJ
 Northing: 6869308.9
 Ground elevation (m AHD): 0.91
 Hydraulic conductivity (m/d): 0.47

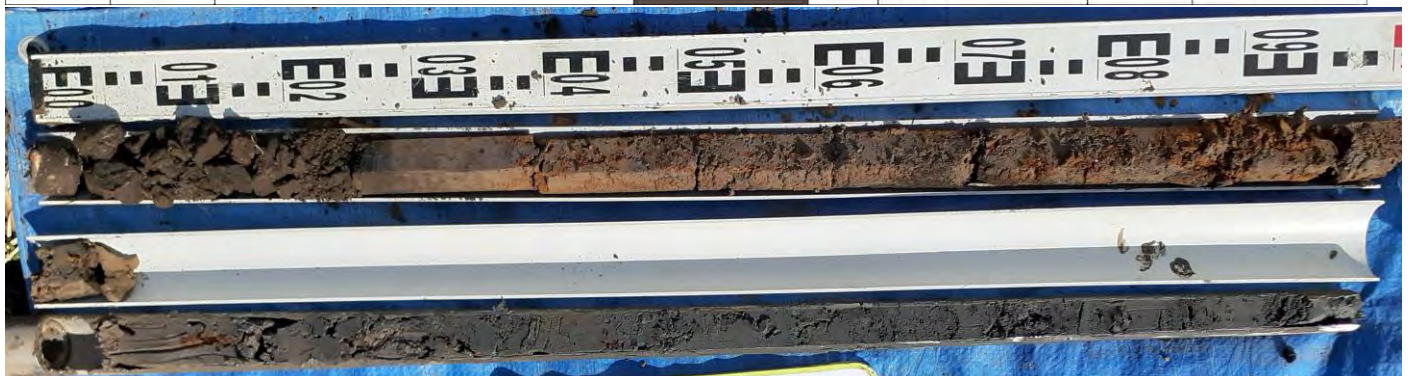
Water quality:

Surface water EC ($\mu\text{S/cm}$): 16,124
 Surface water pH: 7.34
 Groundwater EC ($\mu\text{S/cm}$): 2,452
 Groundwater pH: 6.82

Soil profile details:

Project Number: 2018064 Profile ID: TW_31_P
 River/estuary: Tweed Sample date: 24/02/20
 Easting: 536772.9 Sampled by: AJH DWJ
 Northing: 6867337.5
 Ground elevation (m AHD): 0.91
 Hydraulic conductivity (m/d): 0.25

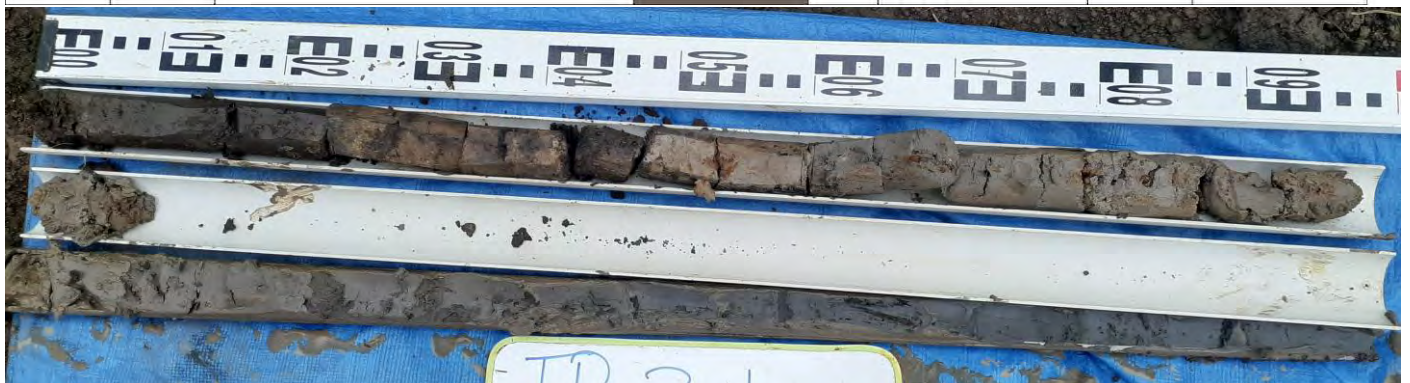
Water quality:

Surface water EC ($\mu\text{S/cm}$): 343
 Surface water pH: 6
 Groundwater EC ($\mu\text{S/cm}$): 1,646
 Groundwater pH: 5.05

Soil profile details:

Project Number: 2018064 Profile ID: TW_32_A
 River/estuary: Tweed Sample date: 23/10/19
 Easting: 538725 Sampled by: TAT DWJ
 Northing: 6865243.3
 Ground elevation (m AHD): 0.96
 Hydraulic conductivity (m/d): 0.74

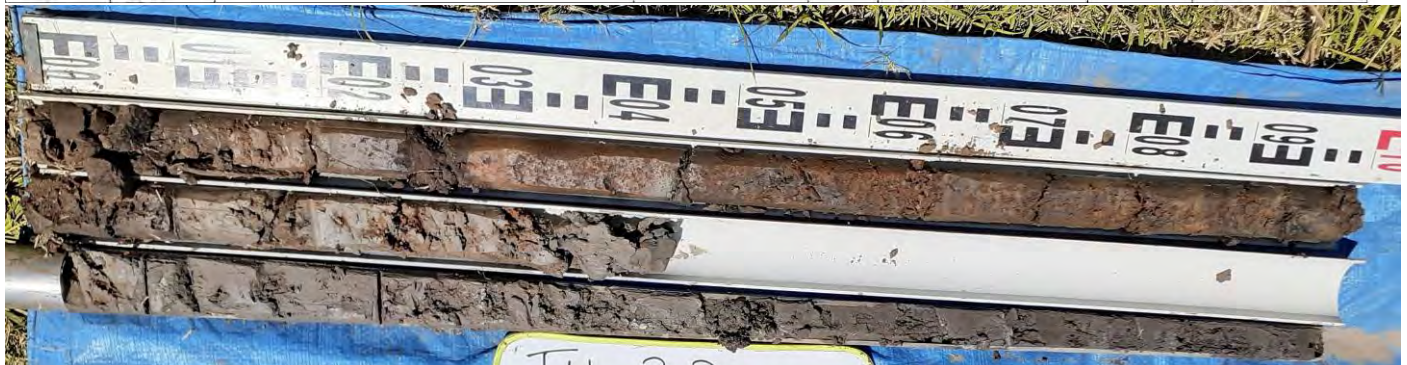
Water quality:

Surface water EC ($\mu\text{S/cm}$): 24,591
 Surface water pH: 6.29
 Groundwater EC ($\mu\text{S/cm}$): 1,757
 Groundwater pH: 6.26

Soil profile details:

Project Number: 2018064 Profile ID: TW_35_P
 River/estuary: Tweed Sample date: 07/11/19
 Easting: 541453.3 Sampled by: AJH GL
 Northing: 6865542.3
 Ground elevation (m AHD): 0.91
 Hydraulic conductivity (m/d): 0.31

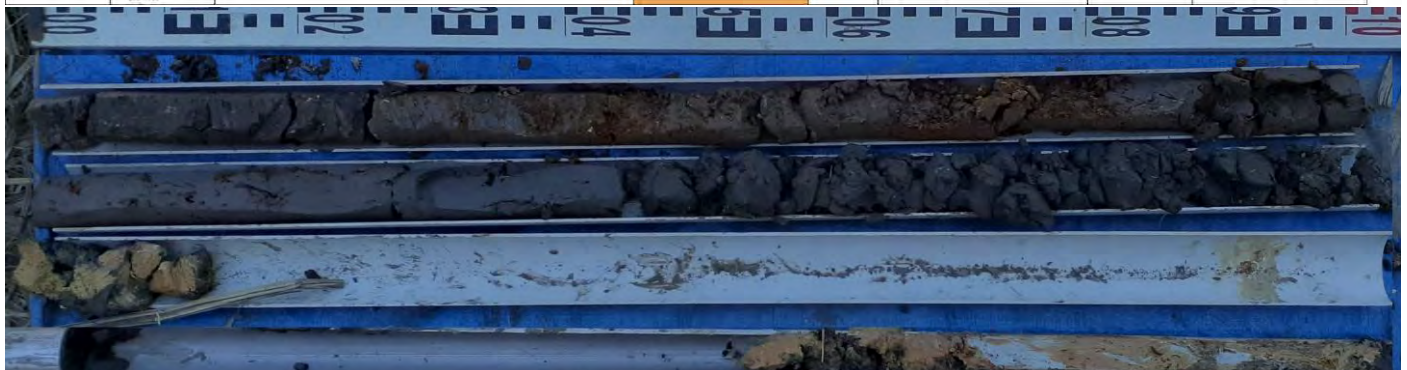
Water quality:

Surface water EC ($\mu\text{S/cm}$): 1,300
 Surface water pH: 6.7
 Groundwater EC ($\mu\text{S/cm}$): 3,600
 Groundwater pH: 5.6

Soil profile details:

Project Number: 2018064 Profile ID: TW_36_A
 River/estuary: Tweed Sample date: 07/11/19
 Easting: 539624.6 Sampled by: AJH GL
 Northing: 6865081.8
 Ground elevation (m AHD): 1.31
 Hydraulic conductivity (m/d): Not measured

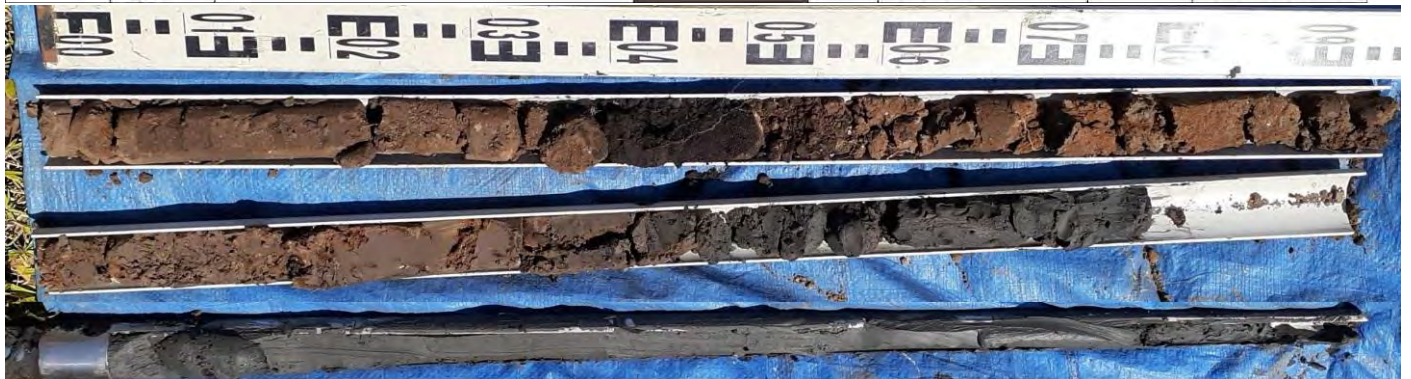
Water quality:

Surface water EC ($\mu\text{S/cm}$): 31,203
 Surface water pH: 7.09
 Groundwater EC ($\mu\text{S/cm}$): Not measured
 Groundwater pH: Not measured

Soil profile details:

Project Number: 2018064 Profile ID: TW_36_P
 River/estuary: Tweed Sample date: 08/11/19
 Easting: 540355.4 Sampled by: AJH GL
 Northing: 6864934.2
 Ground elevation (m AHD): 0.47
 Hydraulic conductivity (m/d): Not measured

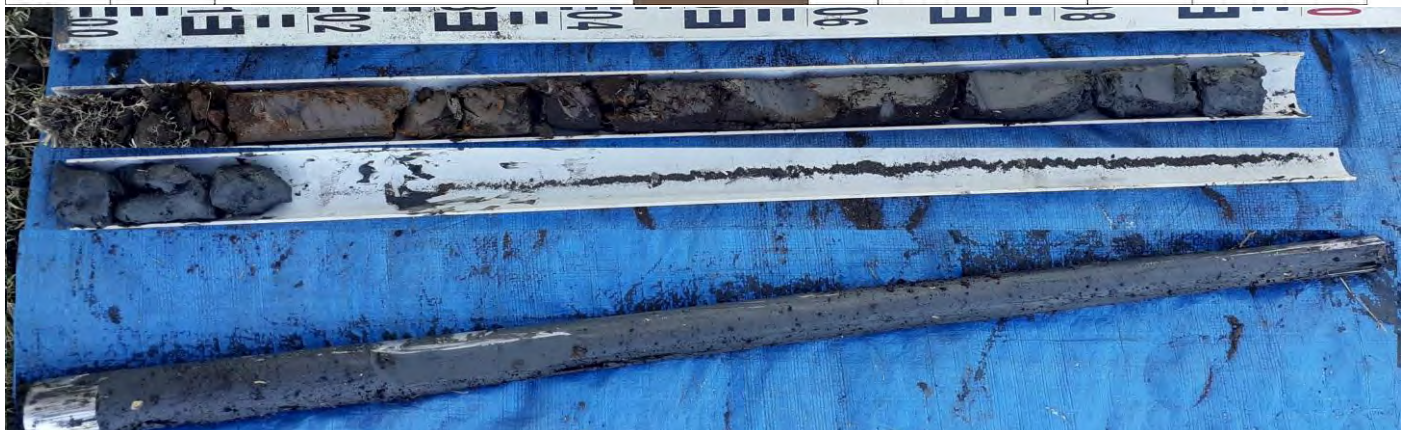
Water quality:

Surface water EC ($\mu\text{S/cm}$): 23,000 (Black Drain)
 Surface water pH: 6.9 (Black Drain)
 Groundwater EC ($\mu\text{S/cm}$): Not measured
 Groundwater pH: Not measured

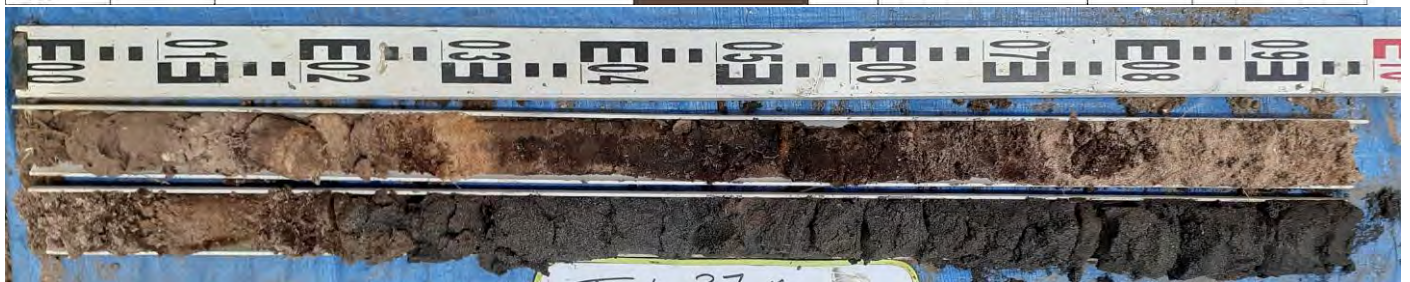
Project Number: 2018064 Profile ID: TW_37_A
 River/estuary: Tweed Sample date: 19/10/19
 Easting: 543850 Sampled by: TAT DWJ
 Northing: 6867300.3
 Ground elevation (m AHD): 0.98
 Hydraulic conductivity (m/d): Not measured

Water quality:

Surface water EC ($\mu\text{S/cm}$): Not measured
 Surface water pH: Not measured
 Groundwater EC ($\mu\text{S/cm}$): 1,189
 Groundwater pH: 4.04

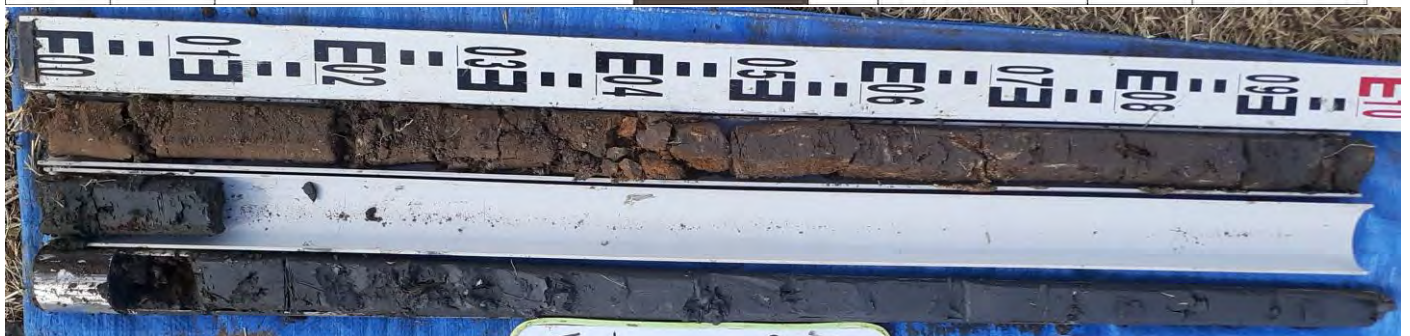
Project Number: 2018064 Profile ID: TW_37_P
 River/estuary: Tweed Sample date: 22/10/19
 Easting: 544020.7 Sampled by: TAT DWJ
 Northing: 6867003.8
 Ground elevation (m AHD): 0.76
 Hydraulic conductivity (m/d): 4.96

Water quality:

Surface water EC ($\mu\text{S/cm}$): 1,269
 Surface water pH: 6.93
 Groundwater EC ($\mu\text{S/cm}$): 3,915
 Groundwater pH: 6.88
