Tweed River Floodplain Prioritisation Study: Appendix A – L

WRL TR 2020/04, June 2023

UNSW
Water Research
Laboratory

Appendix A Floodplain drainage

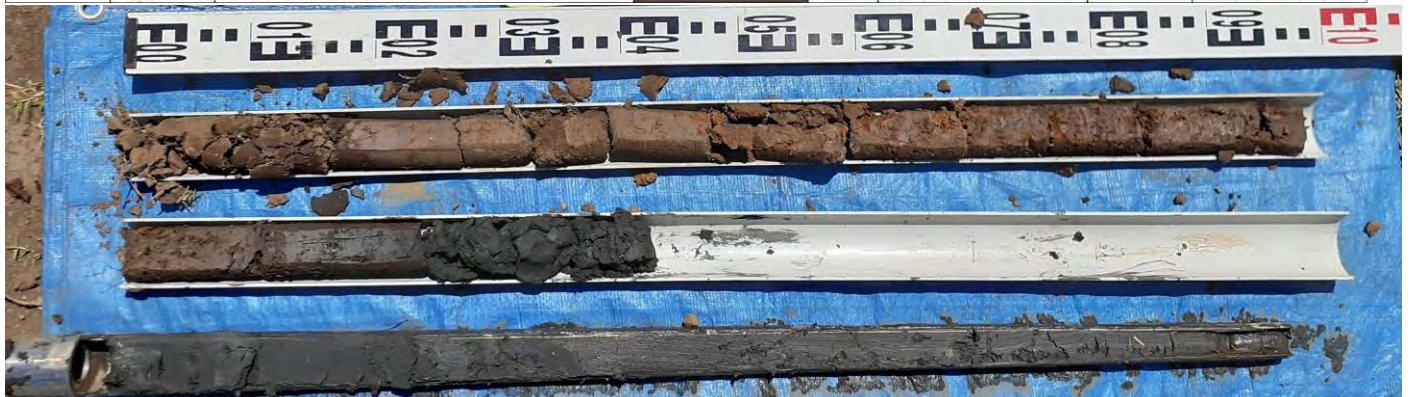
Project Number: 2018064 Profile ID: TW_38_A
 River/estuary: Tweed Sample date: 16/10/19
 Easting: 545358.8 Sampled by: TAT DWJ
 Northing: 6869126.9
 Ground elevation (m AHD): 0.83
 Hydraulic conductivity (m/d): 0.38

Water quality:

Surface water EC ($\mu\text{S/cm}$): 24,852
 Surface water pH: 6.87
 Groundwater EC ($\mu\text{S/cm}$): 3,431
 Groundwater pH: 6.47

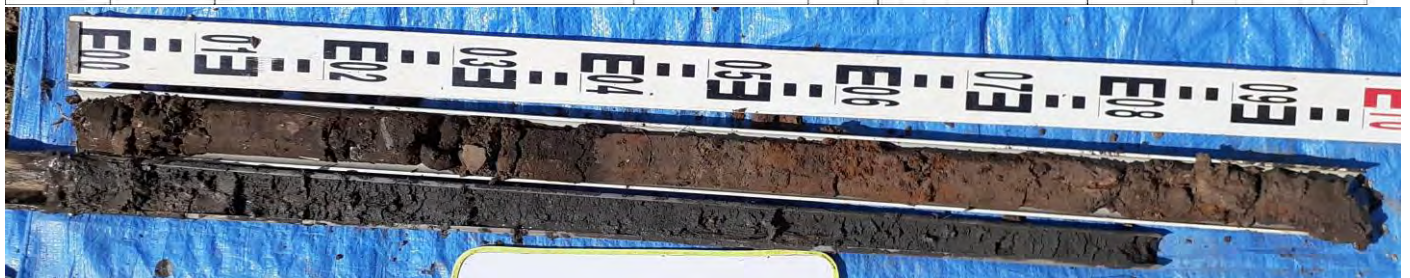
Project Number: 2018064 Profile ID: TW_42_A
 River/estuary: Tweed Sample date: 16/10/19
 Easting: 547652.2 Sampled by: TAT DWJ
 Northing: 6871886.3
 Ground elevation (m AHD): 0.53
 Hydraulic conductivity (m/d): 0.67

Water quality:

Surface water EC ($\mu\text{S/cm}$): Not measured
 Surface water pH: Not measured
 Groundwater EC ($\mu\text{S/cm}$): 4,658
 Groundwater pH: 6.38

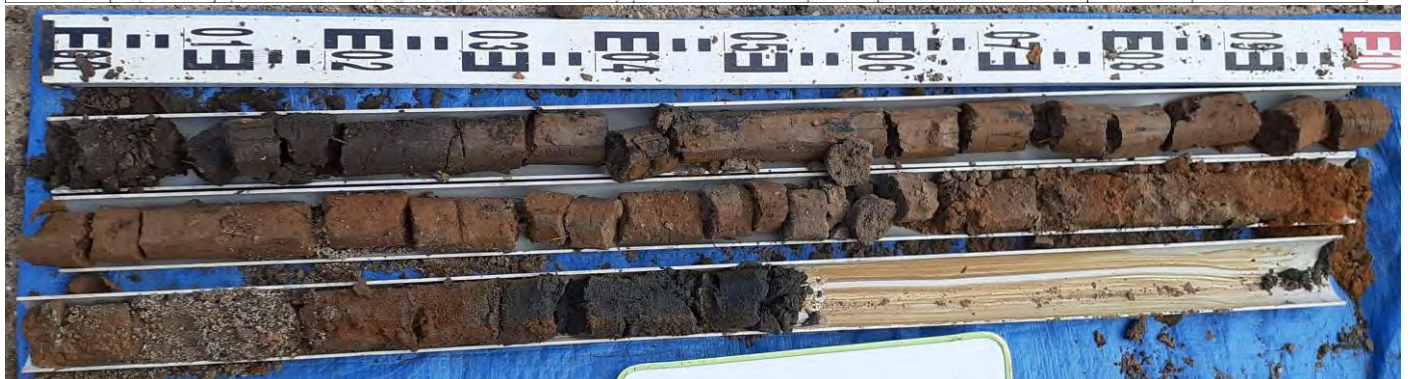
Project Number: 2018064 Profile ID: TW_43_A
 River/estuary: Tweed Sample date: 15/10/19
 Easting: 542750.3 Sampled by: TAT DWJ
 Northing: 6867528.9
 Ground elevation (m AHD): 2.53
 Hydraulic conductivity (m/d): Not measured

Water quality:

Surface water EC ($\mu\text{S}/\text{cm}$): 20,988
 Surface water pH: 6.99
 Groundwater EC ($\mu\text{S}/\text{cm}$): Not measured
 Groundwater pH: Not measured

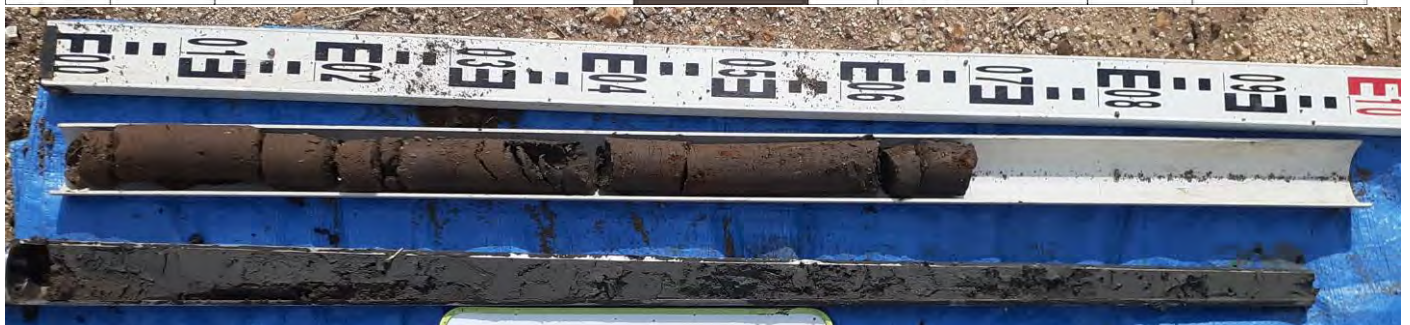
Project Number: 2018064 Profile ID: TW_43_P
 River/estuary: Tweed Sample date: 15/10/19
 Easting: 548377.3 Sampled by: TAT DWJ
 Northing: 6871744.6
 Ground elevation (m AHD): 0.23
 Hydraulic conductivity (m/d): 2.12

Water quality:

Surface water EC ($\mu\text{S/cm}$): Not measured
 Surface water pH: Not measured
 Groundwater EC ($\mu\text{S/cm}$): 6,348
 Groundwater pH: 6.49

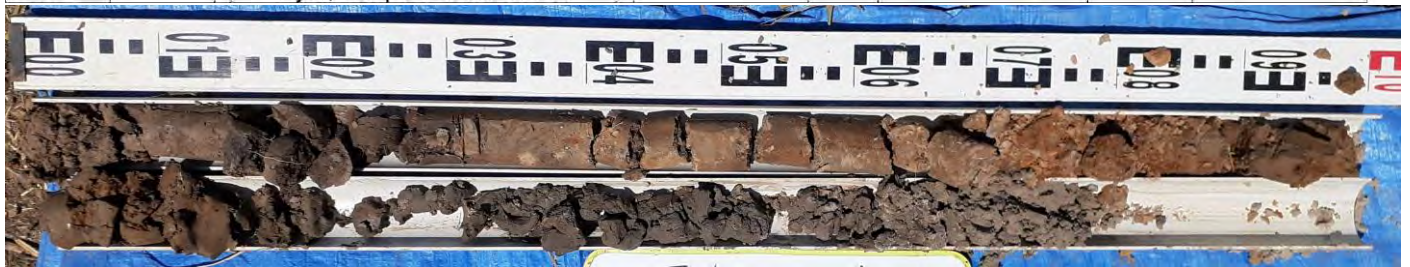
Project Number: 2018064 Profile ID: TW_44_A
 River/estuary: Tweed Sample date: 16/10/19
 Easting: 545813 Sampled by: TAT DWJ
 Northing: 6871053.6
 Ground elevation (m AHD): 1.09
 Hydraulic conductivity (m/d): Not measured

Water quality:

Surface water EC ($\mu\text{S/cm}$): 36,046
 Surface water pH: 7.12
 Groundwater EC ($\mu\text{S/cm}$): Not measured
 Groundwater pH: Not measured

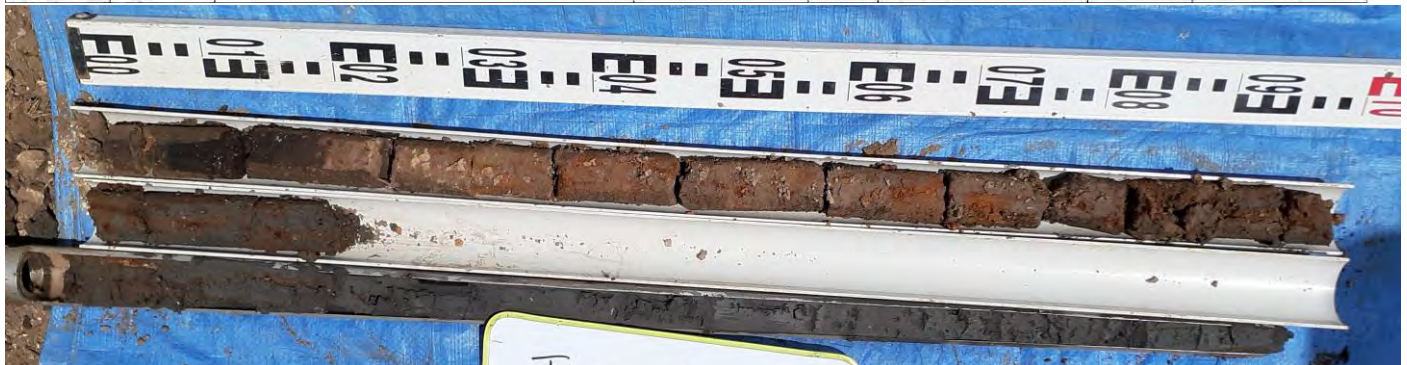
Project Number: 2018064 Profile ID: TW_45_P
 River/estuary: Tweed Sample date: 15/10/19
 Easting: 543189.1 Sampled by: TAT DWJ
 Northing: 6867459.4
 Ground elevation (m AHD): 1.19
 Hydraulic conductivity (m/d): 2.88

Water quality:

Surface water EC ($\mu\text{S/cm}$): 11,876
 Surface water pH: 5.03
 Groundwater EC ($\mu\text{S/cm}$): Not measured
 Groundwater pH: Not measured

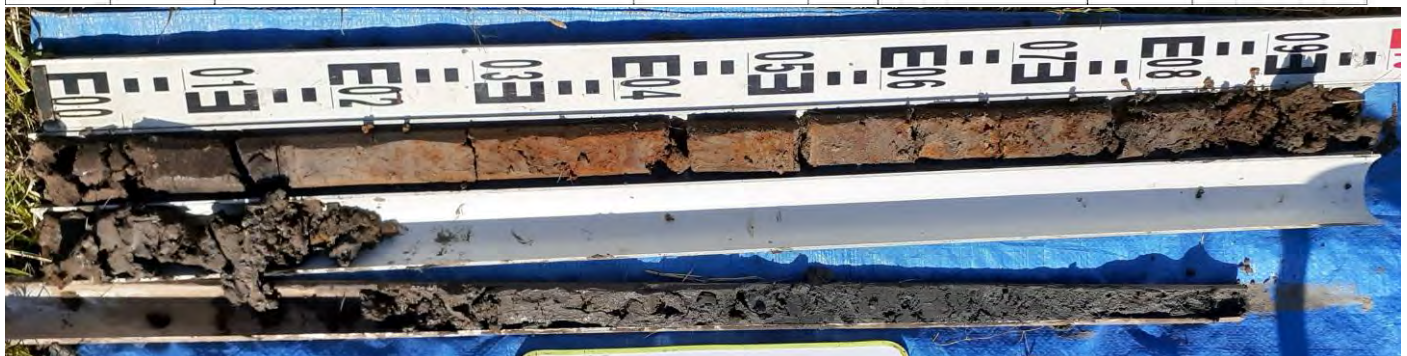
Project Number: 2018064 Profile ID: TW_46_P
 River/estuary: Tweed Sample date: 17/10/19
 Easting: 545905.6 Sampled by: TAT DWJ
 Northing: 6871366.8
 Ground elevation (m AHD): 0.63
 Hydraulic conductivity (m/d): 2.72

Water quality:

Surface water EC ($\mu\text{S/cm}$): 36,728
 Surface water pH: 8.29
 Groundwater EC ($\mu\text{S/cm}$): 5,556
 Groundwater pH: 6.29
